Forensic evaluation of pavement failure Using GPR and UAV technology

Pavement Department Manager, Michael Baker International

Pavement Evaluation 2019 Conference

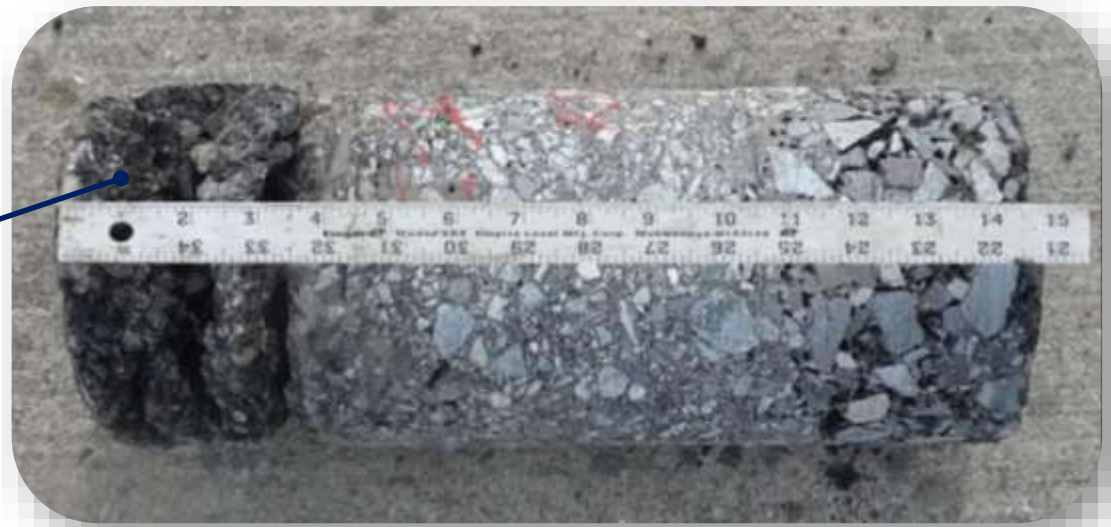
Core 1 (Failed area)

- The core results indicated **significant stripping** of the Hot Mix Asphalt (HMA) surface course in the failed area due to prolonged presence of stagnant water on pavement.

HMA Stripping in
Surface Course

- Seal coat the pavement that was placed circa 2012 between Stations 103+90 to 109+90 (600') to delay further raveling and loss of aggregates.
- Remove the surface course in the failed pavement area to a depth of 4" and replace with a binder rich mix that can resist HMA stripping better. Use of anti-stripping agents in the mix may be considered.
- Regularly remove the deposited aggregates to allow for free flow of surface run-off water and avoid ponding potential.

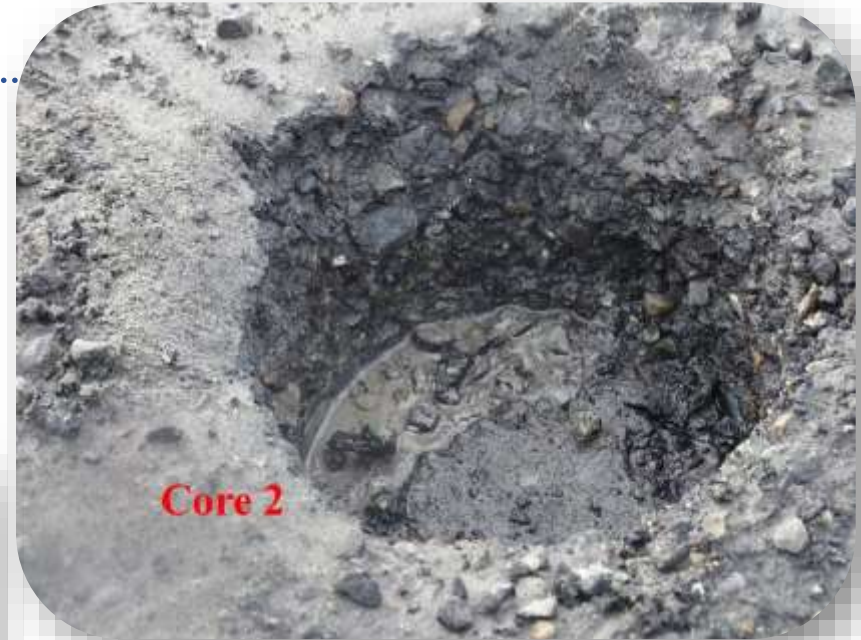
Core 2 (Failed Area; **Severe HMA Stripping**)

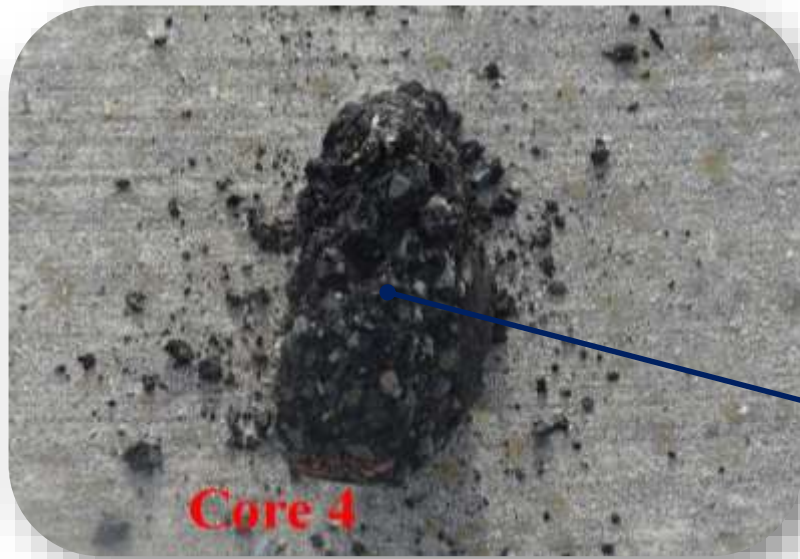
Core 4 (Failed Area)

HMA Stripping in
Surface Course

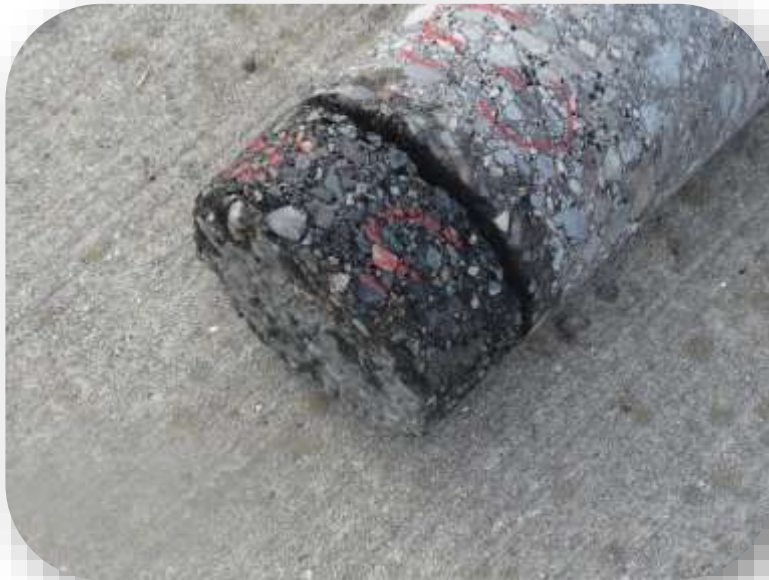
- The HMA stripping was **less severe** further from the failed area.
- Failed pavement area has been subjected to **prolonged presence of stagnant water** that intensifies HMA stripping.

Core 3 (Slight HMA Stripping)

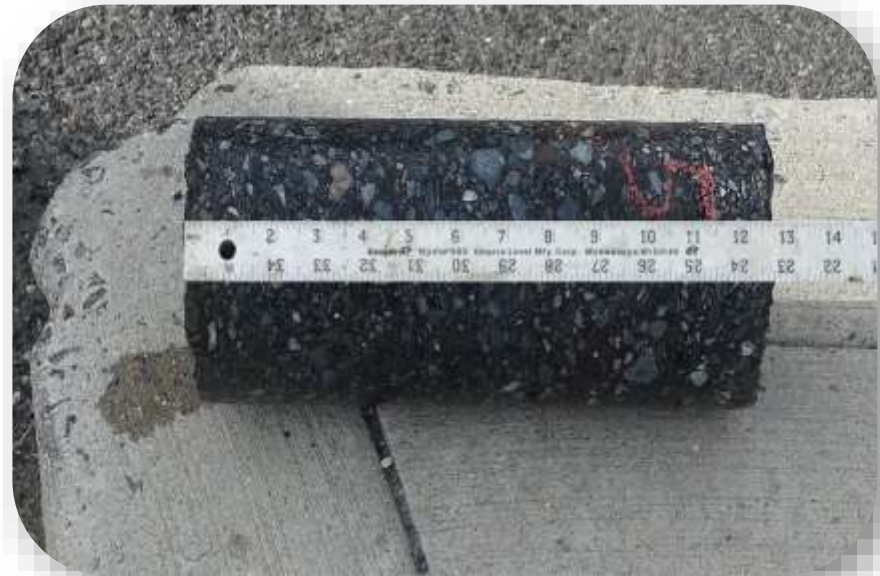
Core 5 (No HMA Stripping)

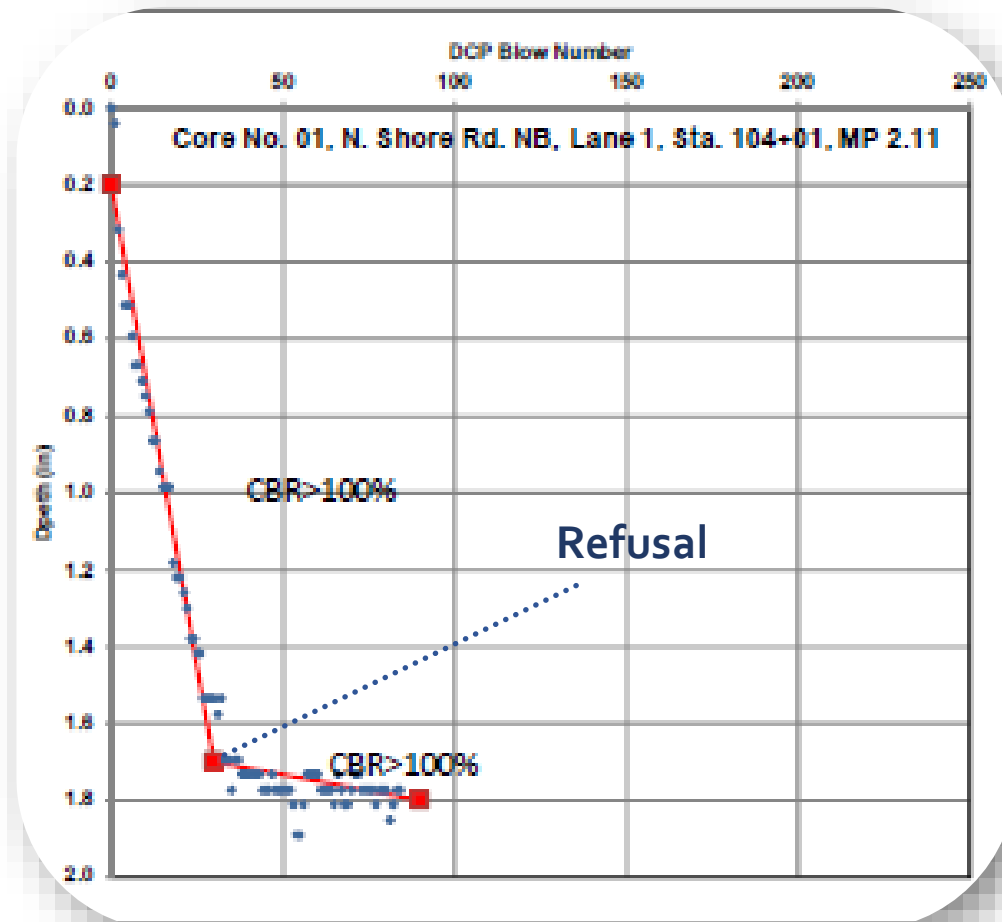
- DCP Testing Indicated a Strong Pavement Base (CBR>100%)

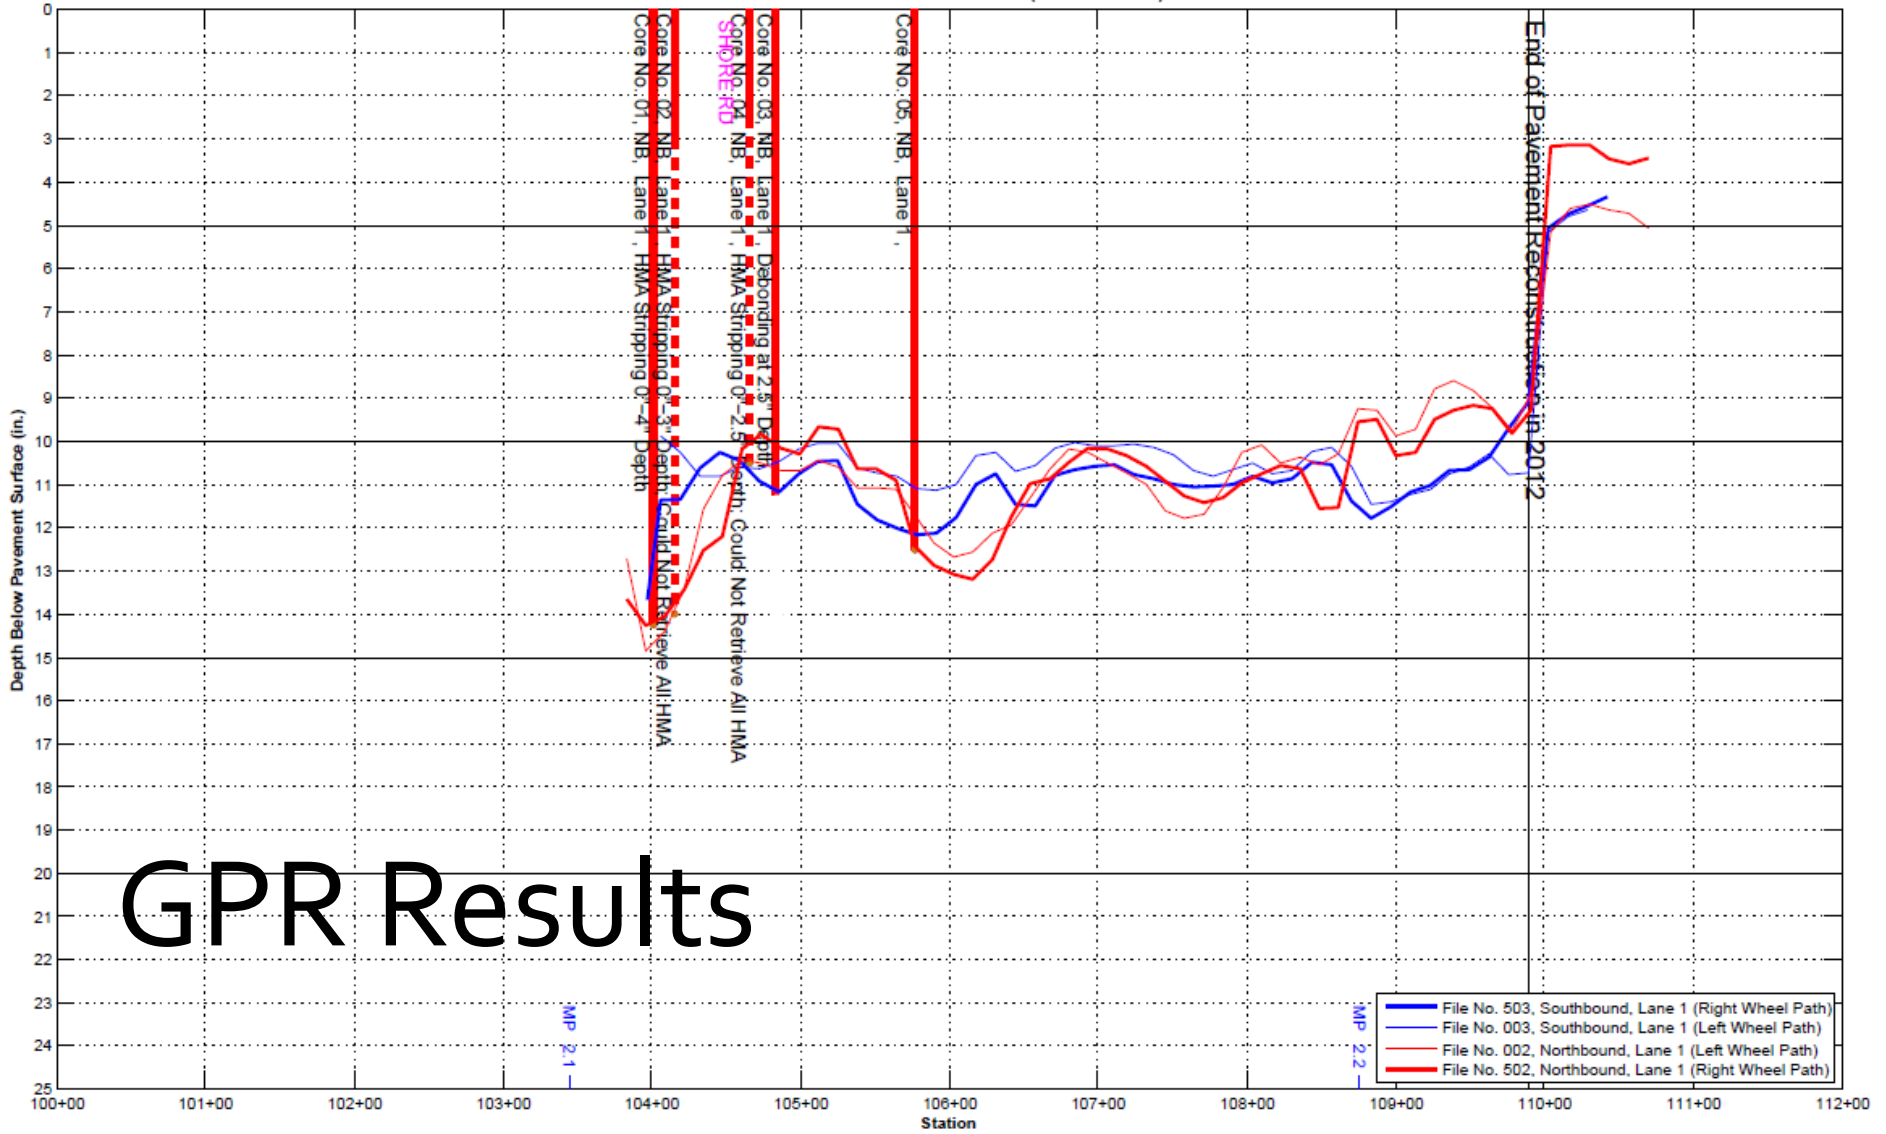
HMA Thickness for Route 52 MP 2.11 (Both Directions)

- Five (5) core samples were extracted from the pavement.
- DCP testing was conducted for three (3) of the cores.
- Based on the core and GPR results, the pavement AC thickness varies from 9" to 14" (average 10").
- The aggregate base layer appears to have been stabilized and DCP could not penetrate indicating California Bearing Ratio (CBR) values more than 100%.
- The relatively thick pavement, strong aggregate base layer, and light traffic indicate that the pavement is structurally adequate. Hence, the cause of the pavement failure is not the structural capacity of the pavement.

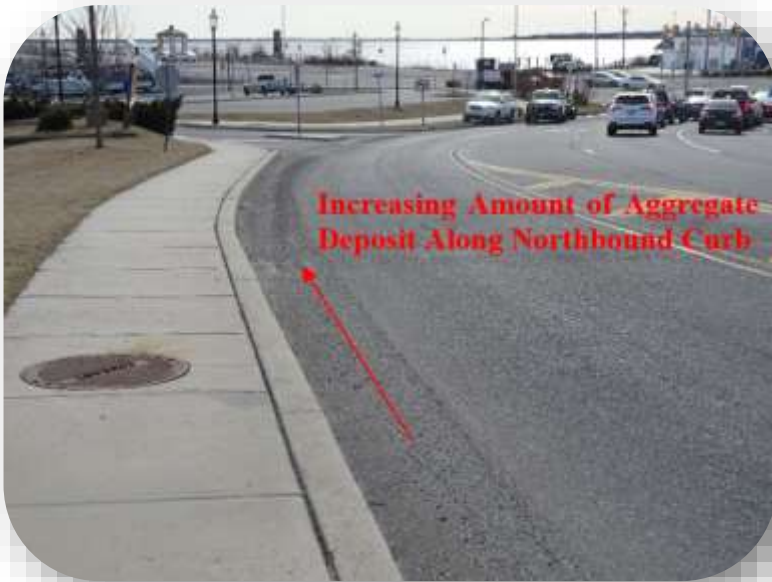
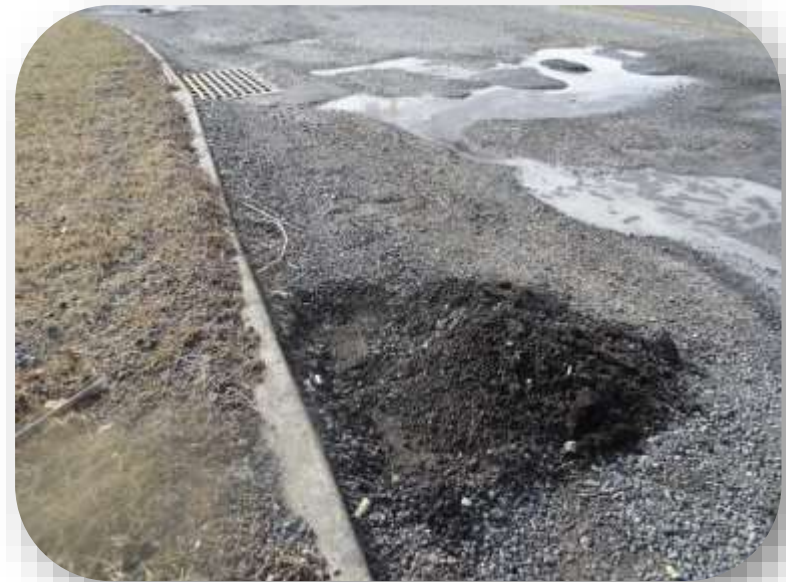
- considerable amount of deposited aggregates observed along the northbound curb on North Shore Road.

- The increasing aggregate deposits are indicative of reduced water velocity (due to decreased slope).

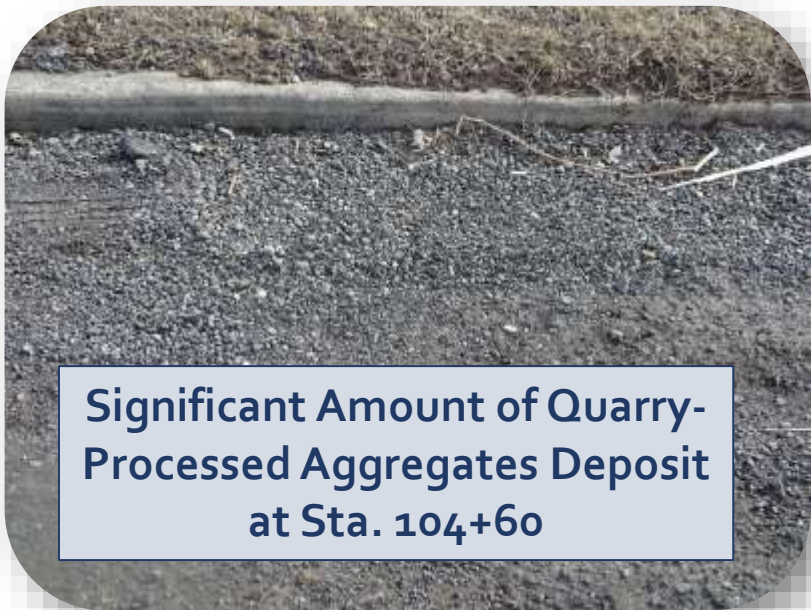
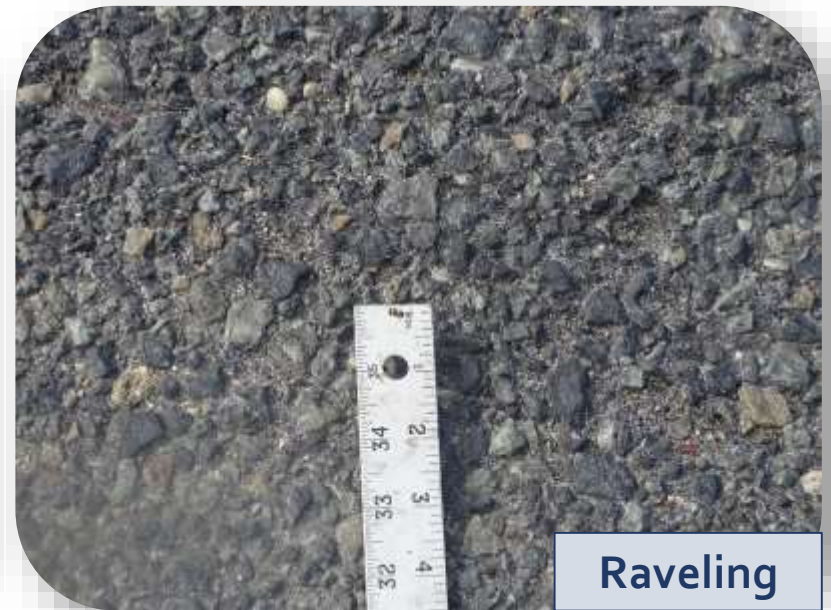
- A review of the pavement surface condition within the project area indicated that the pavement surface course placed circa 2012 shows **signs of raveling** and loss of aggregate, which can be the source of quarry processed aggregates along the curb.

- Mill 3" of the pavement from the intersection of Route 52 to Sta. 109+90 to remove the raveled surface course and overlay with a binder rich surface course resistant to HMA stripping. Use of anti-stripping agents may be considered.
- Survey the area and study drainage issues.
- Use of concrete curb and gutter may be considered to better channel the surface run-off water into the inlets.

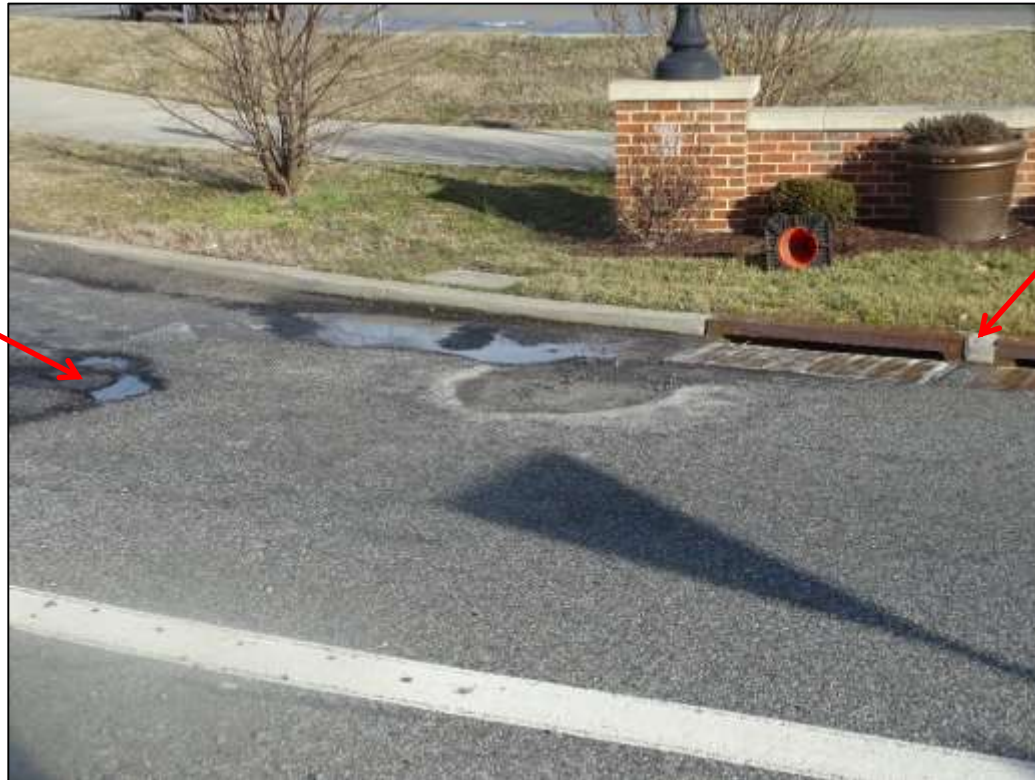
Inlets 1 and 2 Do Not Coincide with Low Point of Road

Approximate
Location of
Low Point of
Road

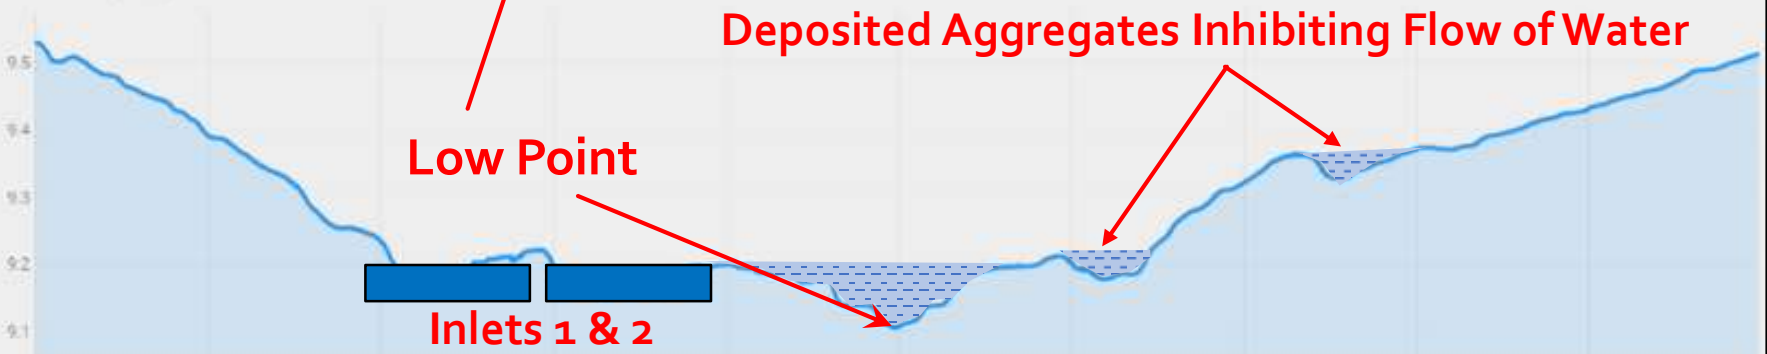
Elevation Profile (feet)

Low Point

Inlets 1 & 2

Deposited Aggregates Inhibiting Flow of Water
