# Evaluating Pavement Texture Uniformity in Connecticut

Pavement Evaluation Conference

ConnDOT - Engineering Services

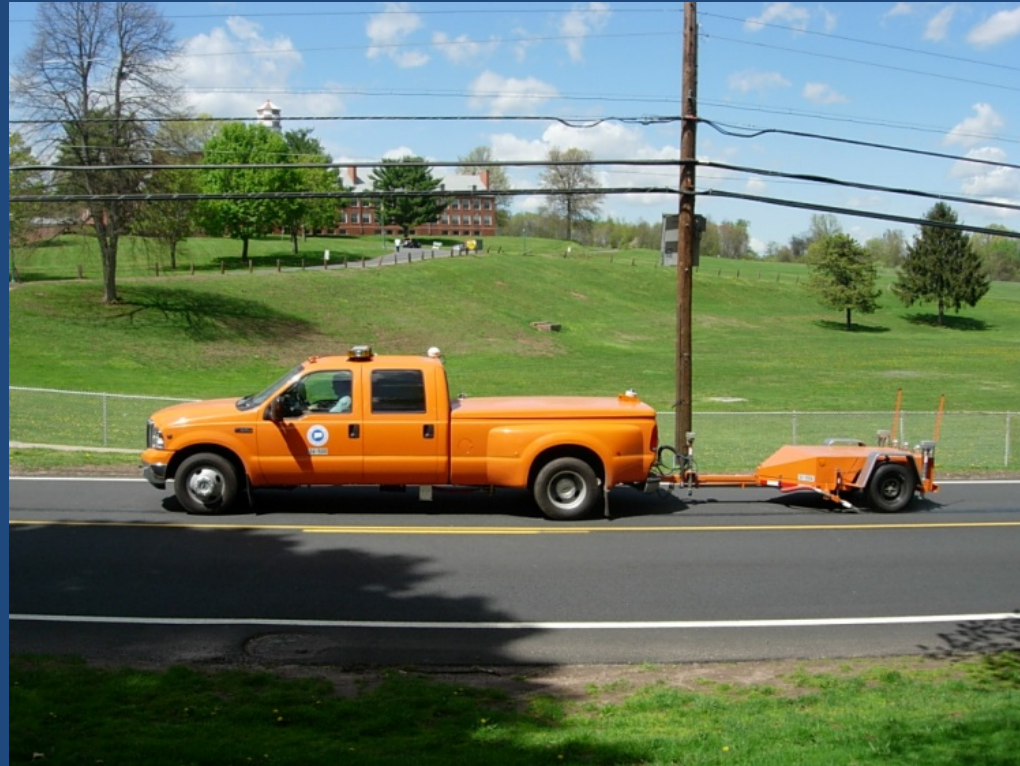
## ASTM E 274 Dynatest Locked-Wheel Pavement Friction Tester

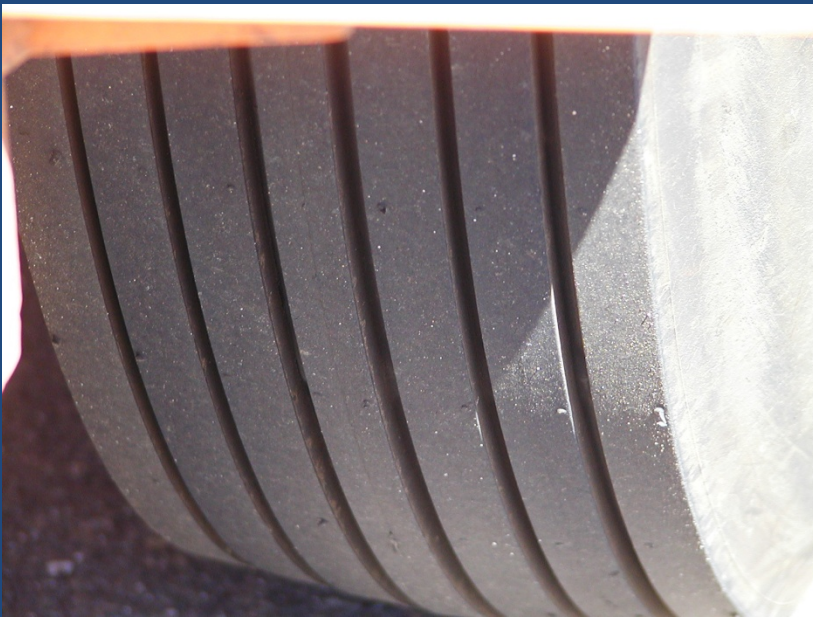
ASTM E 501  
Standard Rib Tire –  
Relates to Pavement Micro-texture  
( $\lambda < 0.02$  inches)

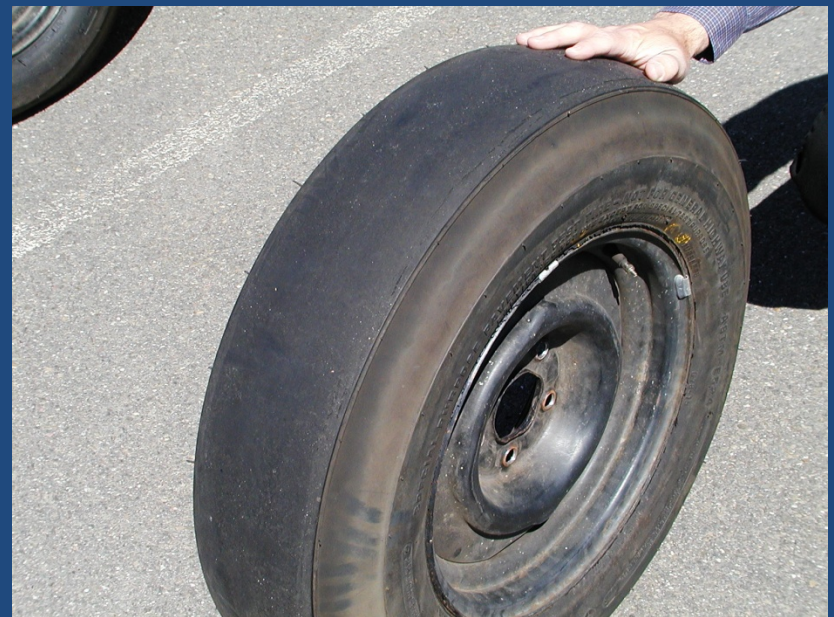
ASTM E 524  
Standard Smooth Tire –  
Relates to Pavement Macro-texture  
( $0.02 < \lambda < 2$  inches)

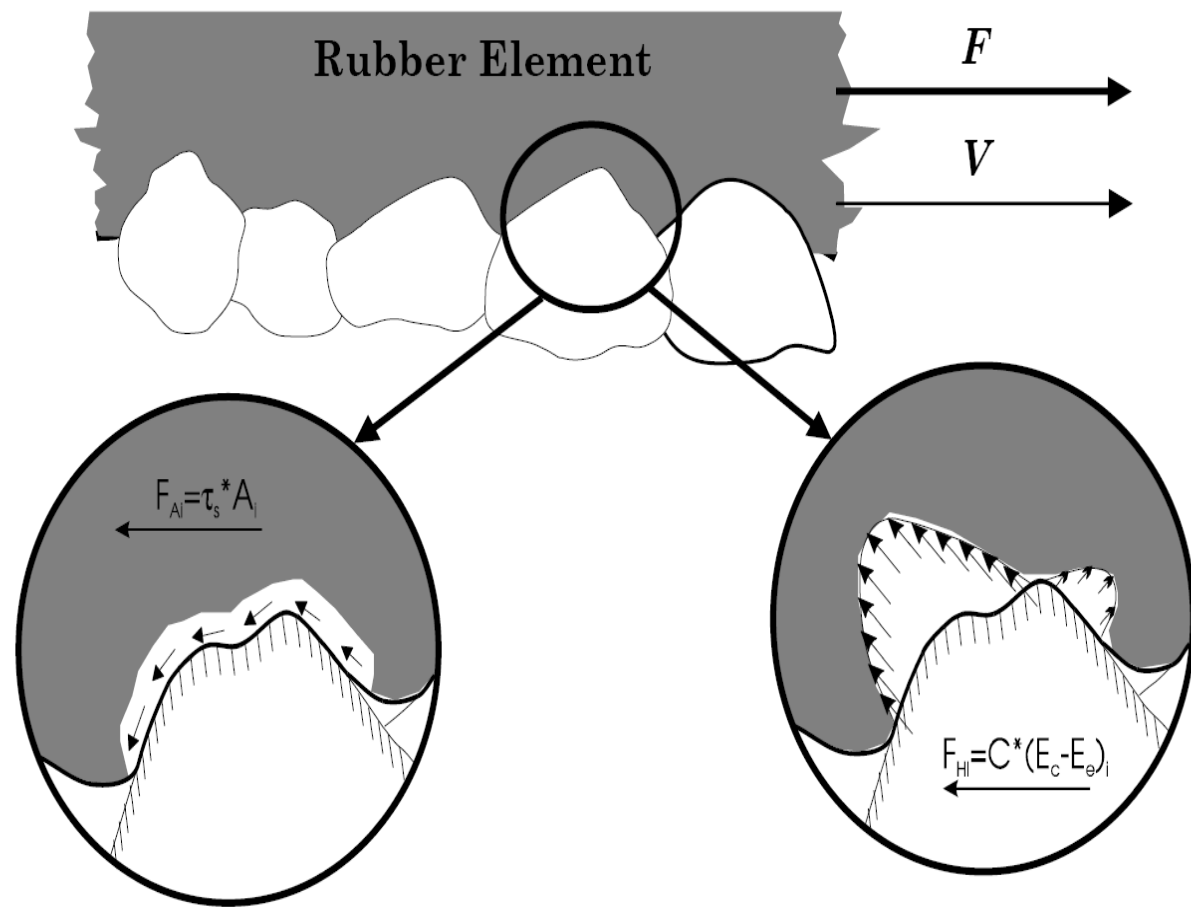
Figure 9. Simplified illustration of the various texture ranges that exist for a given pavement surface (Sandburg, 1998).

**Adhesion**  
Depends mostly on micro-level surface roughness

**Hysteresis**  
Depends mostly on macro-level surface roughness

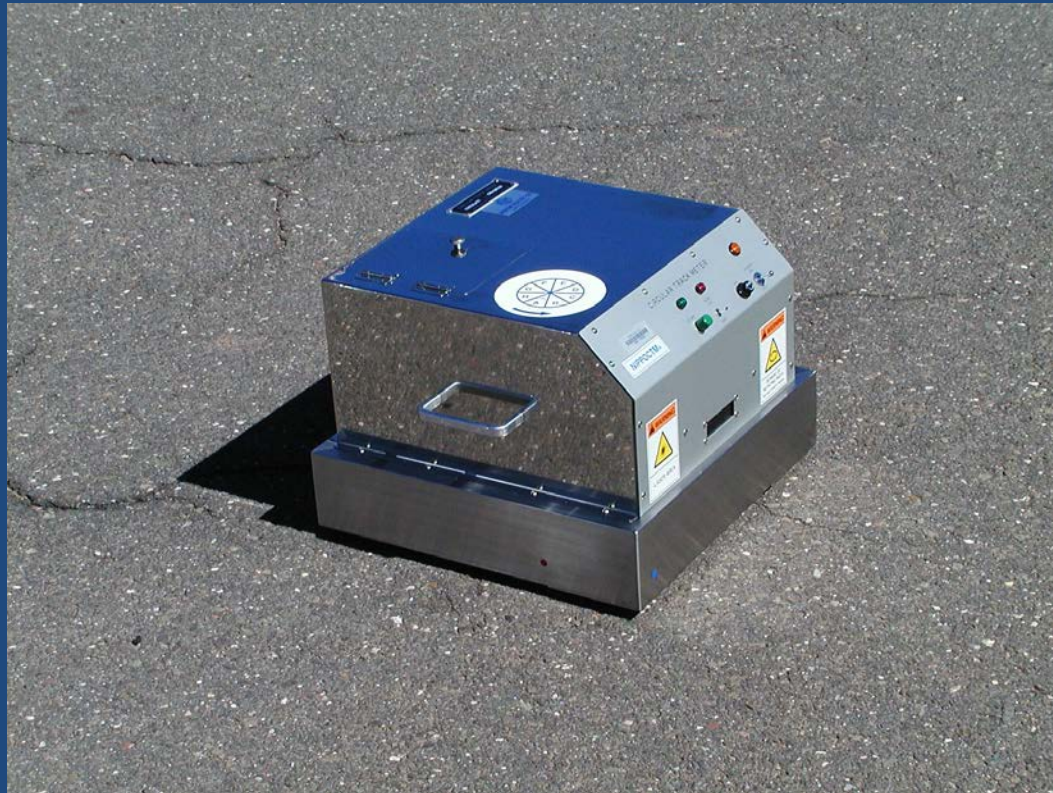
ASTM 2157 Circular Track Meter (CTMeter)

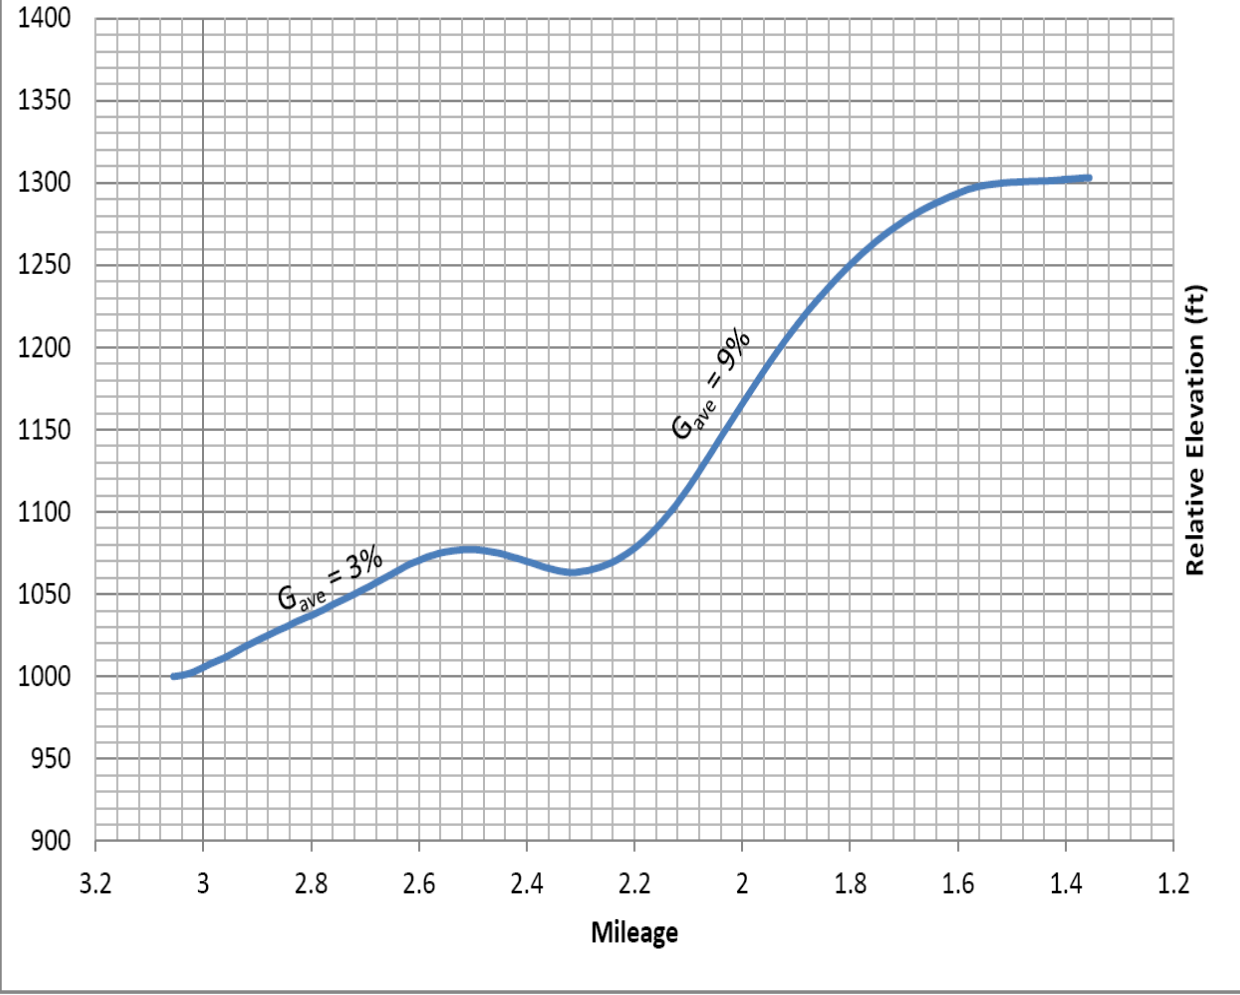
FIGURE 1 Profile from DigitHiway datastream for Route 262 Southbound (shown in reverse log direction).

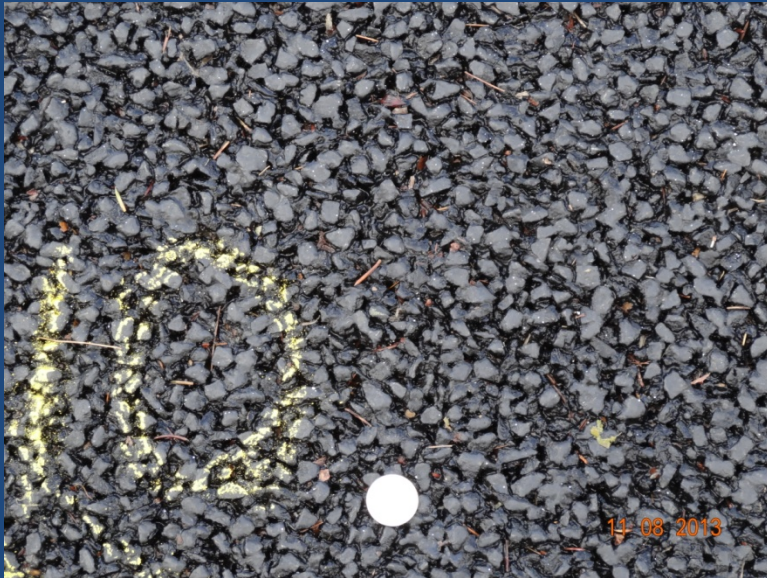
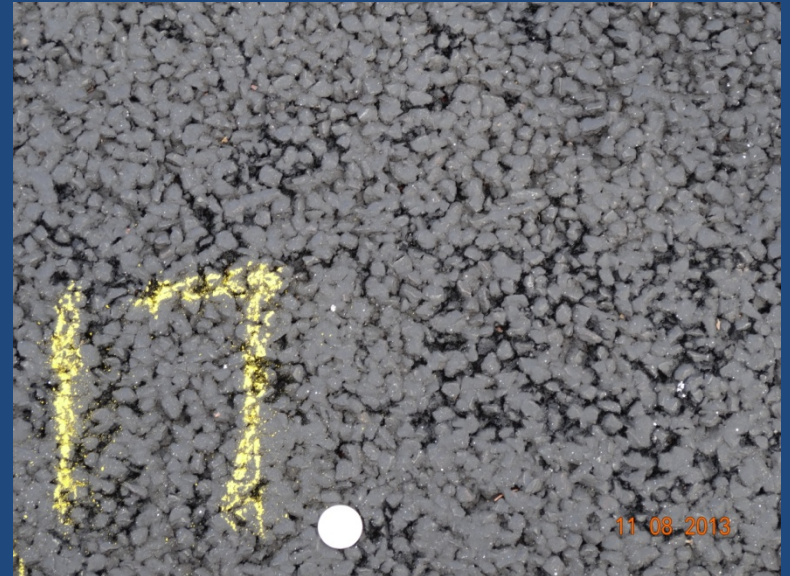
# Texture Uniformity

- Ultra-thin Bonded HMA used on a project on CT Route 4.
- Several isolated areas of bleeding (fat spots) were identified on mat following construction.
- A dispute between the contractor and ConnDOT regarding texture uniformity arose.
