Pavement Evaluation 2019

Assessment of Jointed Concrete Pavement Using Continuous Deflection

Jerry Daleiden, P.E.
ARRB Group, Inc.

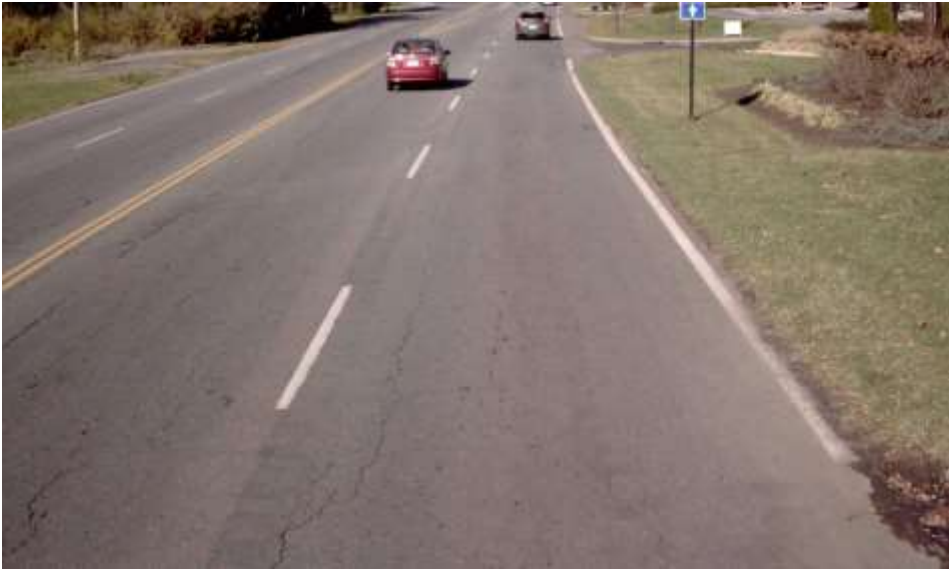
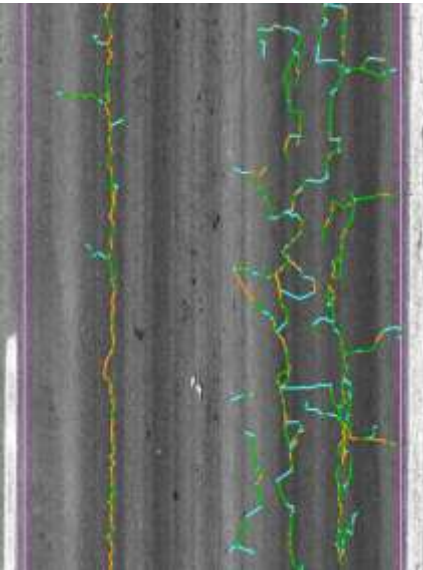
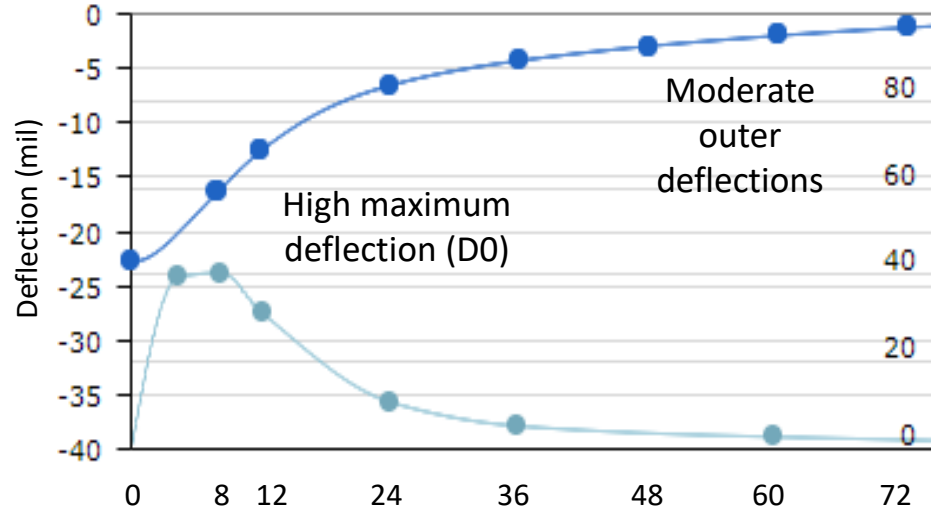
Structurally Deficient+ (Case 1)

Significant visible cracking

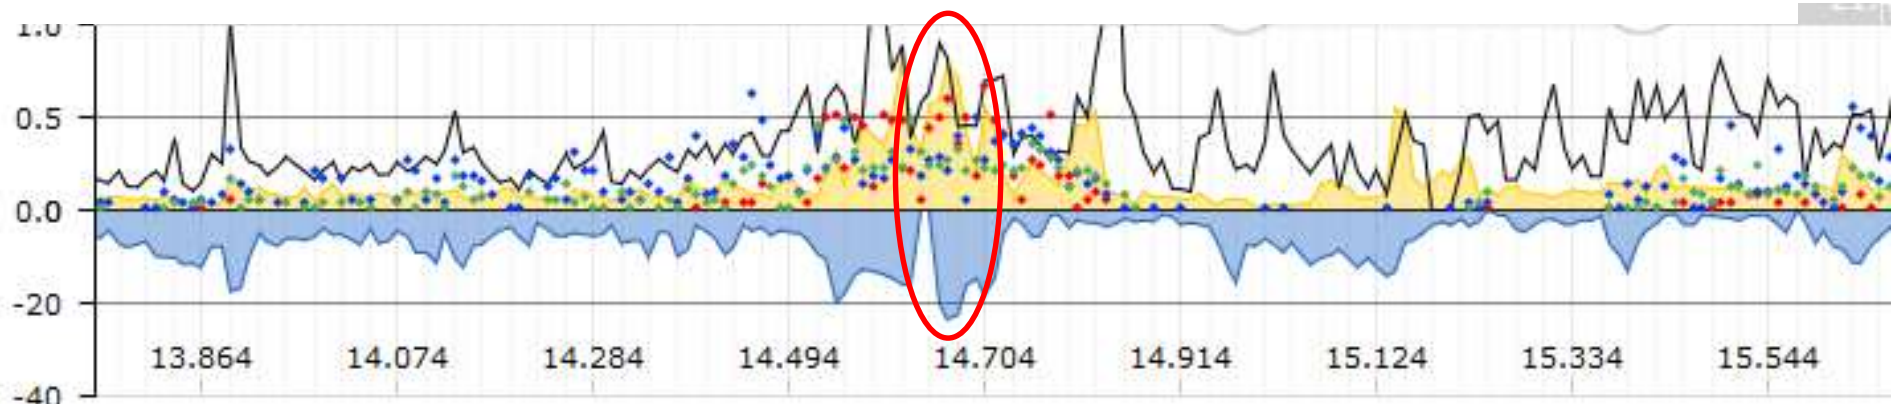
- Maximum Deflection (D0) (mils)
- IRI Right (in/mi)
- Rut Depth Right (in)
- Total Cells Alligator Cracked (%)
- Total Cells Longitudinal Cracked (%)
- Total Cells Transverse Cracked (%)

- Filters:**
- IRI > 120
 - Rutting > 0.3 in
 - WP Cracking > 50%
 - D0 > 21 mils

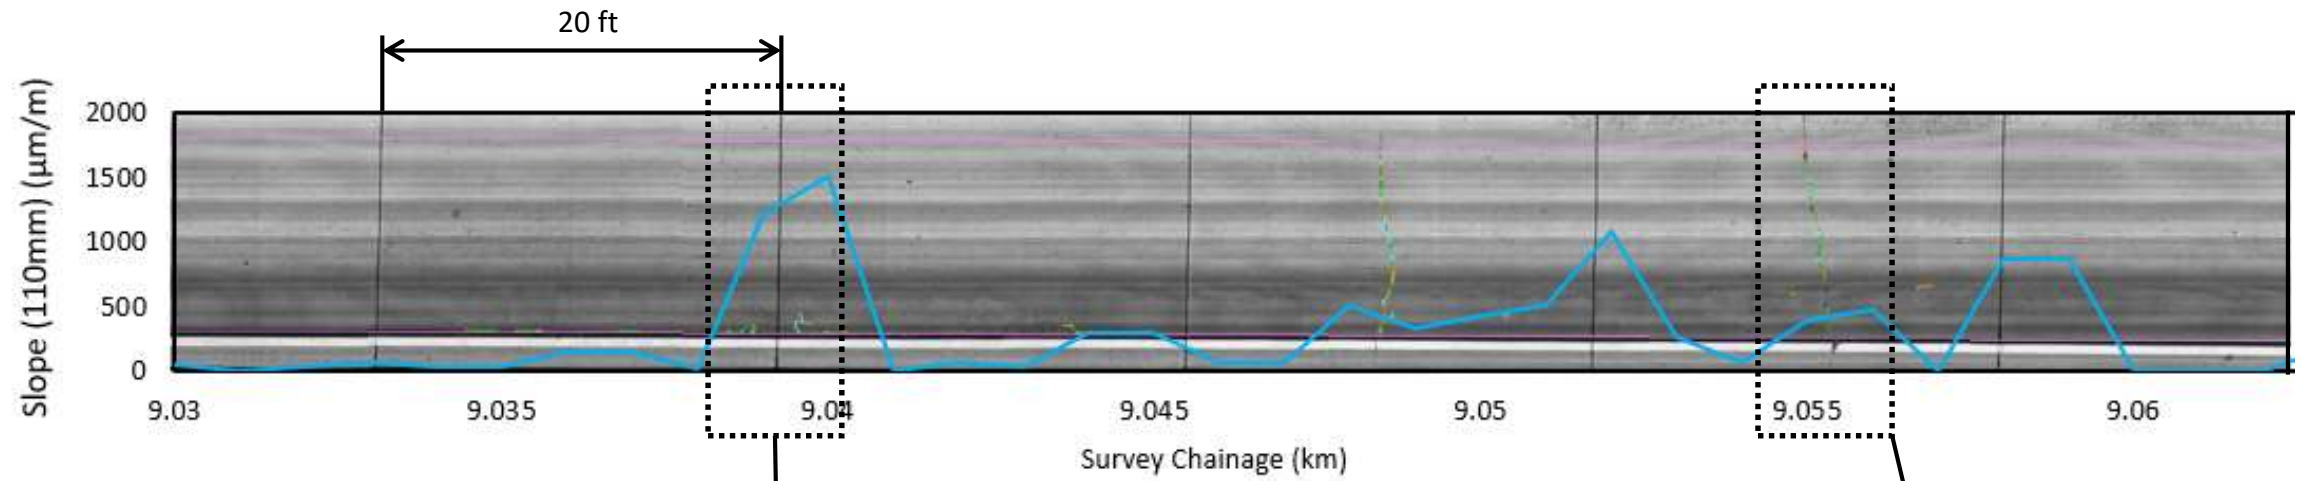
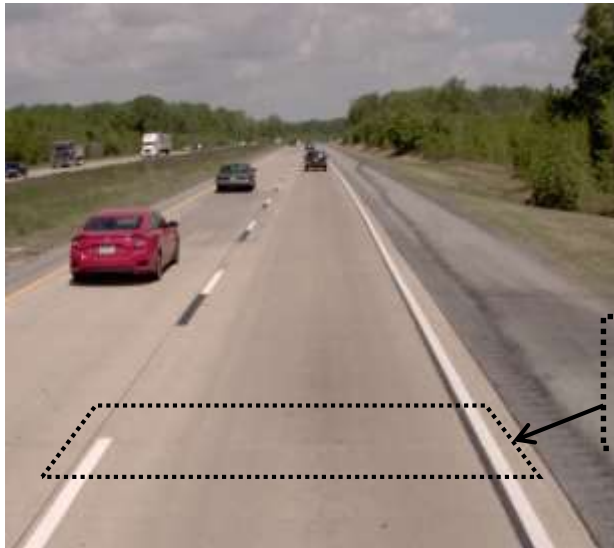
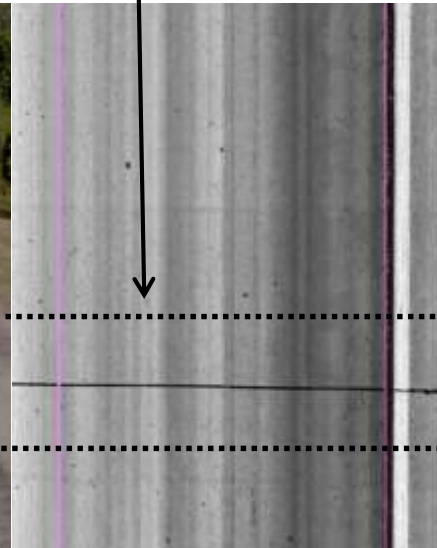
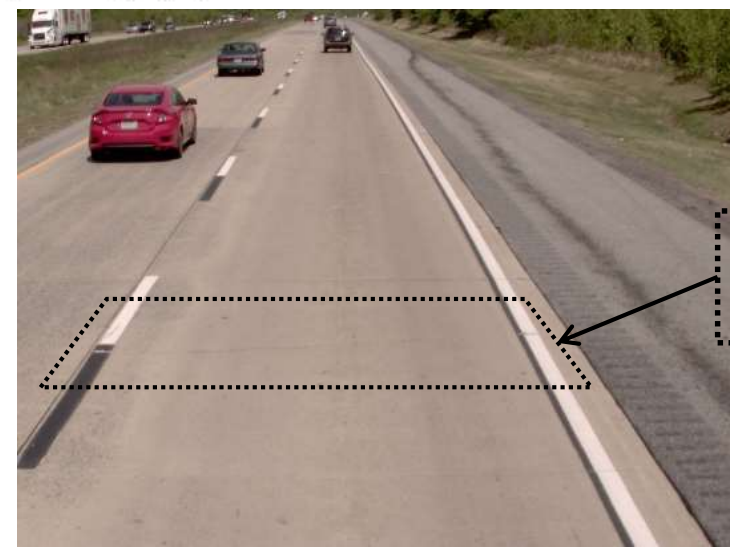
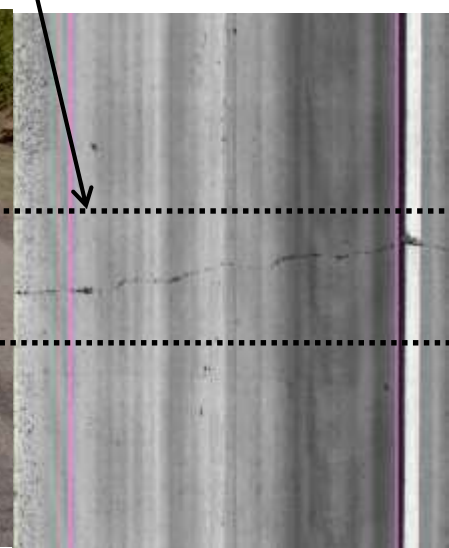
Case #2 – Structurally Deficient, but?

- IRI Average <= 120
- Rut Depth Right <= 0.33
- Maximum Deflection (D0) >= -5

- Availability of Continuous Structural Capacity:
 - Facilitates detection of structural deficiencies,
 - In spite of Good Surface Condition.
- Enables Agencies to be more proactive:
 - Plan for future,
 - Rather than reacting to deterioration.

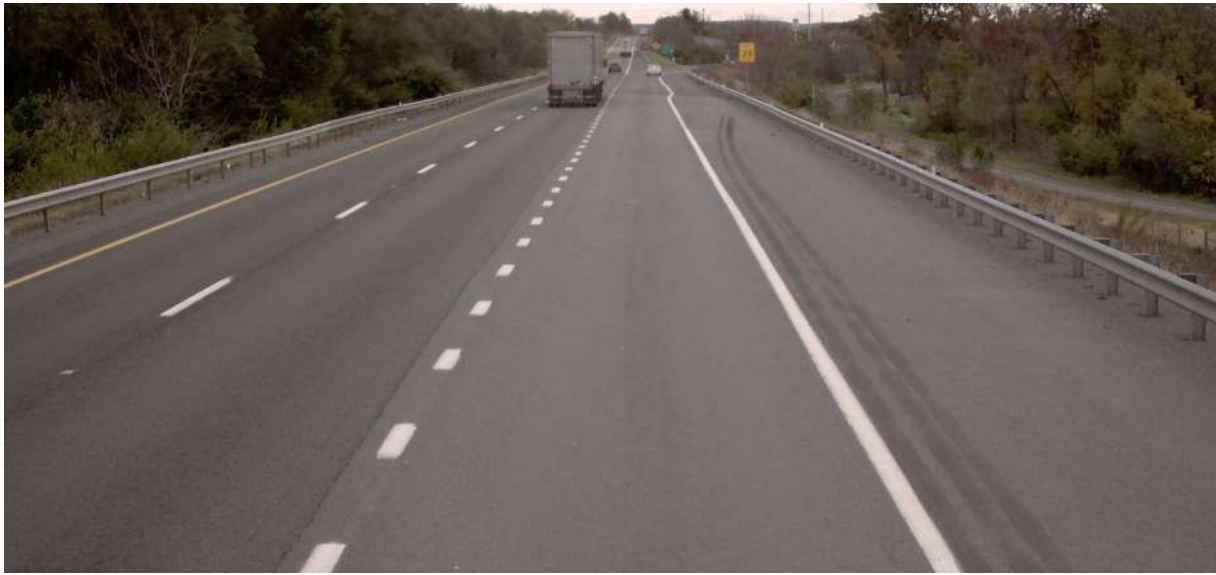
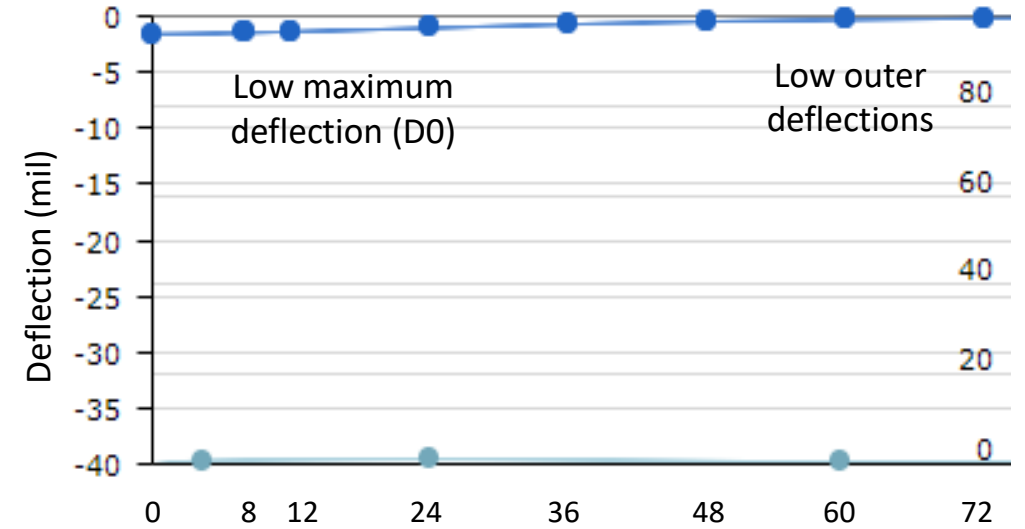
All Good (Case 4 ...Celebration 😊)

No visible cracking

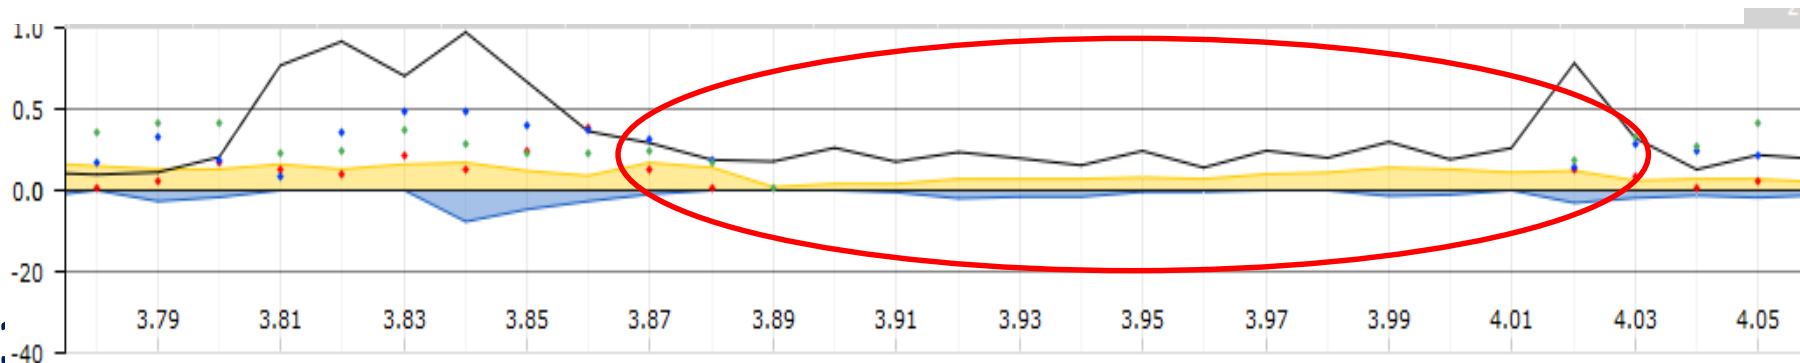
- IRI < 120
- Rutting < 0.3 in
- WP Cracking < 25%
- D0 < 6 mils
