Rutting and Faulting Data for the Interstate Highway System: Equipment Validation

Project Rutting and Faulting Data

Validation Procedure

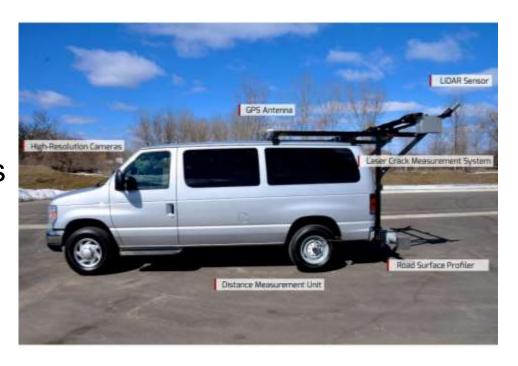
- ➤ Laser Crack Measurement System
 - Sampling Rate: 5,600 profile/s
 - Transversal field of view: 13.1 ft.
 - Transversal resolution: 0.04 inch
 - Depth range of operation: 9.8 inches
 - Depth resolution: 0.02 inch

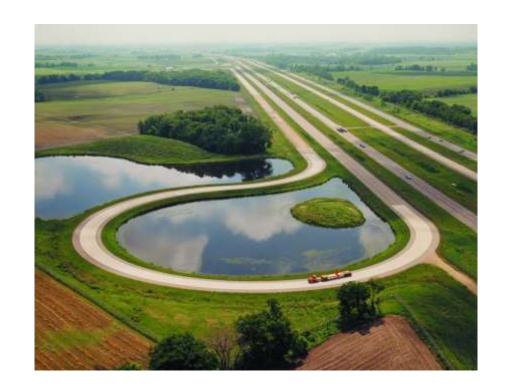
- Validation testing of the LCMS for rutting and faulting measurements
- Field testing at the Minnesota Road Research Facility (MnROAD) facility
- Collecting reference data using the MnROAD Automated Laser Profile System (ALPS) and a faultmeter

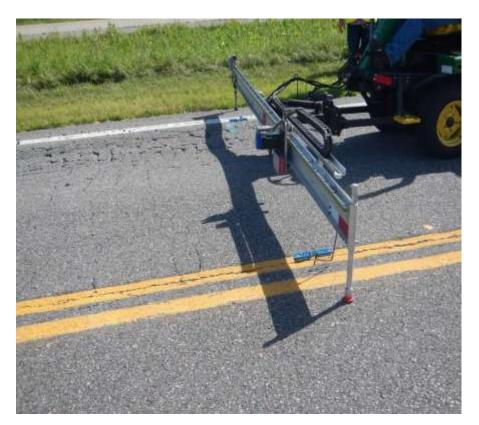
Reference Rutting Data, ALPS

- 10 transverse profiles
- Rut depth from 0.25 to 2 inches

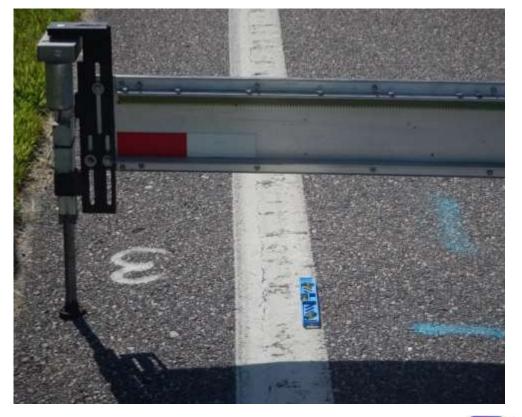
- Markers on the edges of the lane
- Algorithm based on PP69-14

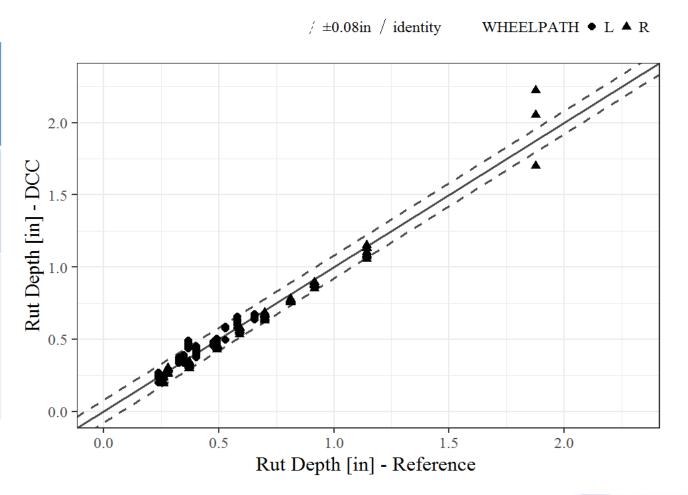
Validation of Rutting Measurements

Acceptance Criteria	
Accuracy	±0.08 inches
Precision	Values within ±0.08 inches of mean with a 90% CL

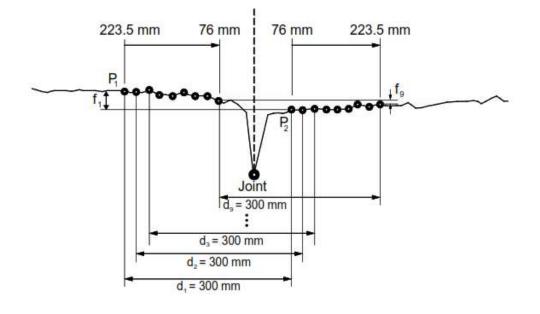
Faulting – AASHTO R36

Method A

-230.00 -232.00 Mask the profile within 76 mm of the joint from the fitted -234.00 -236.00 Faulting (f) -238.00 Approach Slab Departure Slab -240.001219 mm 1219 mm -242.00 -244.00 Normalized Distance (m) Fitted Line—Approach Fitted Line—Departure

Method B

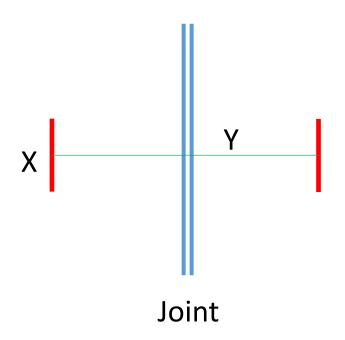
Faulting – LCMS Measurement

X, inches	Y, inches
8	12
8	2
12	12
12	2
0.5	12
0.5	2

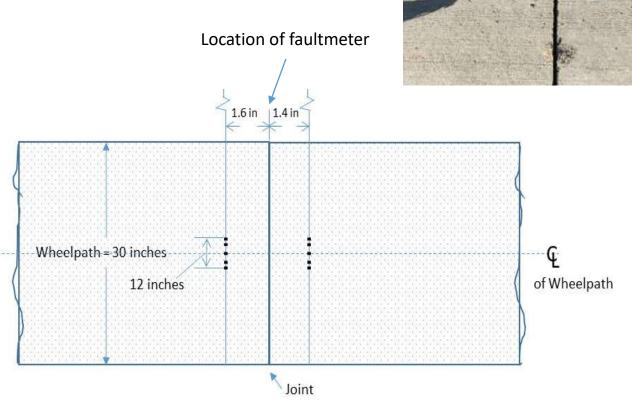
Reference Faulting Data, Faultmeter

- 10 joints with average faulting from 0.0 to 0.4 inches
- Measurement locations:
 - 1. Centerline of the outside wheelpath
 - 2. 4 in. to either side of the centerline
 - 3. 6 in. to either side of the centerline

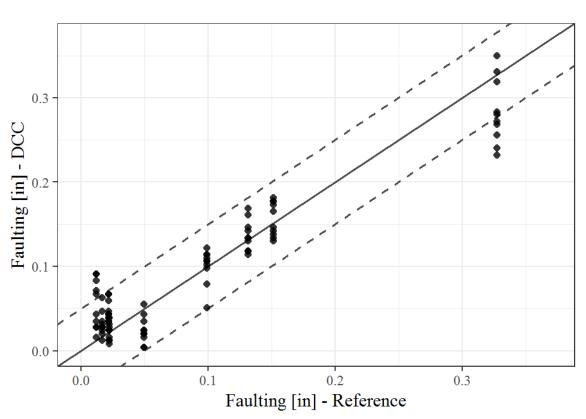
Validation of Faulting Measurements

> 10 repeat measurements at each joint using the data collector's LCMS

Acceptance Criteria	
Accuracy	±0.05 inches
Precision	 Standard deviation of values not to exceed 15% of mean value if the mean is greater than 0.1 inches
	 Not to exceed 0.03 inches if the mean is lower than 0.1 inches

$/ \pm 0.05$ in / identity

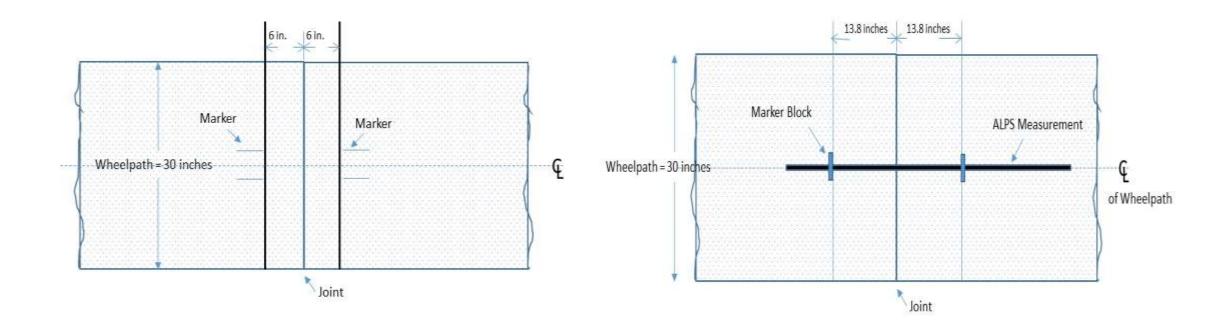
Reference Faulting Data, ALPS

1) Transverse profiles from 6 inches before joint to 6 inches after joint

2) Longitudinal profile across a joint

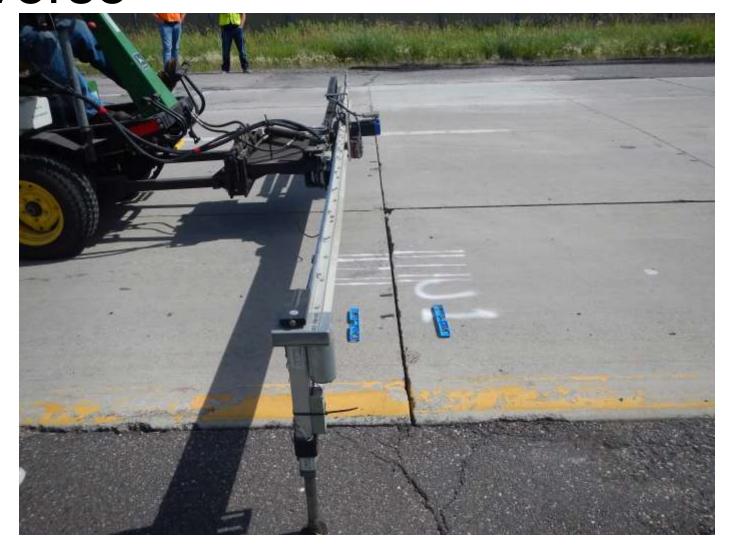
Faulting Measurement – ALPS Transverse

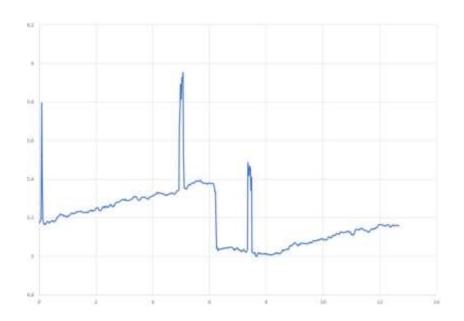
ALPS – LCMS comparison

- ALPS measurement across the joint
 - Method A 0.31 inch
 - Method B 0.34 inch
- LCMS measurement (12 x 12) 0.35 inch
- Transverse comparison
 - No elevation reference
