FRICTION STUDY ON LTPP SECTIONS IN CONNECTICUT

John W. Henault, P.E.
Connecticut Department of Transportation

Iliya Yut, M.S.
Adam Zofka, Ph.D.
University of Connecticut

Pavement Evaluation 2010
October 25-27, 2010
Roanoke, Virginia

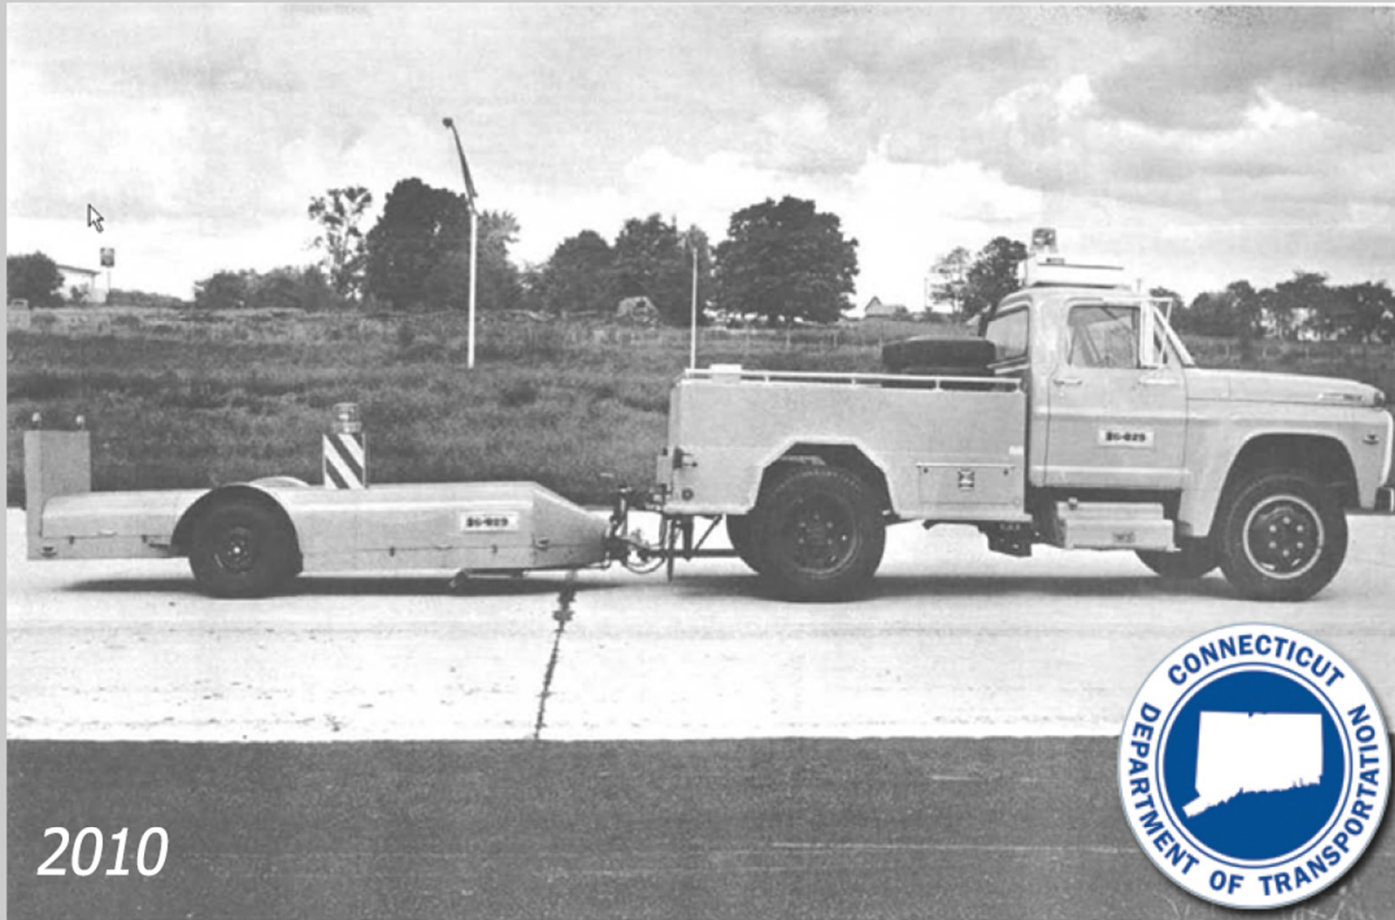
In 1970, ConnDOT's first pavement friction tester was this 'one-of-a-kind' unit from TestLab Corporation of Chicago

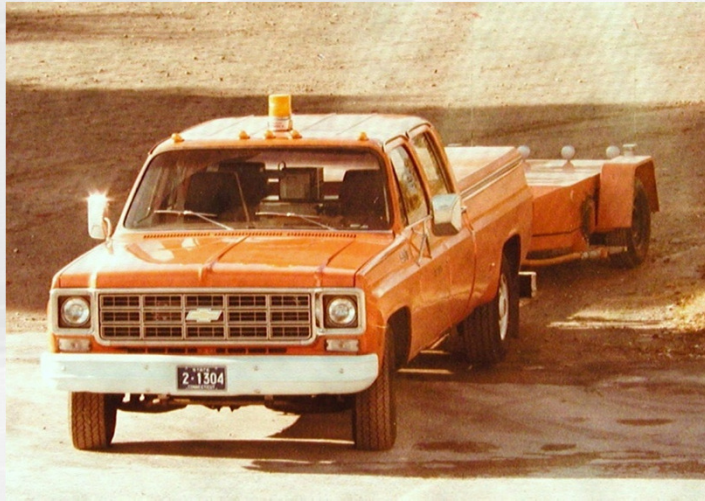
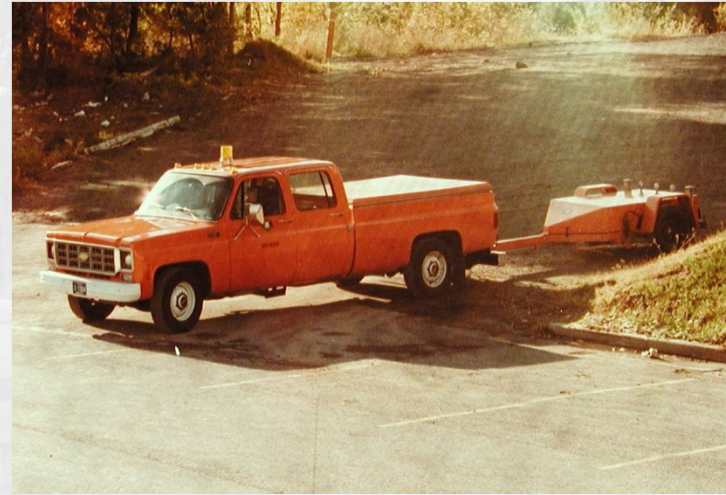
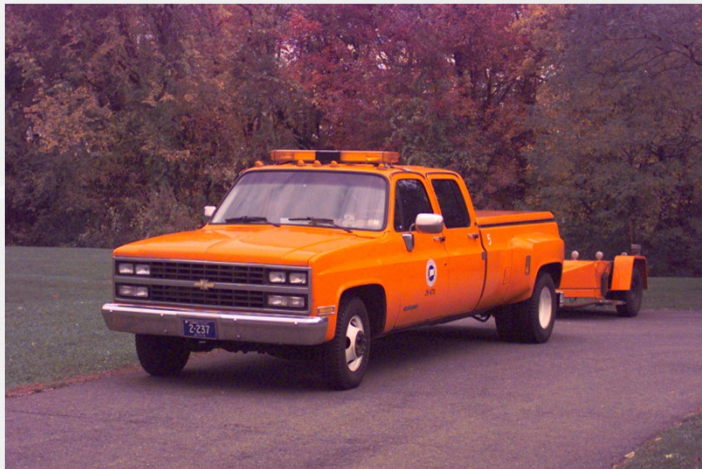
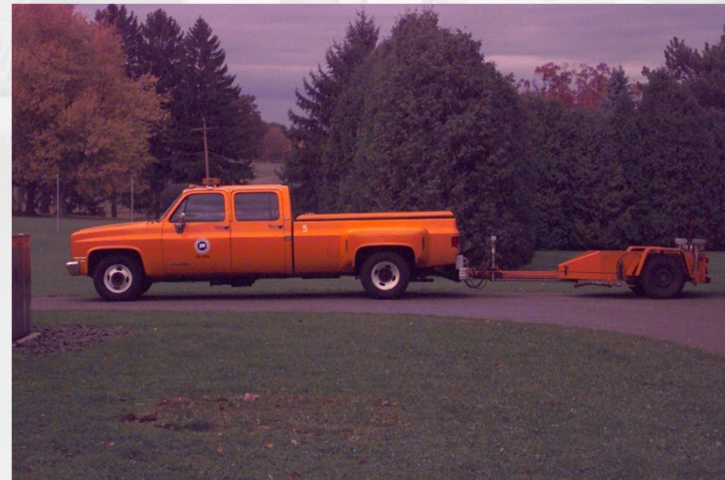
K J Law Engineers Friction Testers

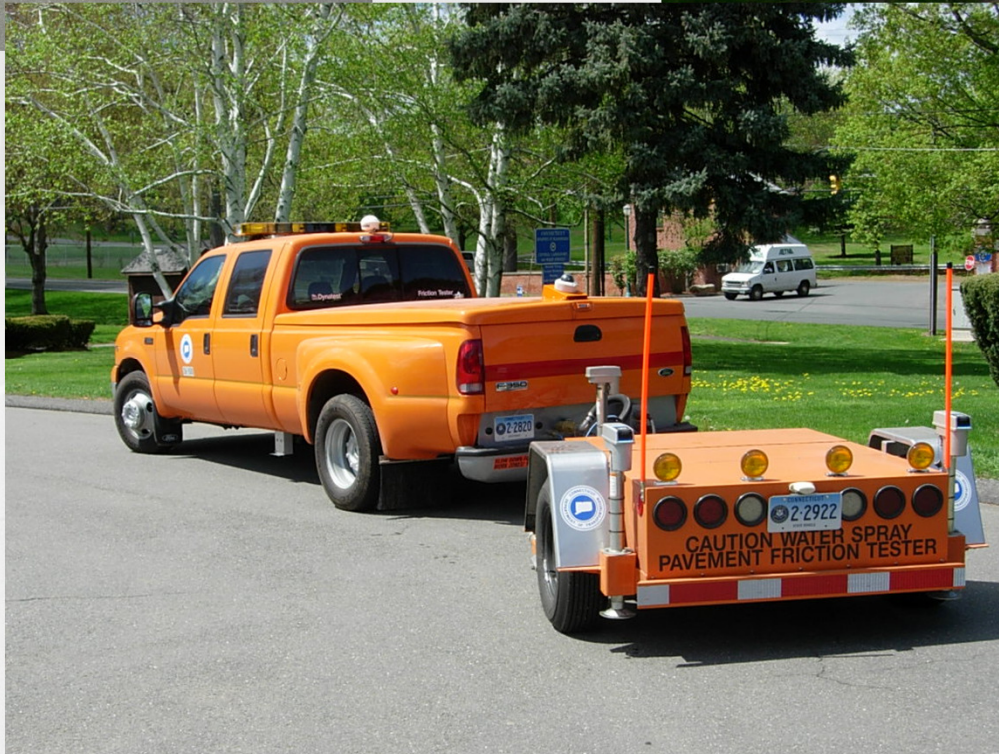
High-Speed Laser Instrument Mounted to Dynatest Pavement Friction Tester

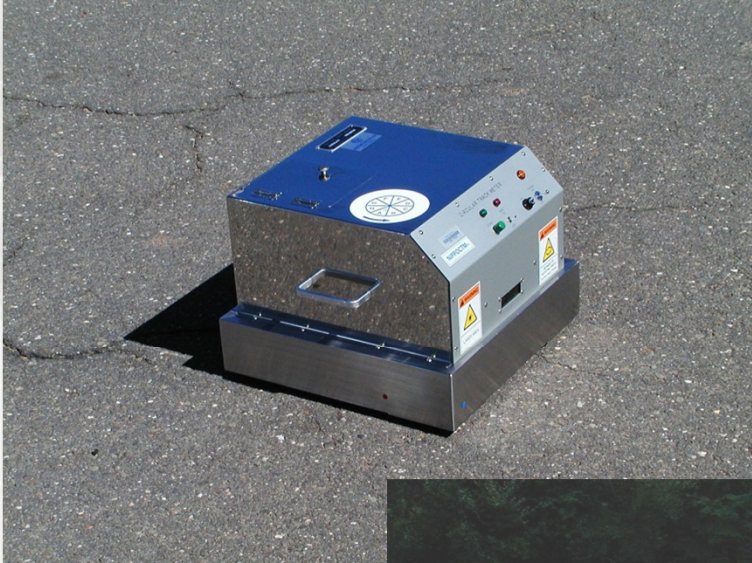
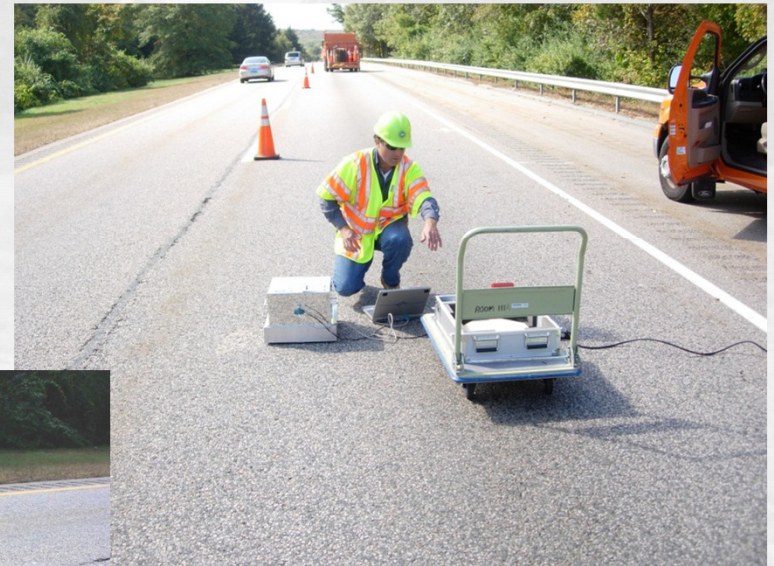
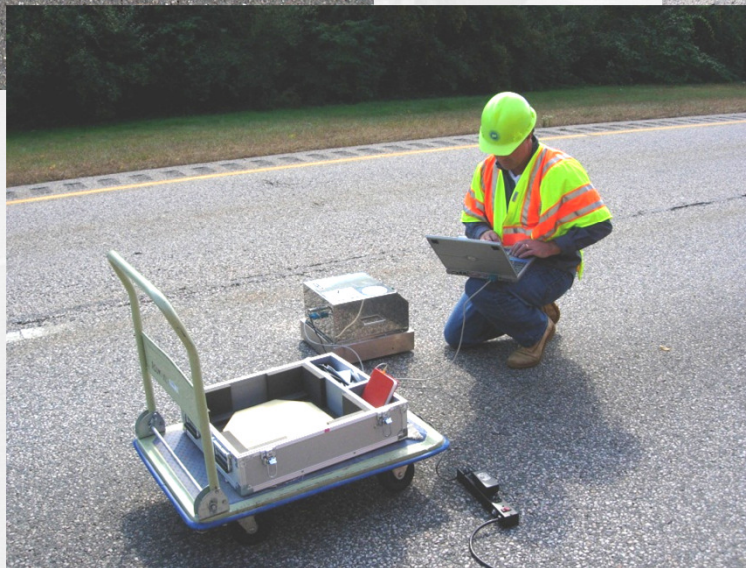
2007 - Circular Texture Meter (CTMeter)

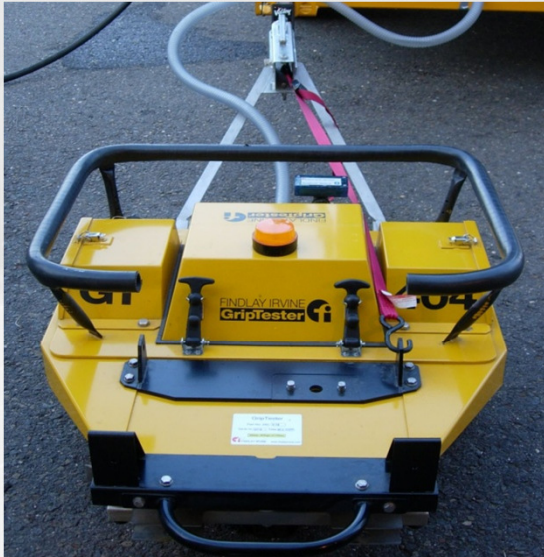
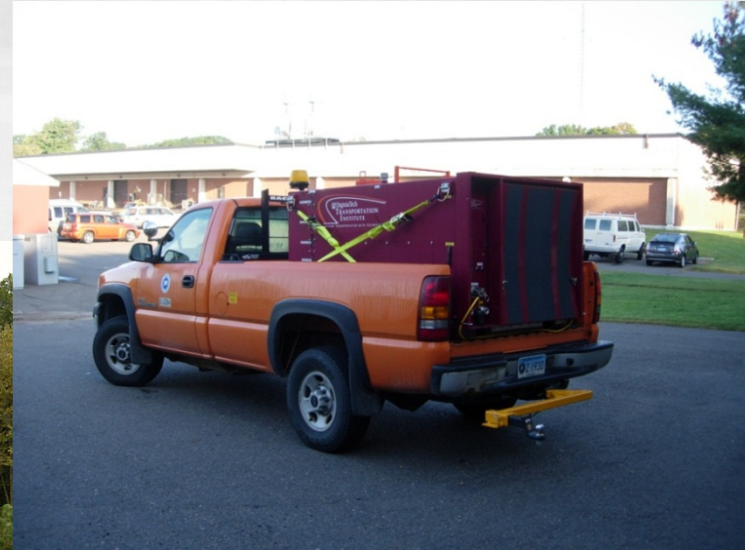
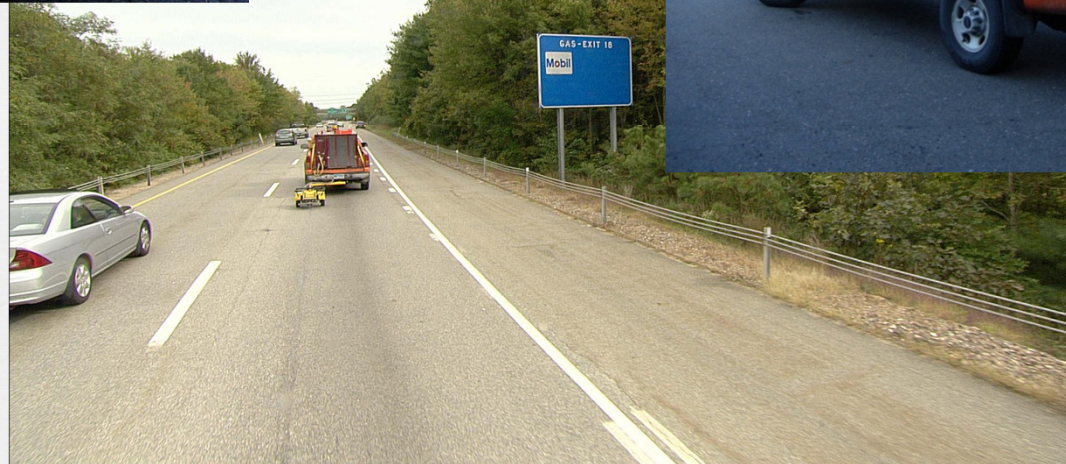
2009 - GripTester™ Loan to ConnDOT

- A high correlation between FN_{40R} and GN values was found ($R^2 = 0.93$).
- No correlation between FN_{40S} and GN values was found ($R^2 = 0.07$).
- Indicates Grip Numbers relate better to microtexture than macrotexture even though a smooth tire is used.

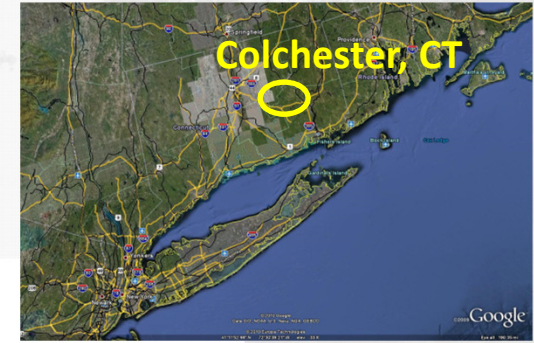
Rt. 2 LTPP (SPS-9A) Sections

WB 6 Alternative Superpave 20% RAP PG 64-22 (LTPP 090962)	WB 5 Superpave 20% RAP PG 64-28 (LTPP 090961)	WB 4 CT Class 1 20% RAP AC-20 (LTPP 090960)

EB 1 CT Class 1 AC-20 (LTPP 090901)	EB 2 Superpave PG 64-28 (LTPP 090902)	EB 3 Alternative Superpave PG 64-22 (LTPP 090903)

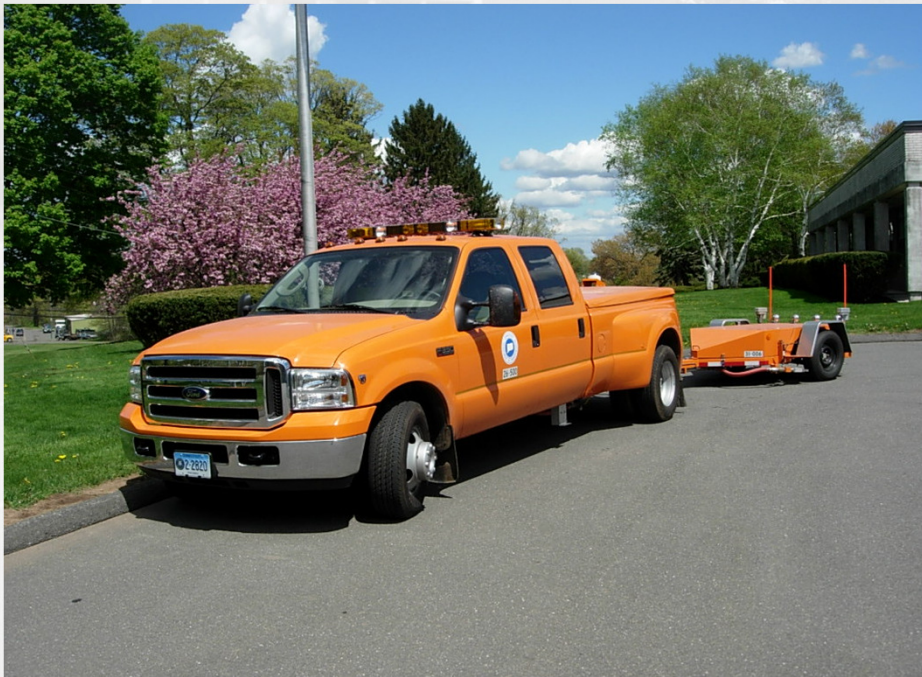
ASTM E-274 locked-wheel tester

- $V=40\pm 1$ mi/hr
- 100% slip
- SN_{40R} and SN_{40S} measured at start /end of ea. section
- 3 passes
- Macrotexture measured with high-speed laser
- Mean profile depth (MPD) and estimated texture depth (ETD) reported

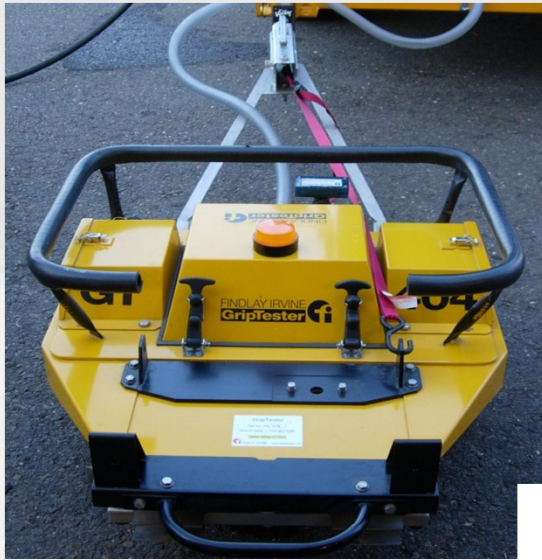
GripTester™ fixed-slip tester

- Borrowed from VTTI
- $V=40\pm 2$ mi/hr
- ~15% slip
- GN reported
- 5 passes per section

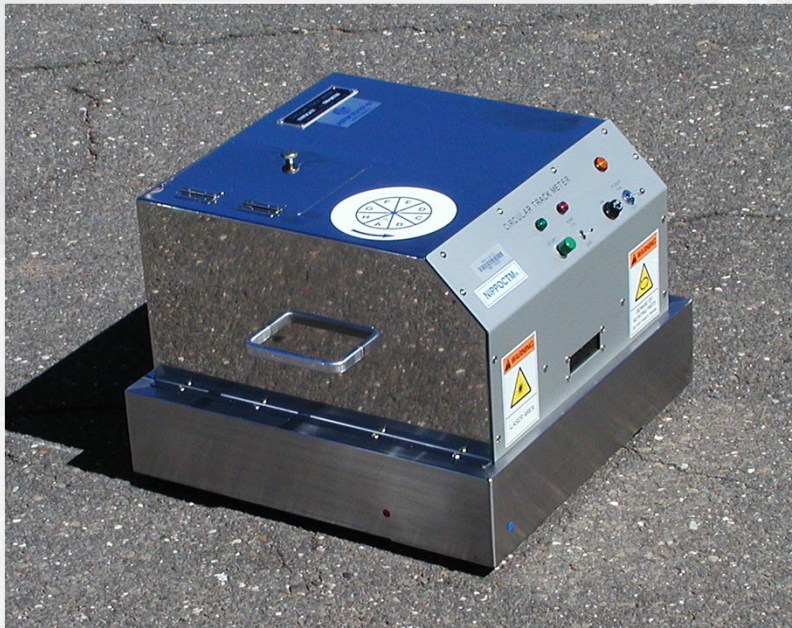
CTMeter

- ASTM E 2157 for measuring macrotexture.
- 5.6 inch radius circle.
- MPD measured every 50 ft.
- 8 measurements per section.

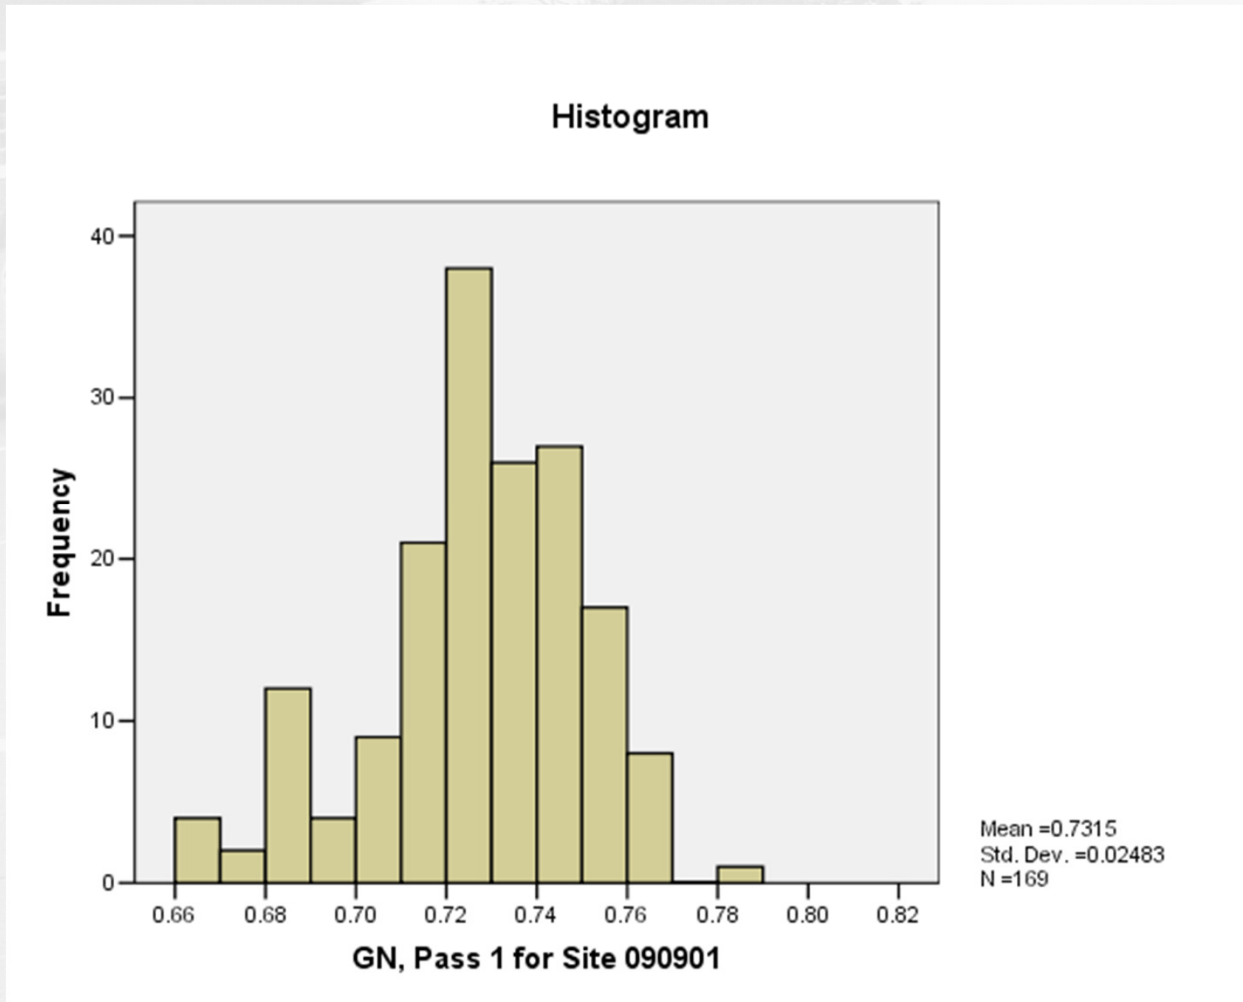
GN Histogram for Site 090901

Normal Distribution (Typical of Others)

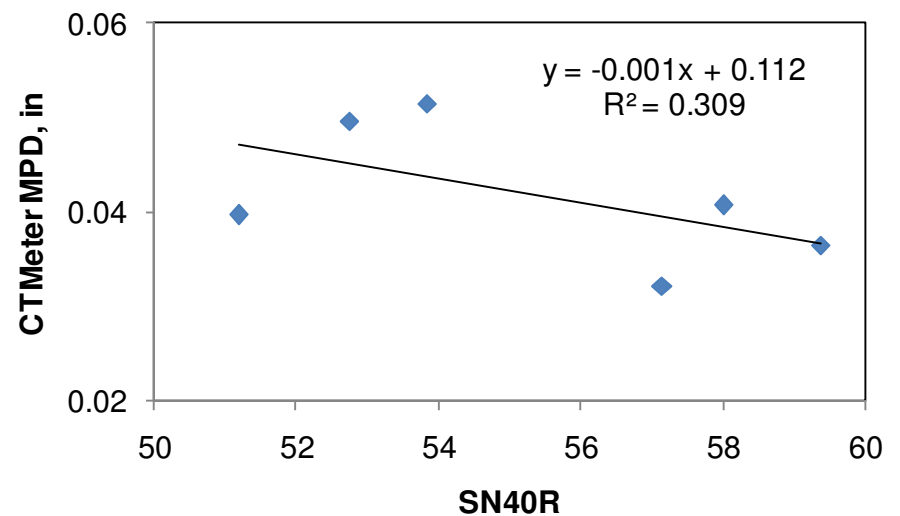
Cross-Correlation

- No correlation between ribbed and smooth tire.
- Very low correlation between ribbed tire and texture ($R^2 = 0.3$).

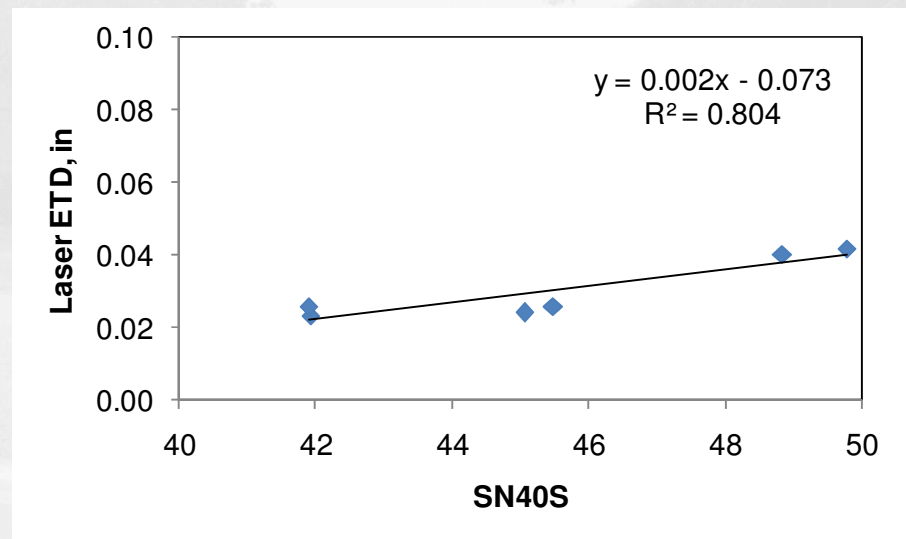
Macrotexture vs. Smooth-Tire Friction Cross-Correlation

- Good correlation between smooth tire and texture ($R^2 = 0.8$)
- Validates how smooth-tire measurements correspond with pavement macrotexture.

- Good correlation between FN_{40S} and texture was found ($R^2 = 0.8$).
- High-speed texture measurements corresponded very well with CTMeter measurements ($R^2 = 0.93$).
