# **LCMS – Laser Crack Measurement System**

Vision Technology for Inspection of Transportation Infrastructures

**John Laurent**

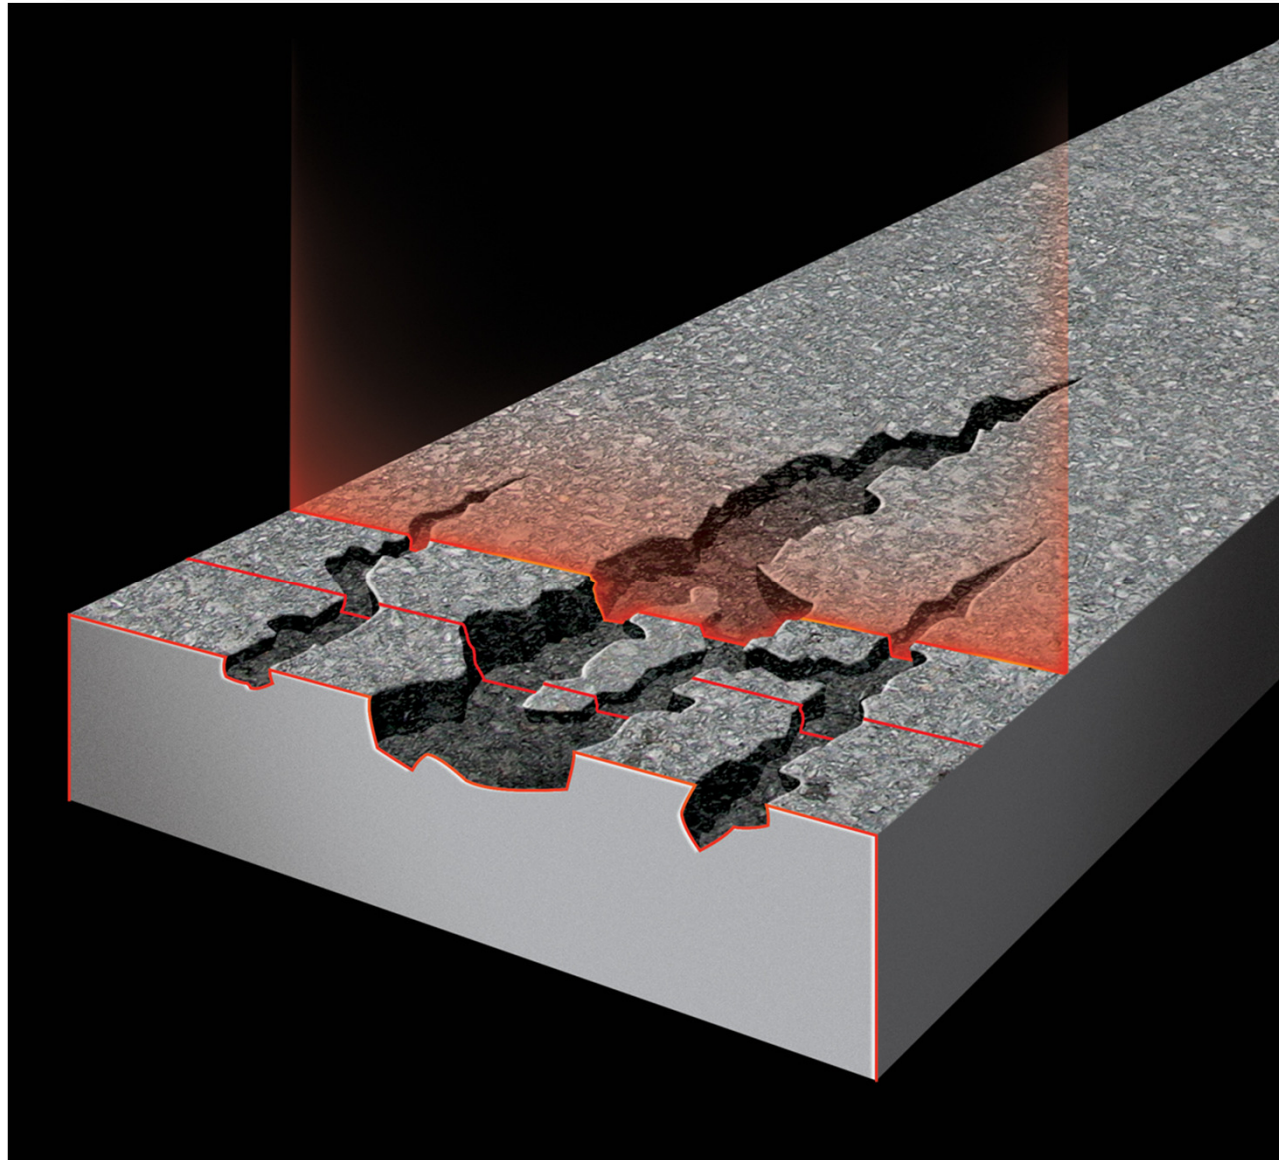
# Laser profiling (principle)

What makes a 3D sensor very good for crack measurement?

Excellent 3D Accuracy

Good Lateral Resolution

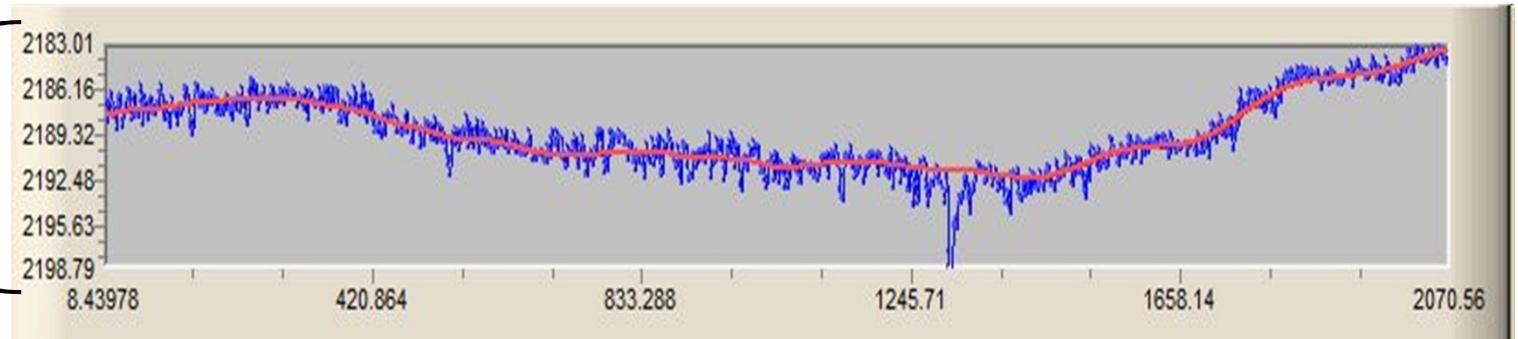
# Single Road Profile (2 meter)

Distance  
between Sensor  
and ground  
(in mm)

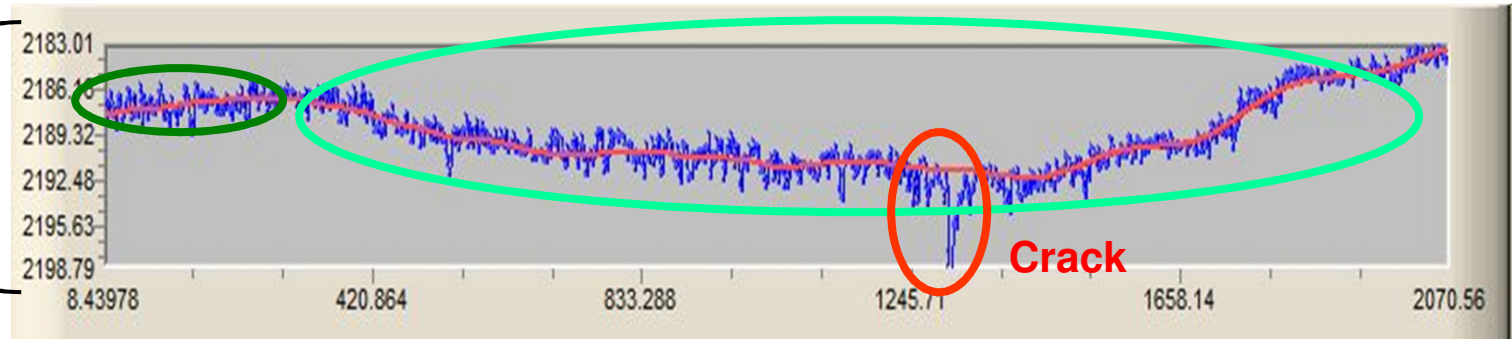
# Single Road Profile (2 meter)

Macro-texture

Rut

Distance  
between Sensor  
and ground  
(in mm)

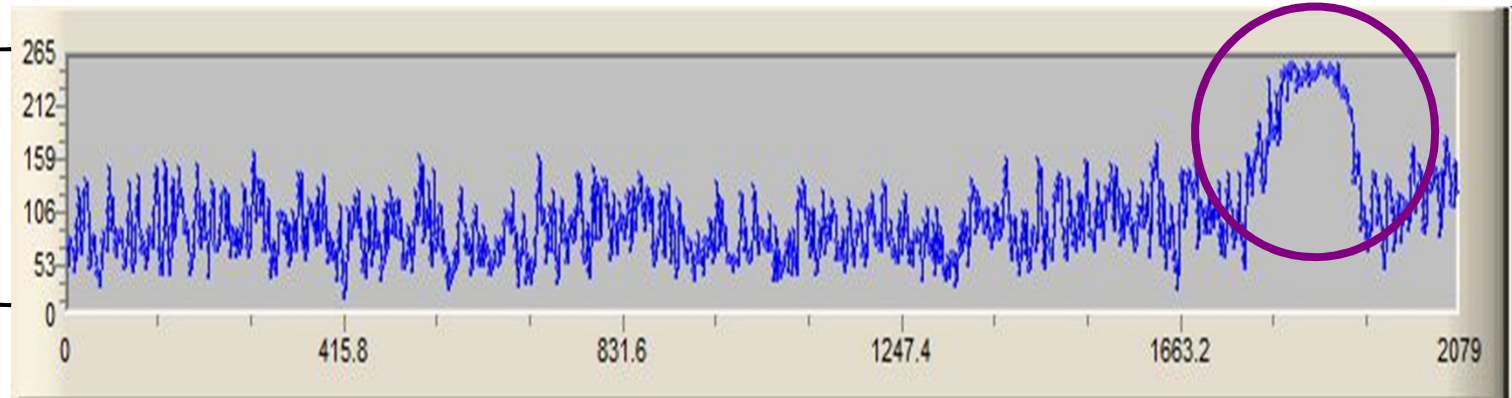
Laser intensity  
(black = 0,  
white = 255)

Right Lane  
Marking

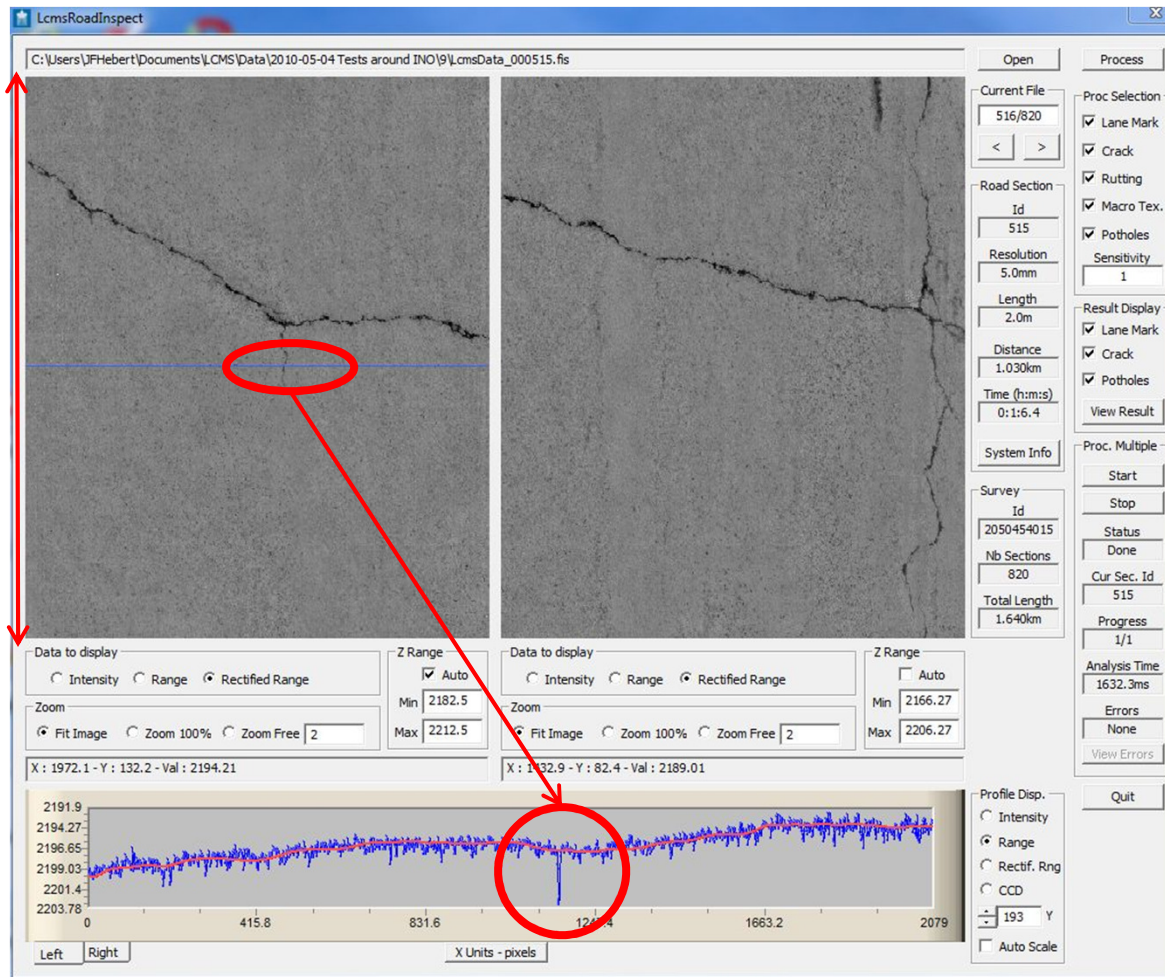
# Road Section: Range Data

400 road profiles captured every 5 mm = 2m road section

## Range:

- Gives the distance to the ground.

- Darker points = further away
- Gray points = on-surface
- White points = closer

- Notch in the profile
- Appear darker in range image

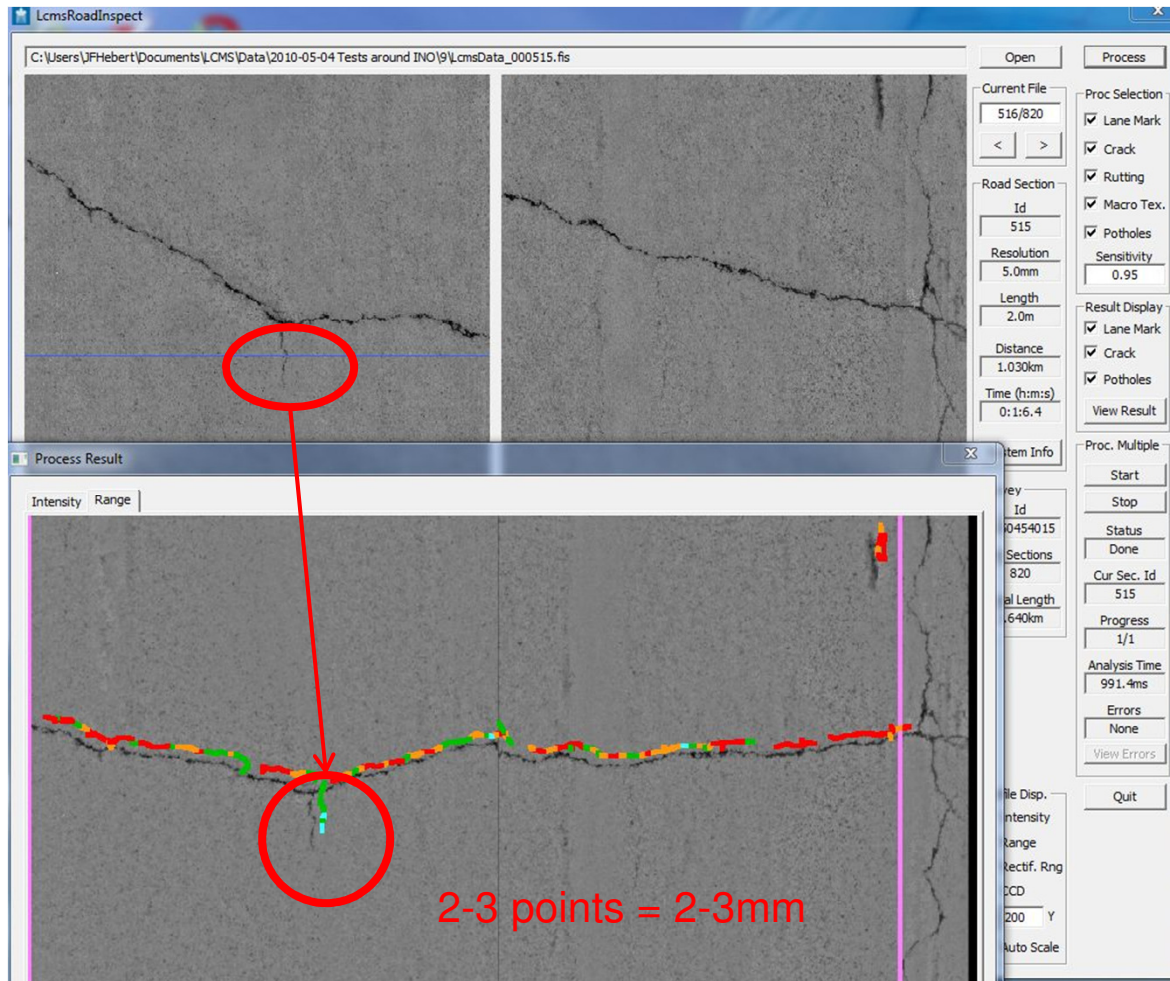
# Crack detection example

## LCMSLib:

- C/C++ Win32 DLL library
- Easy to interface (Open, Process, GetResults)
- Outputs crackmap as a XML string.

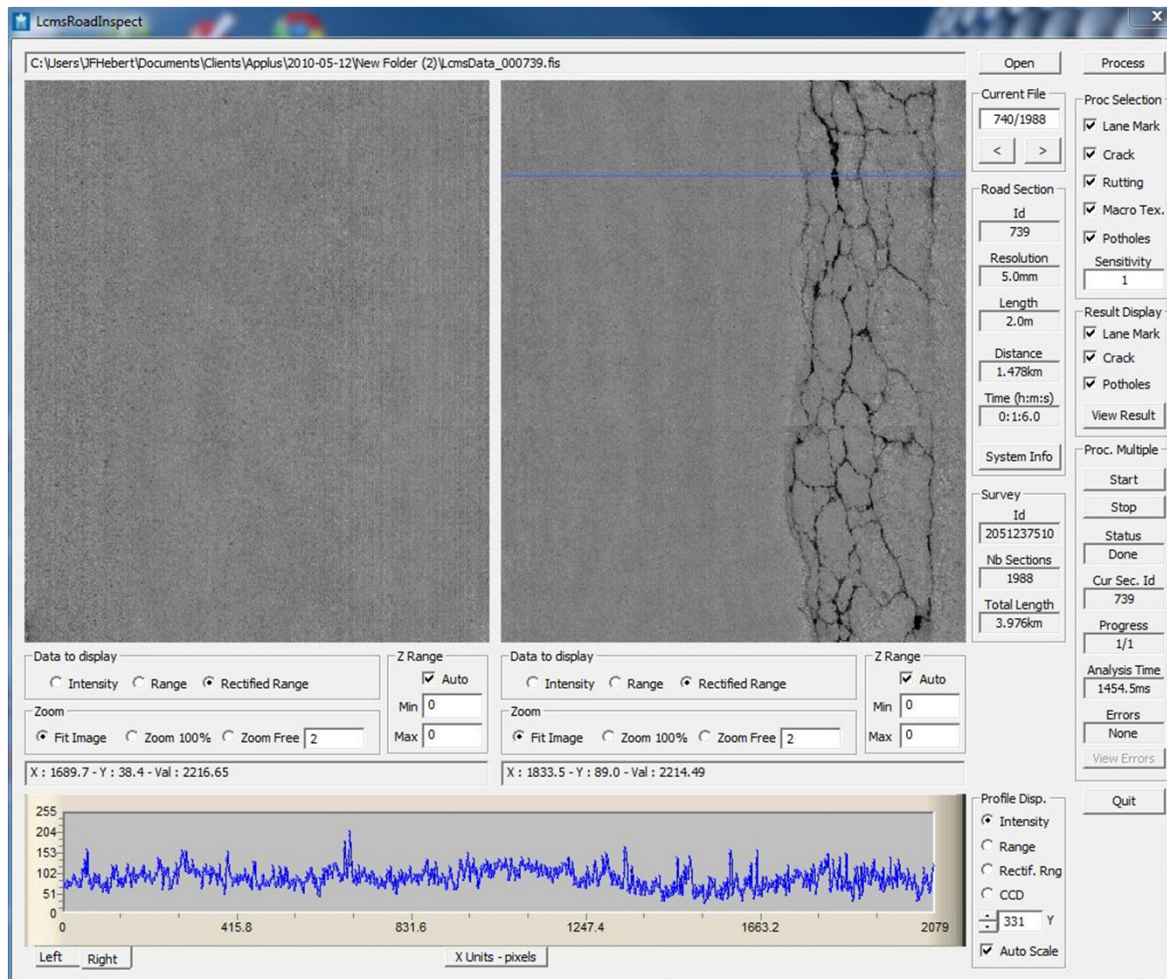
# Alligator Cracks

Definition  
Alligator cracking

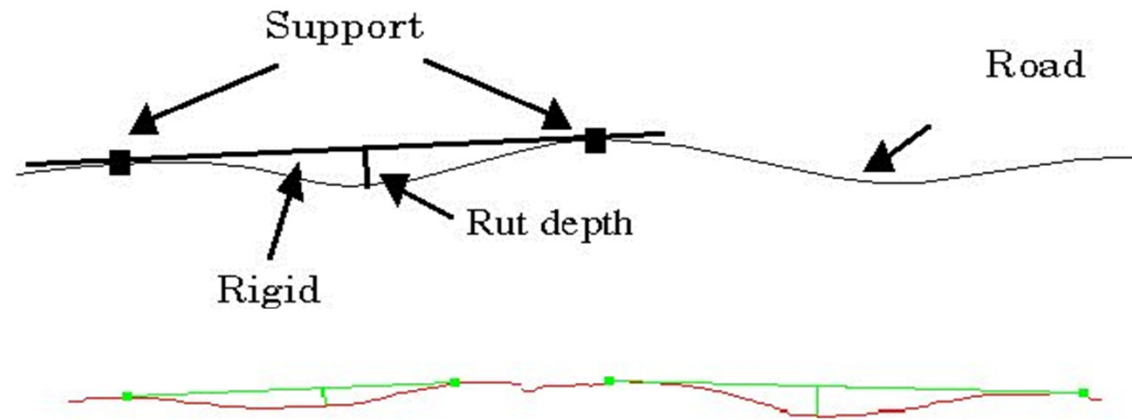
# Manual rut depth measurements

Display:  **Fit. Profiles**,  **Markings**,  **RUTs**,  Intensity,  3-Point Simulation,  5-Point Simulation

**Right Sensor      Looking Backward      Left Sensor**

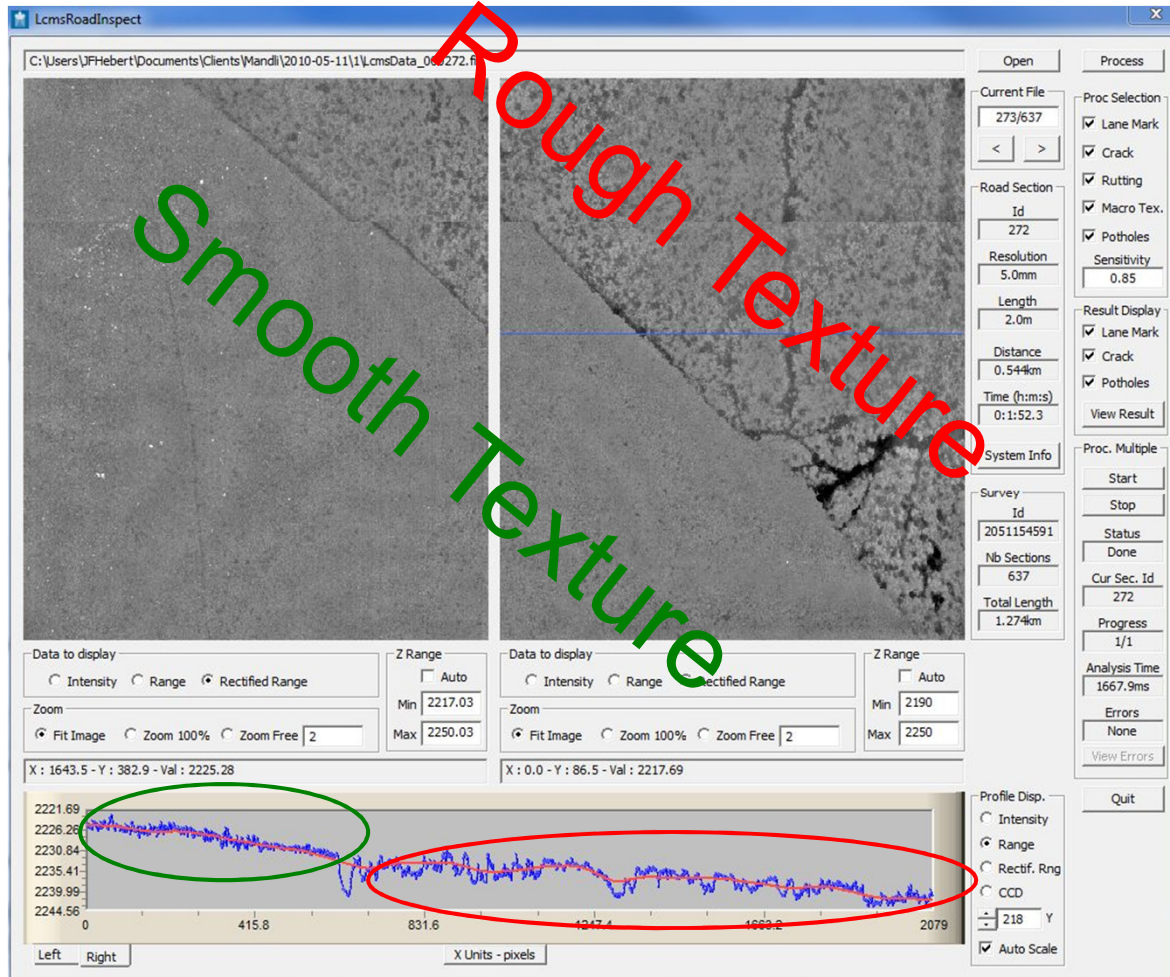
# Macrotexture (MPD - ASTM E1845-01)

- Preliminary results are promising
- Studies are underway to compare with other devices

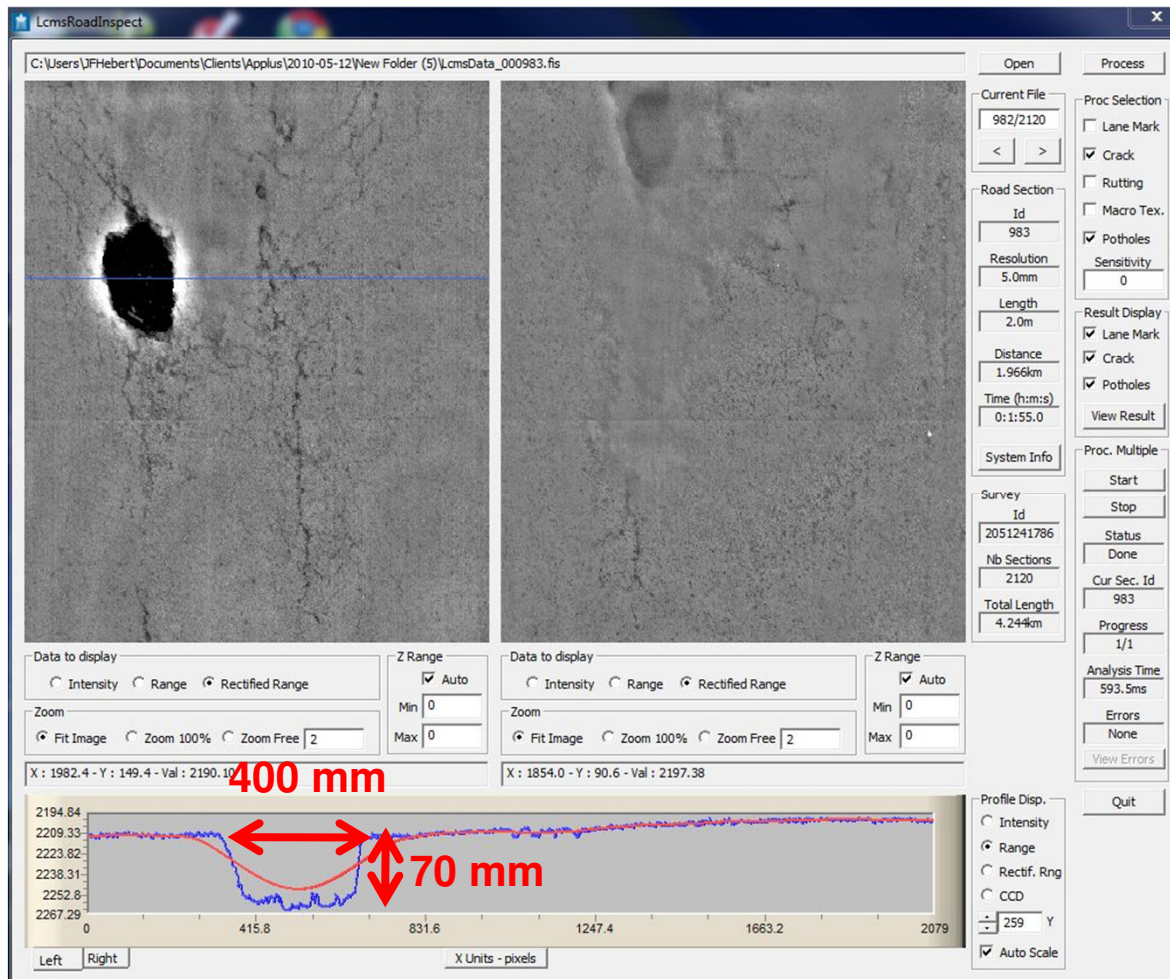
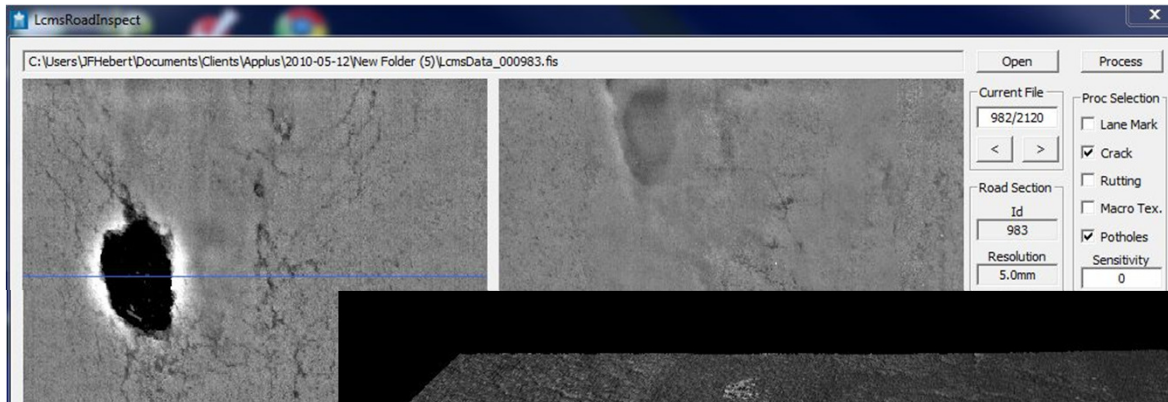
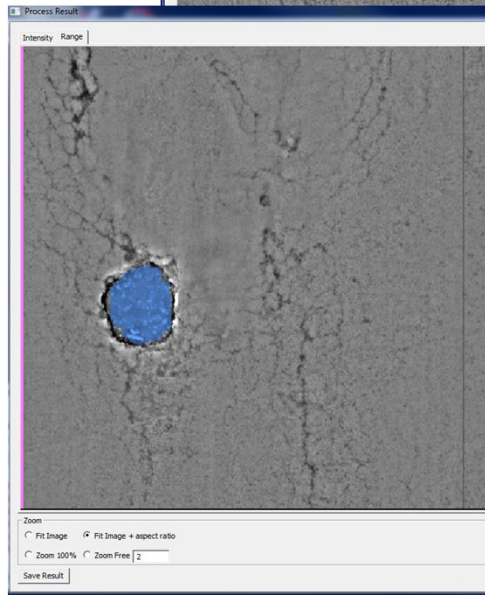
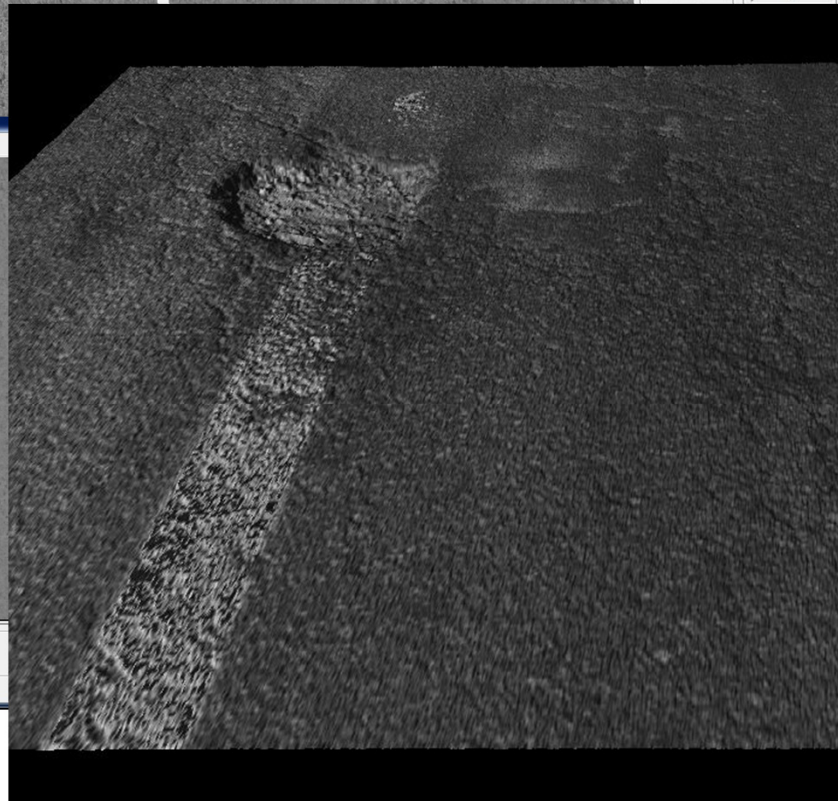
# Pothole Detection

•Our library detects and characterize the potholes

Characterization:

- Bounding box
- Area
- Perimeter (list of points)
- Volume

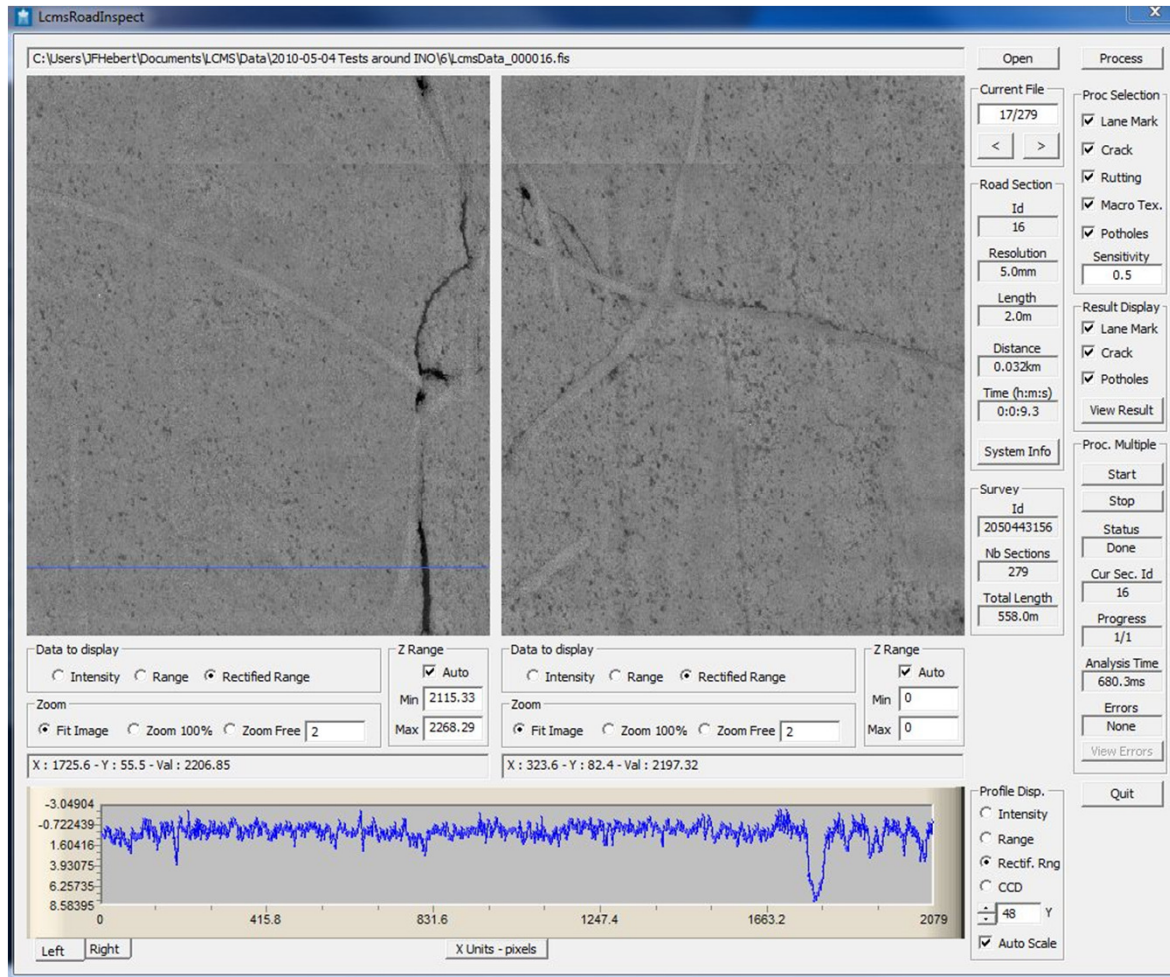
# Sealed cracks: Work in progress...

•But they aren't visible in 3D...

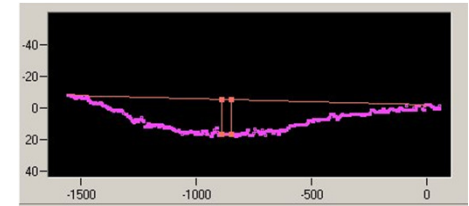
- Rut Measurement

- Type
- Depth
- Width

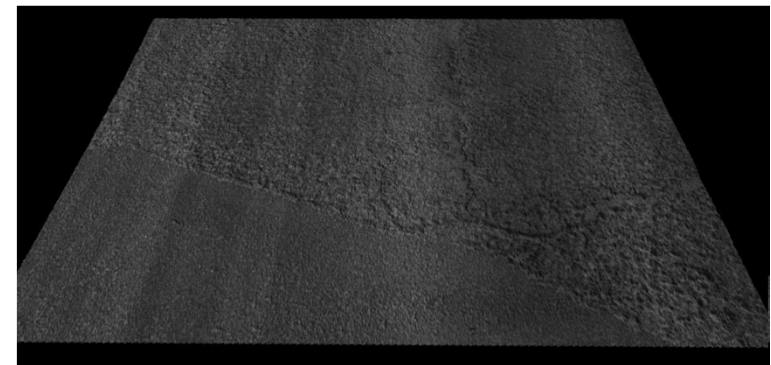
- Macro-Texture Measurement using MPD - ASTM E1845-01
