Engineering Analysis and PMS

Washington State Experience

**National Pavement Management Conference
Norfolk, Virginia
May 6-9, 2007**

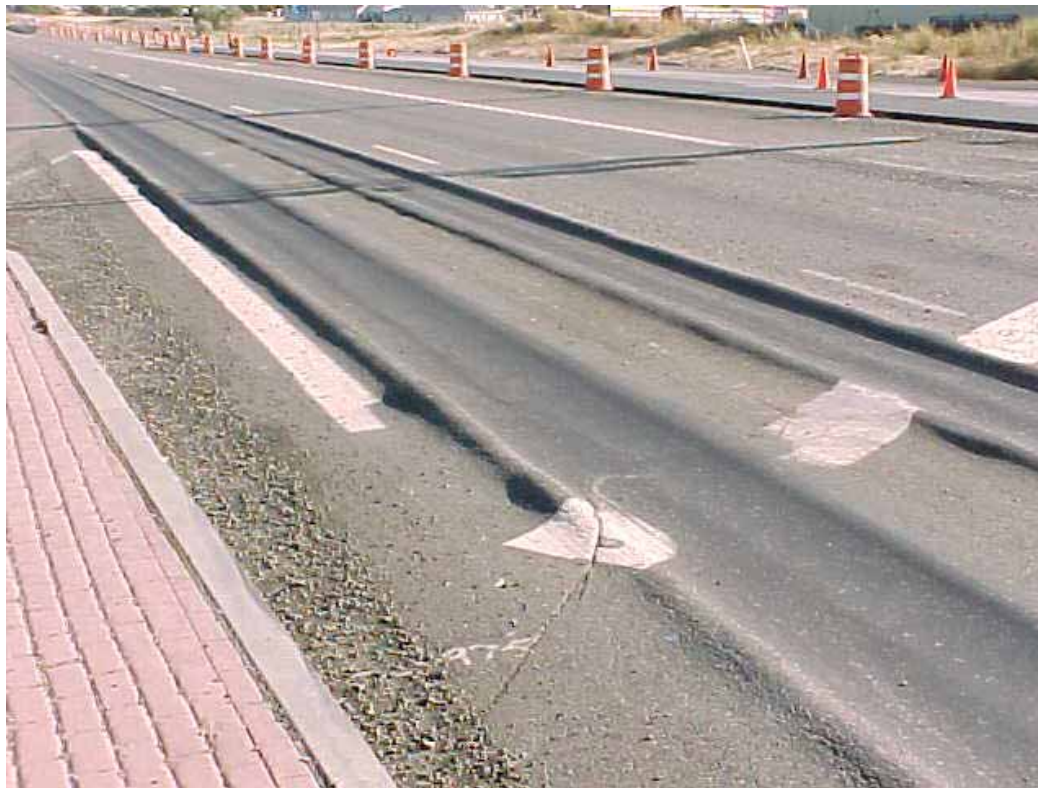
- What caused the failure of this road? Design? Construction? Materials?

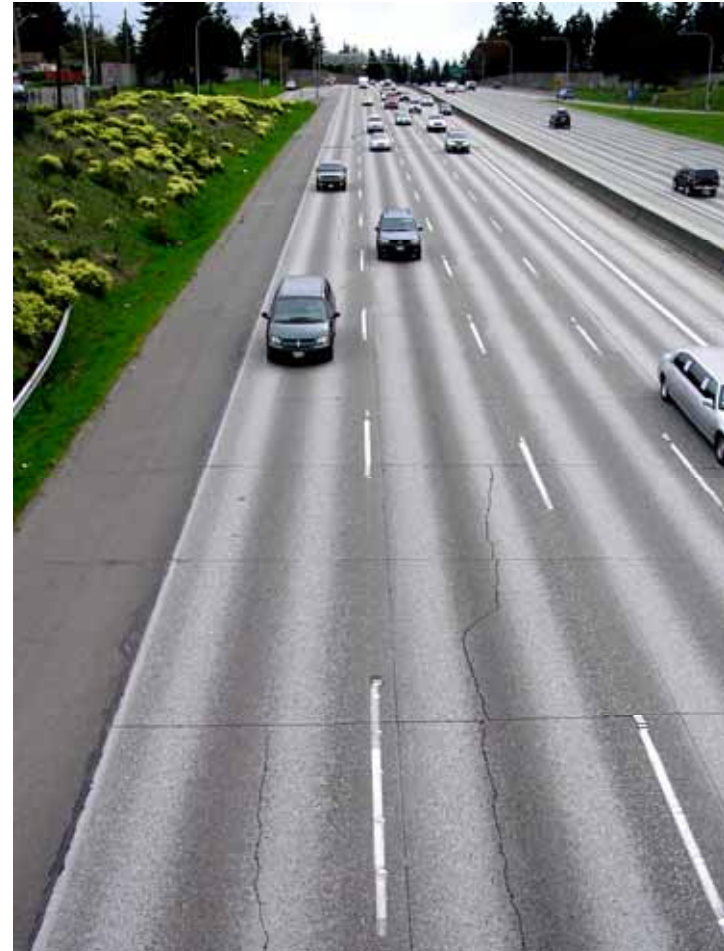
- Scope
 - Understand the condition of PCCP in King County (greater Seattle area)
 - Application to the remainder of state
- Rehabilitated and non-rehabilitated sections
- Varying construction dates
- Performance of different sections

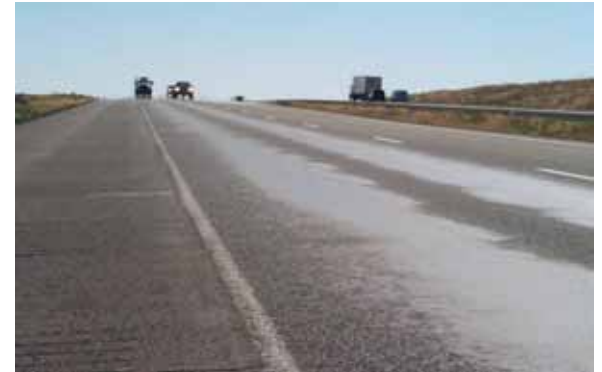
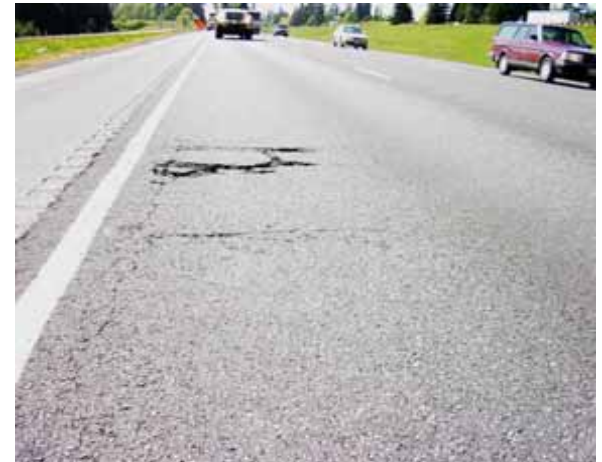
Example of Condition Data

Pavement distresses comparison						
	1999			2004		
Distress	Low	Medium	High	Low	Medium	High
Alligator Cracking	0.0	0.0	0.0	0.4	0.0	0.0
Patching	0.0	0.1	0.0	0.0	1.6	0.0
Raveling	0.0	0.0	0.0	0.0	0.0	0.0
Longitudinal Cracking	0.3	0.0	0.0	1.4	0.0	0.0
Transverse Cracking	0.0	0.0	0.0	0.3	0.1	0.0
Flushing	0.0	0.0	0.0	0.0	0.0	0.0
