9th International Conference on MANAGING PAVEMENT ASSETS (ICMPA9)

Precast Panels for Temporary Military Airfield Pavement Repairs

Lucy P. Priddy, P.E., Ph.D.
Peter G. Bly, P.E.
Gerardo W. Flintsch, P.E., Ph.D.

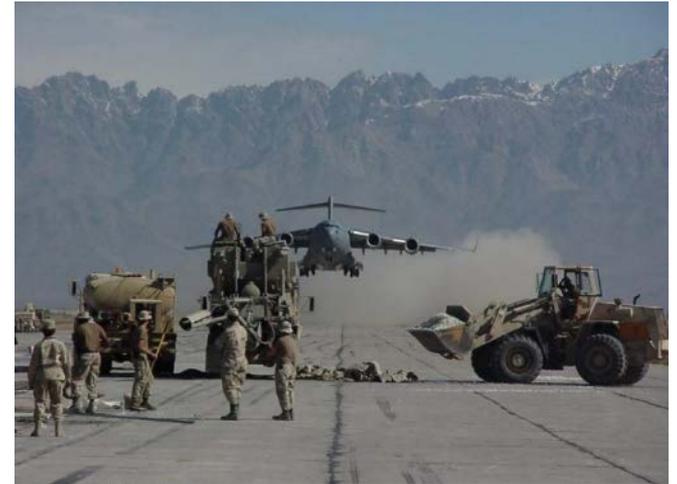
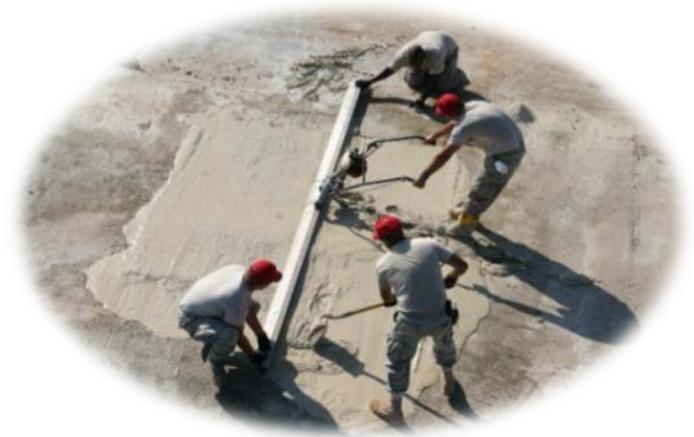
Expedient military repair methods are required for concrete airfield pavements

- **Emergency repair operations do not allow for long closures**
- **Traditional PCC requires time to gain strength**
- **Proprietary repair materials are costly and a logistical burden**

Solution: precast PCC technology?

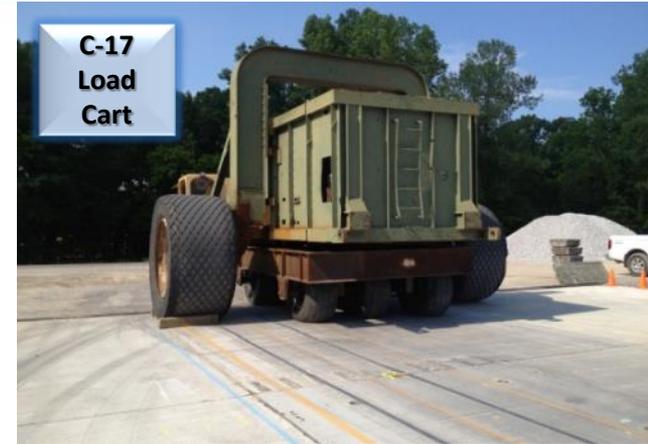
C-17
Load
Cart

6 Tires
 138 to 144 psi per tire
 Wheel load=44,930 lb
 Gear load=269,560 lb
