9th International Conference on MANAGING PAVEMENT ASSETS (ICMPA9)

Advancing Pavement Evaluation to Support Engineering & Investment Decisions

Jerome Daleiden, P.E.
Thomas Burchett,
Andy Mergenmeier, P.E.

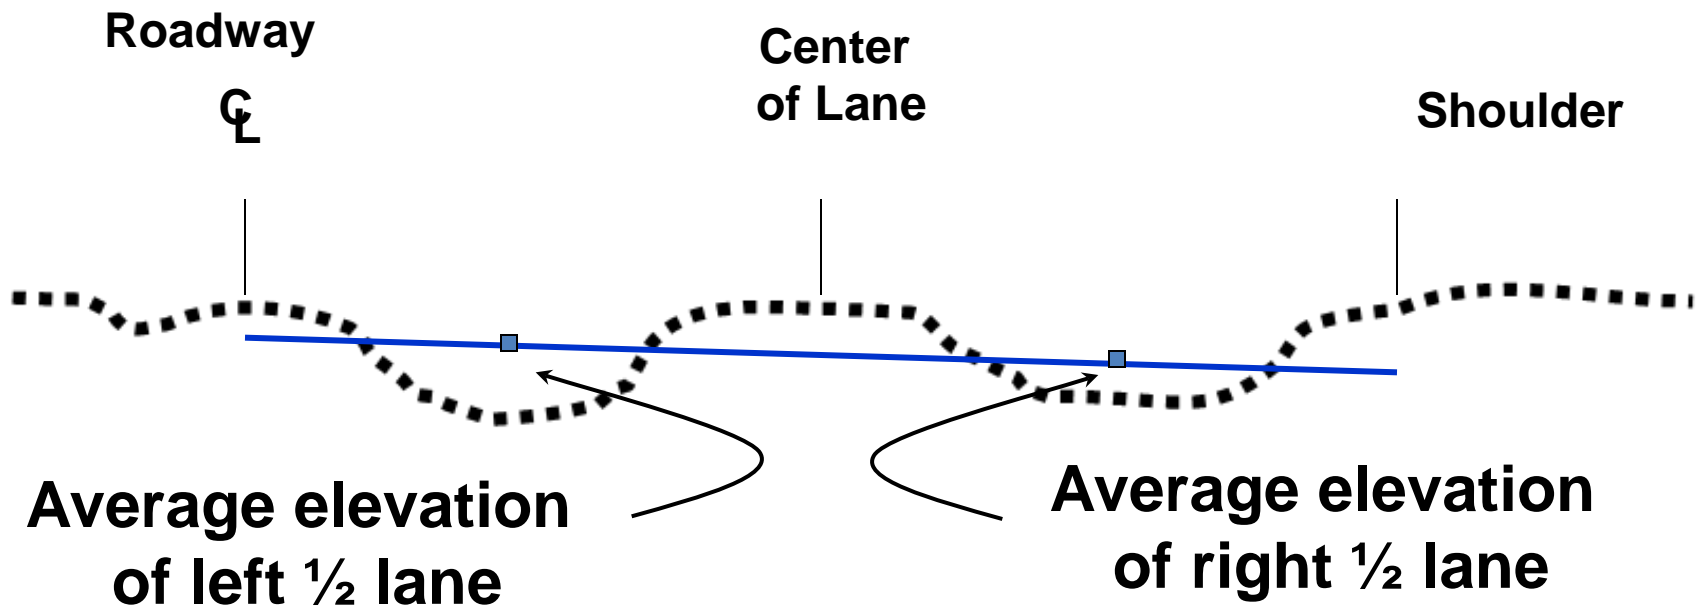
Transverse Profile Analysis

1. Calculate Cross-slope
