Forensic evaluation of pavement failure Using GPR and UAV technology

Pavement Department Manager, Michael Baker International

Pavement Evaluation 2019 Conference

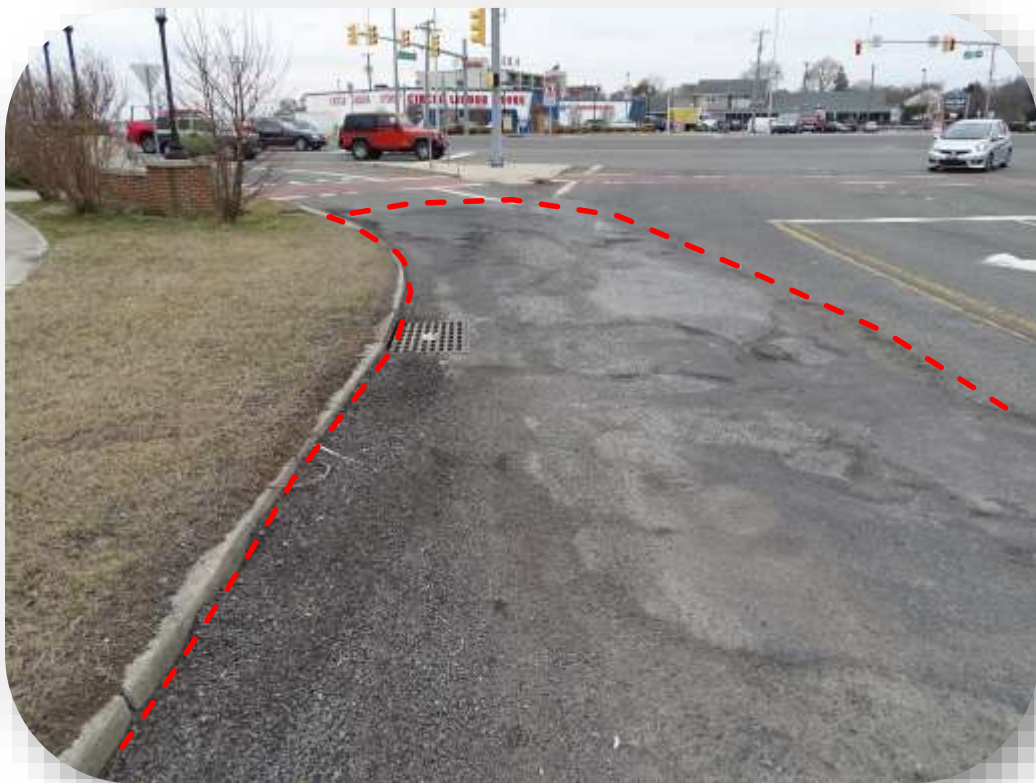
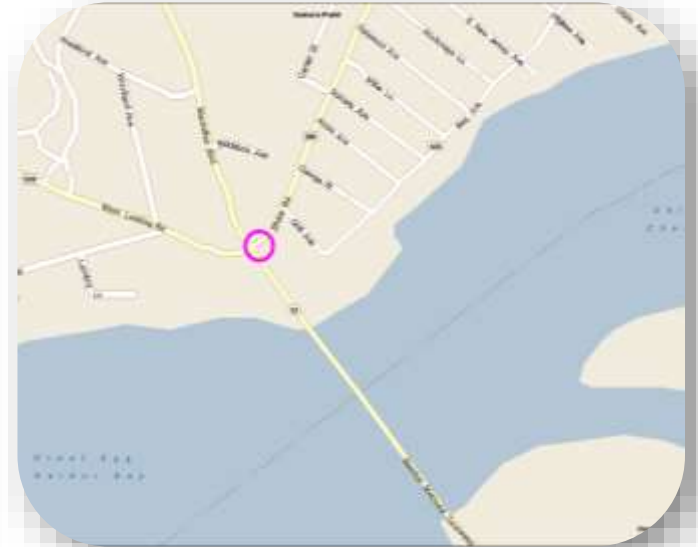
- The ramp from Route 52 WB to North Shore Road in City of Somers Point, NJ exhibited pavement failures that required frequent patching.
- The ramp was constructed between 2011 and 2012 as part of a project to eliminate the traffic circle at this location and premature failures were unexpected.

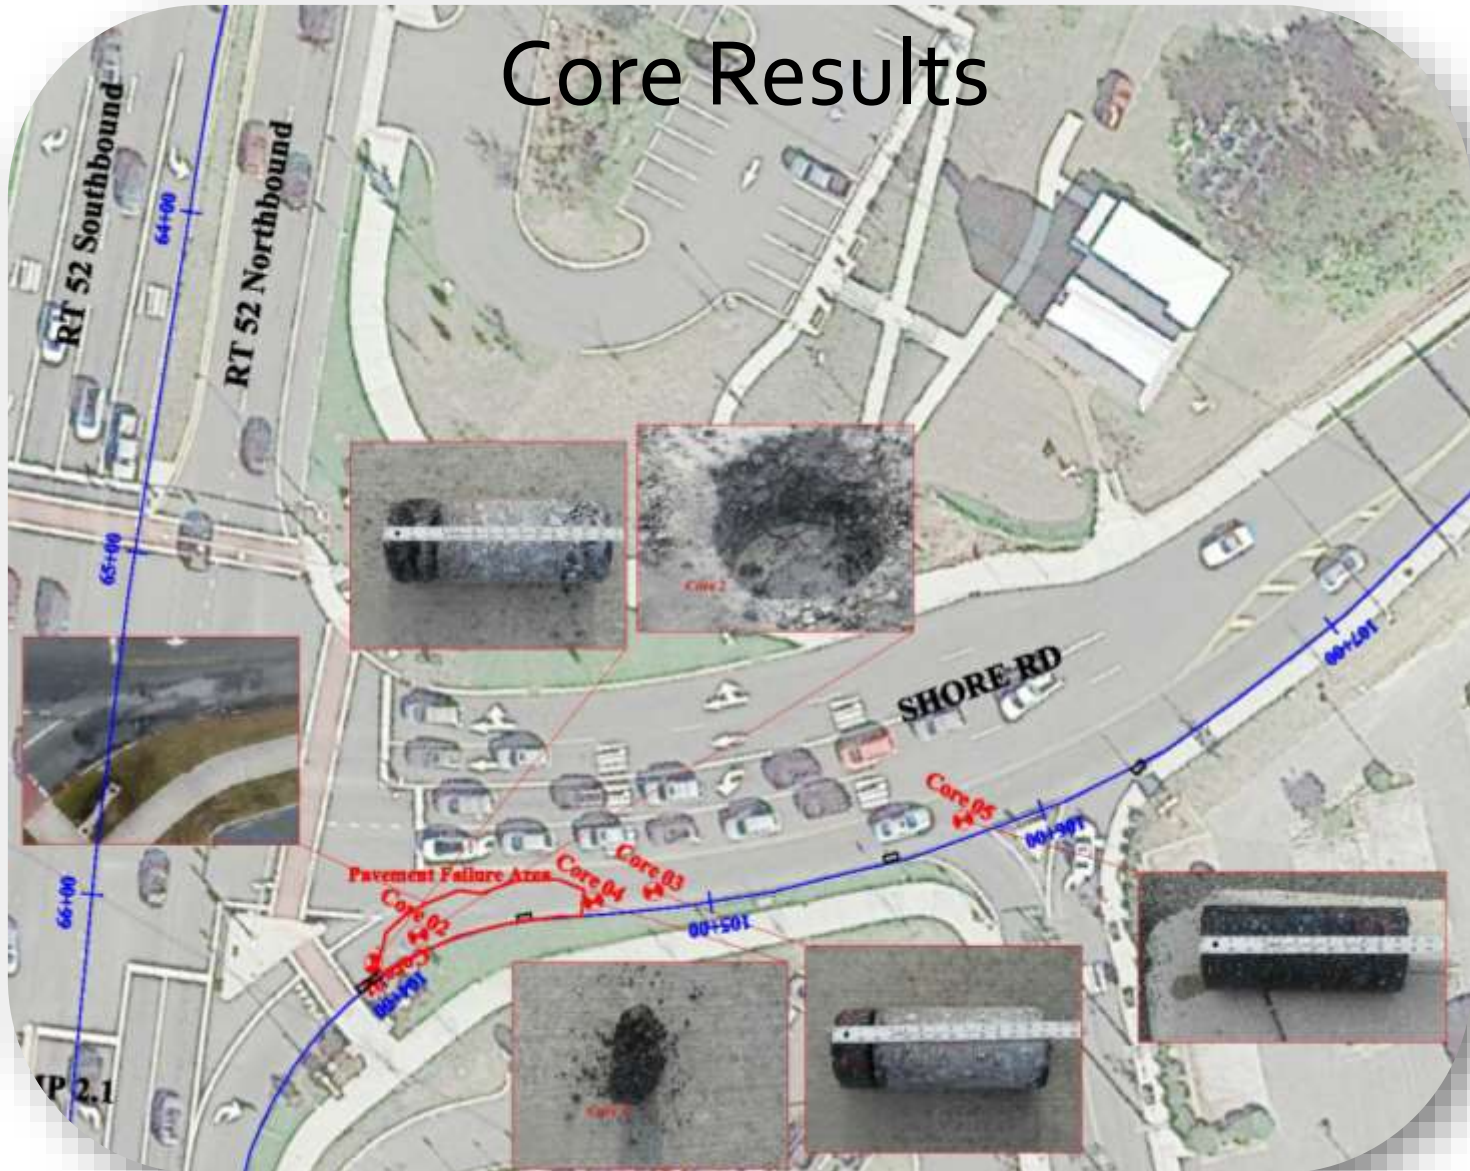
Core Results

- Five (5) core samples were extracted from the pavement.
- DCP testing was conducted for three (3) of the cores.
- Based on the core and GPR results, the pavement AC thickness varies from 9" to 14" (average 10").
- The aggregate base layer appears to have been stabilized and DCP could not penetrate indicating California Bearing Ratio (CBR) values more than 100%.
- The relatively thick pavement, strong aggregate base layer, and light traffic indicate that the pavement is structurally adequate. Hence, the cause of the pavement failure is not the structural capacity of the pavement.

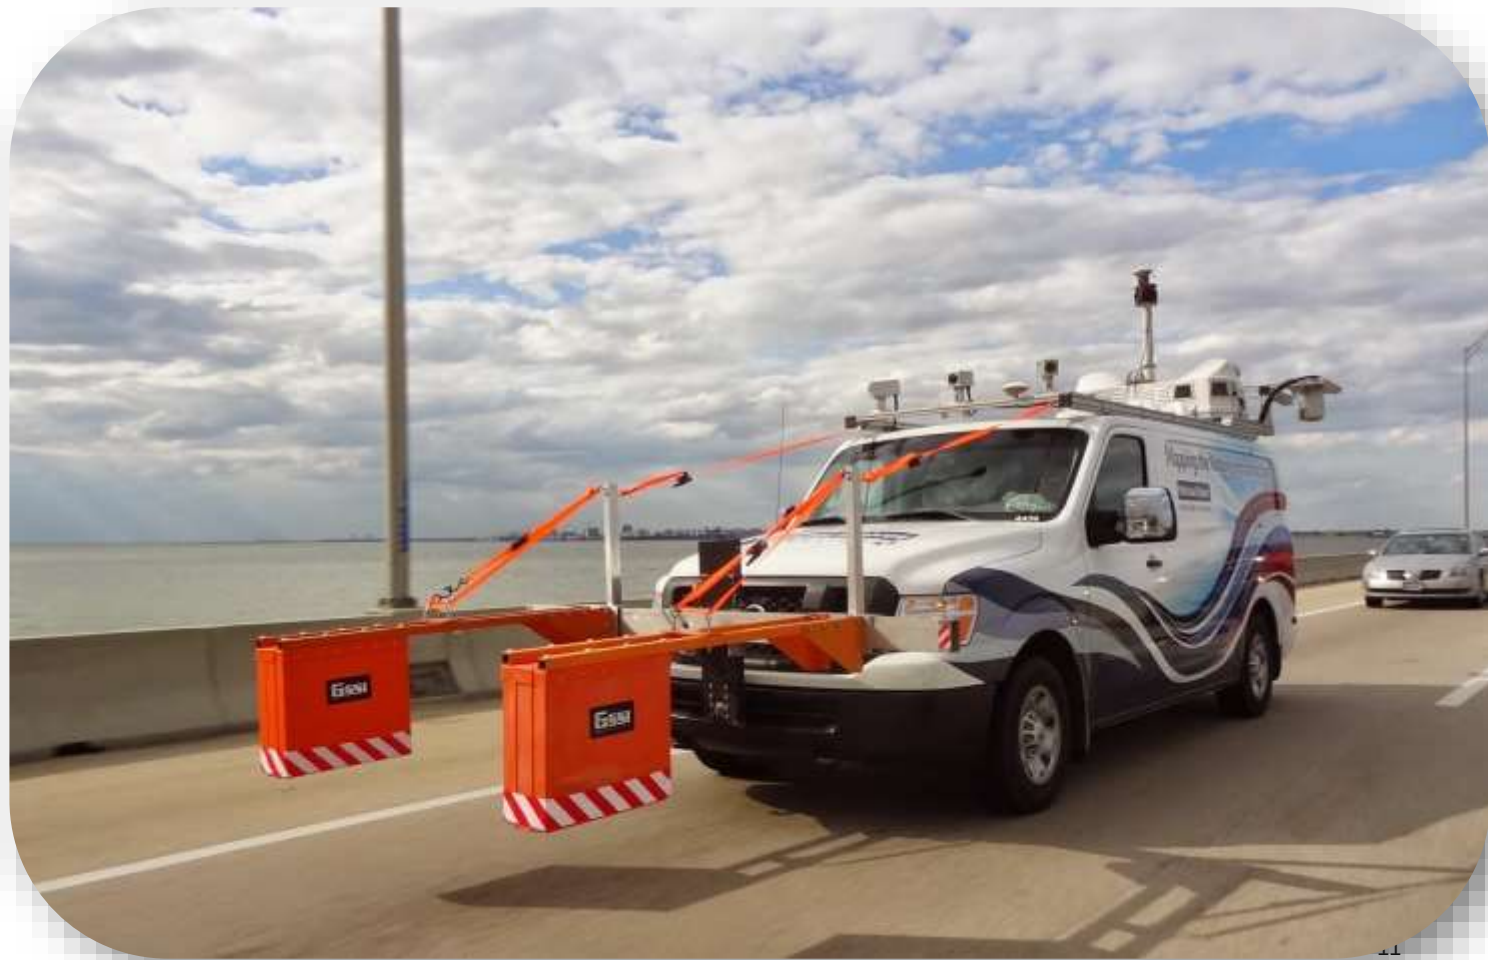
- GPR testing was conducted using two GSSI 2 GHz air-coupled antennas.

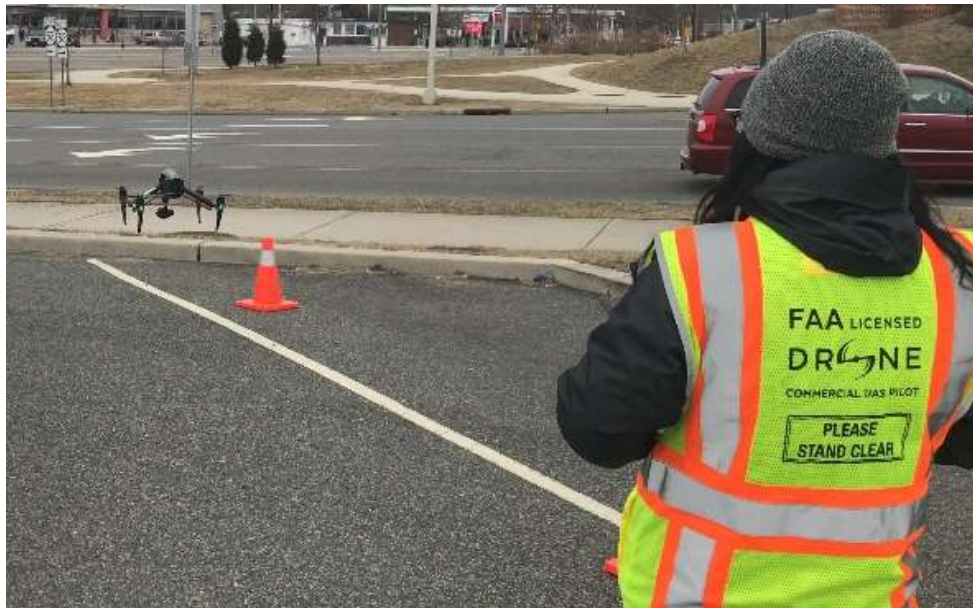
- UAV survey was done on 2/22/2019. The traffic was stopped from the survey area for 3 minutes to fly the UAV and collect the aerial photos.
- The 3-D point cloud mapping can be viewed at the address below using Google Chrome [here](#)

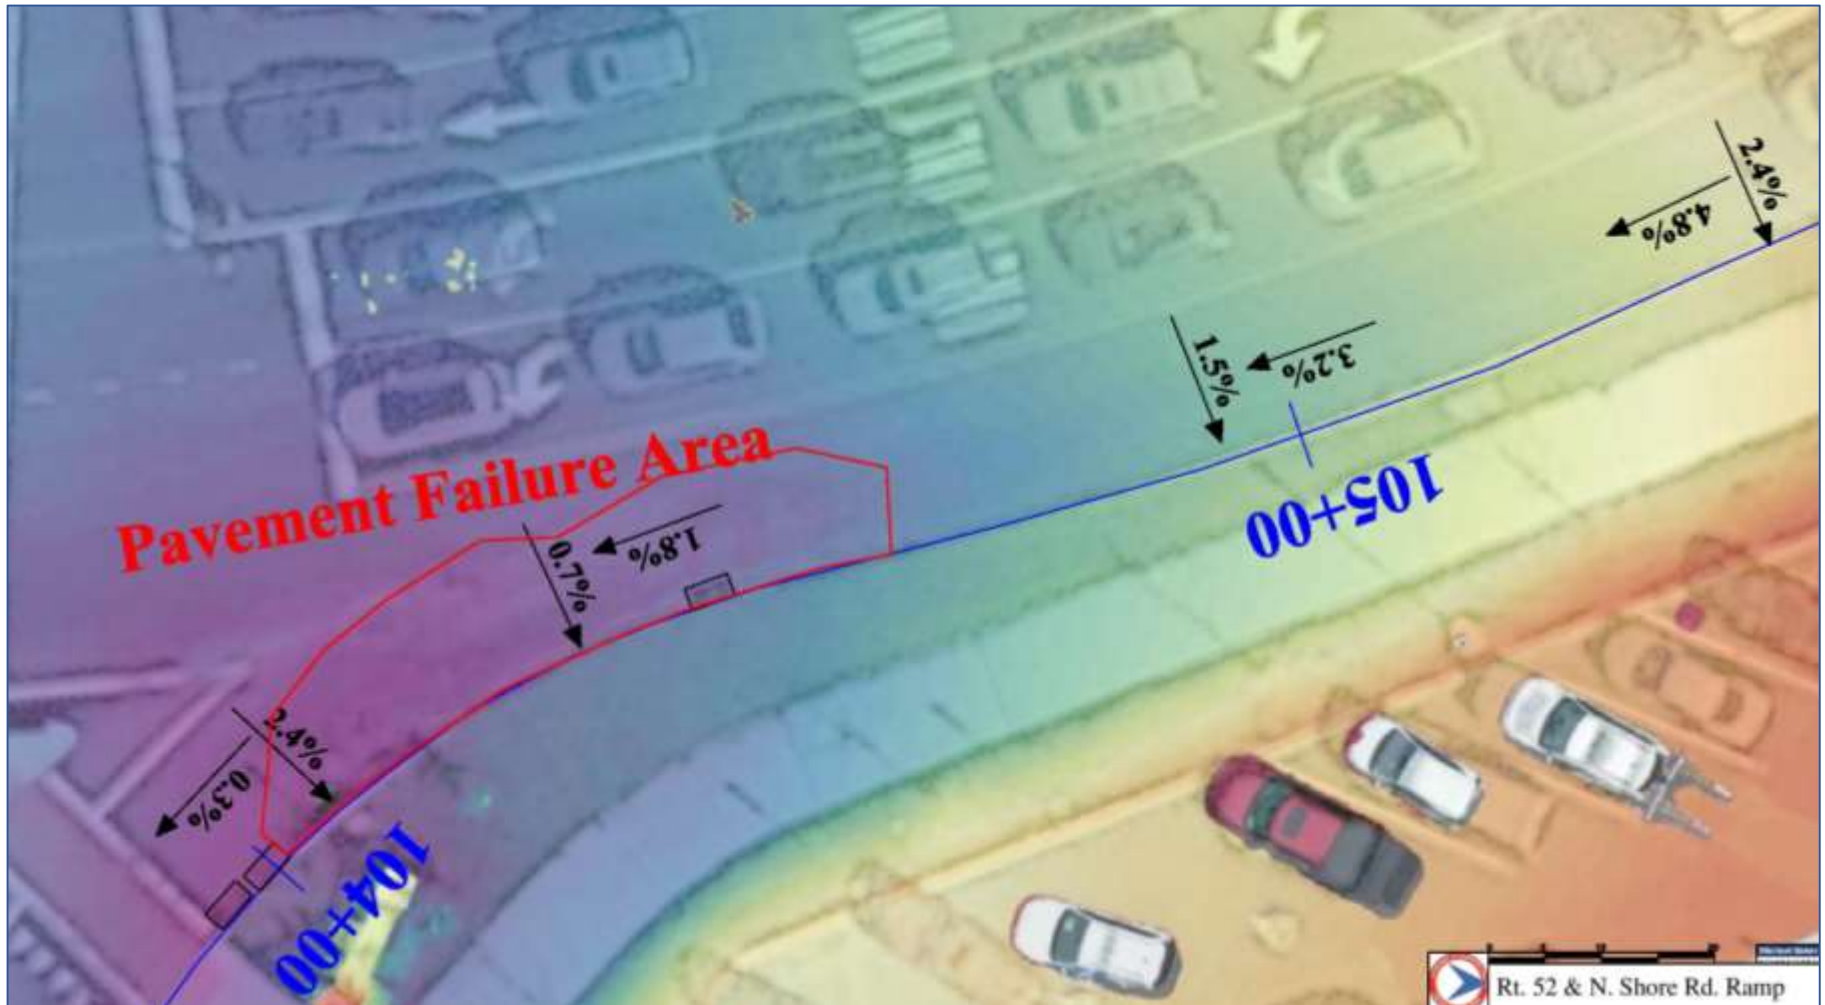
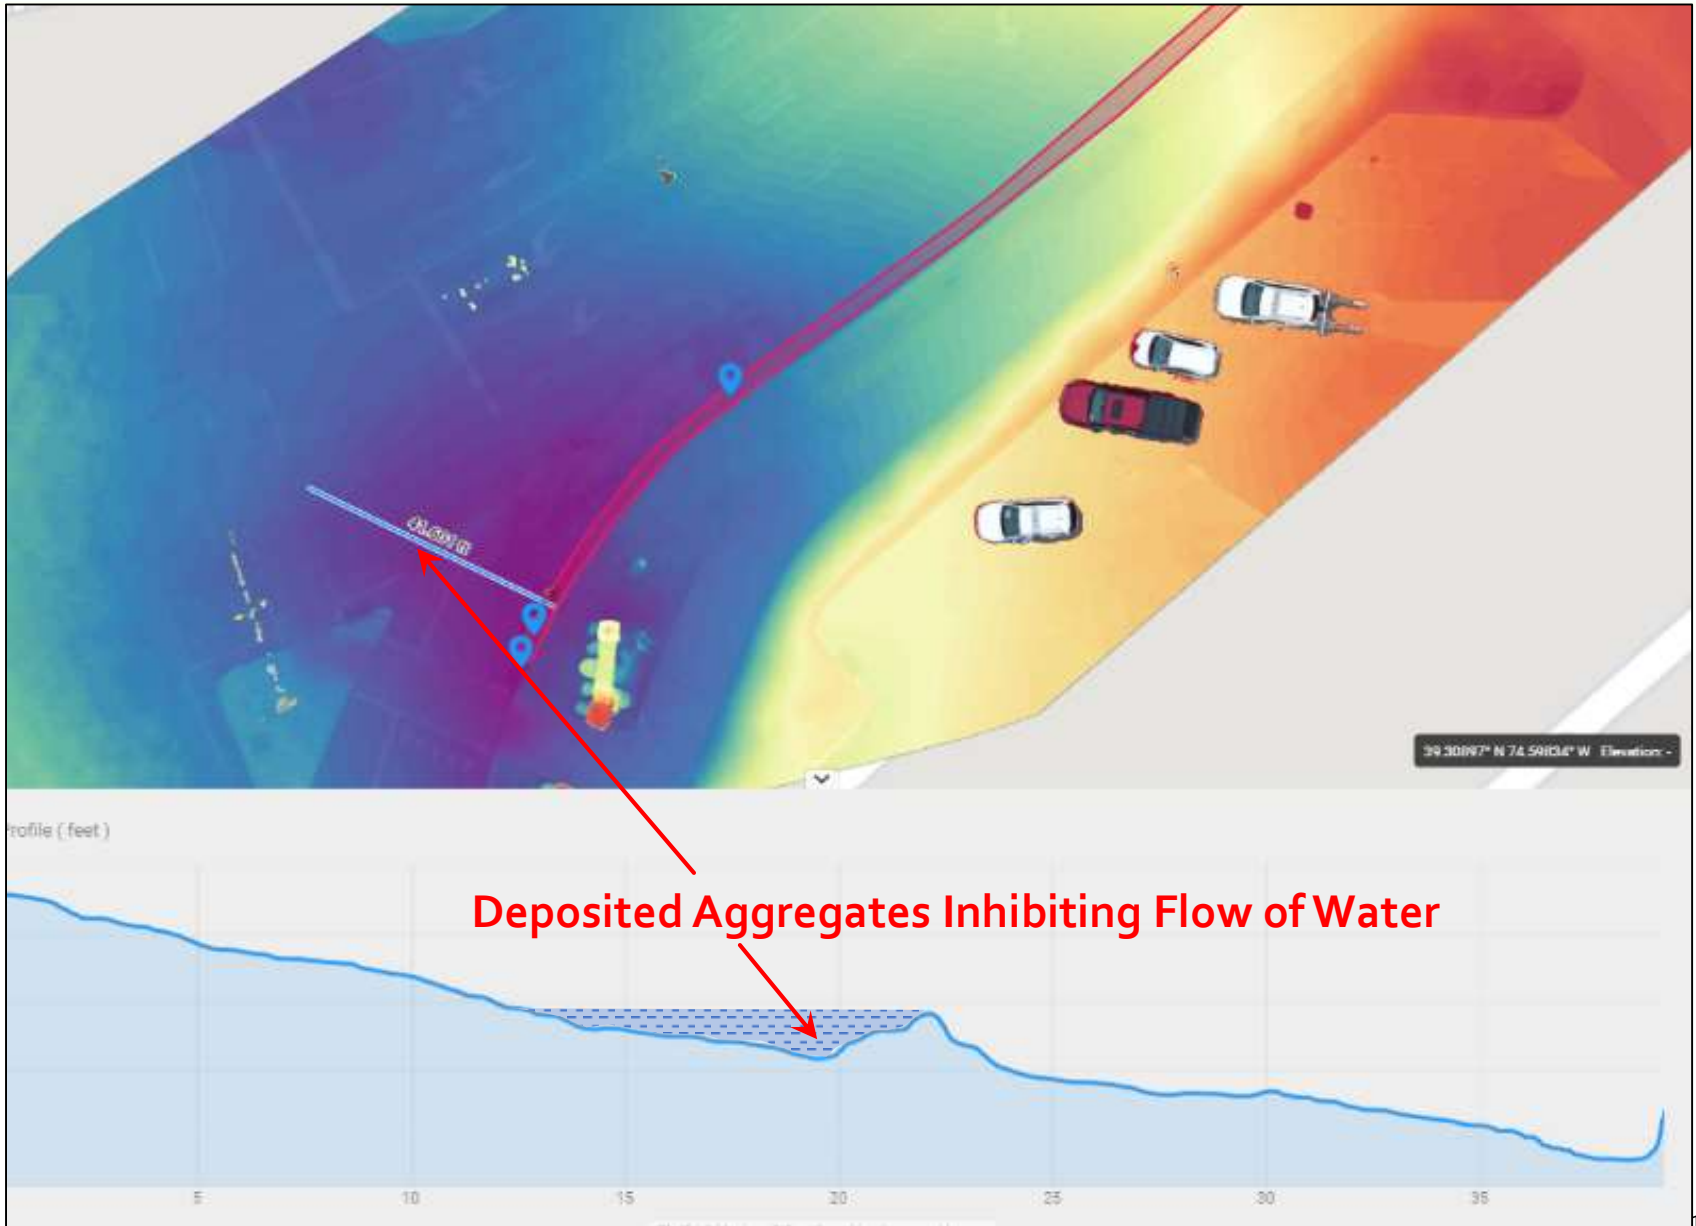
UAV Survey: Slope Measurement

- A visual survey of the project area indicated that the pavement failure area is at a low point receiving surface runoff water from the N. Shore Road Sta. 104+00 to Sta. 107+70.
- There are four inlets to catch the surface runoff water. Due to the relatively steep slope north of Sta. 104+46, it is expected that majority of the water is to be captured by Inlets 1 and 2 near the low point of the roadway.
- Inlets 1 and 2 do not seem to coincide with the low point of the roadway (next slide). The low point is approximately 15' north of the inlets

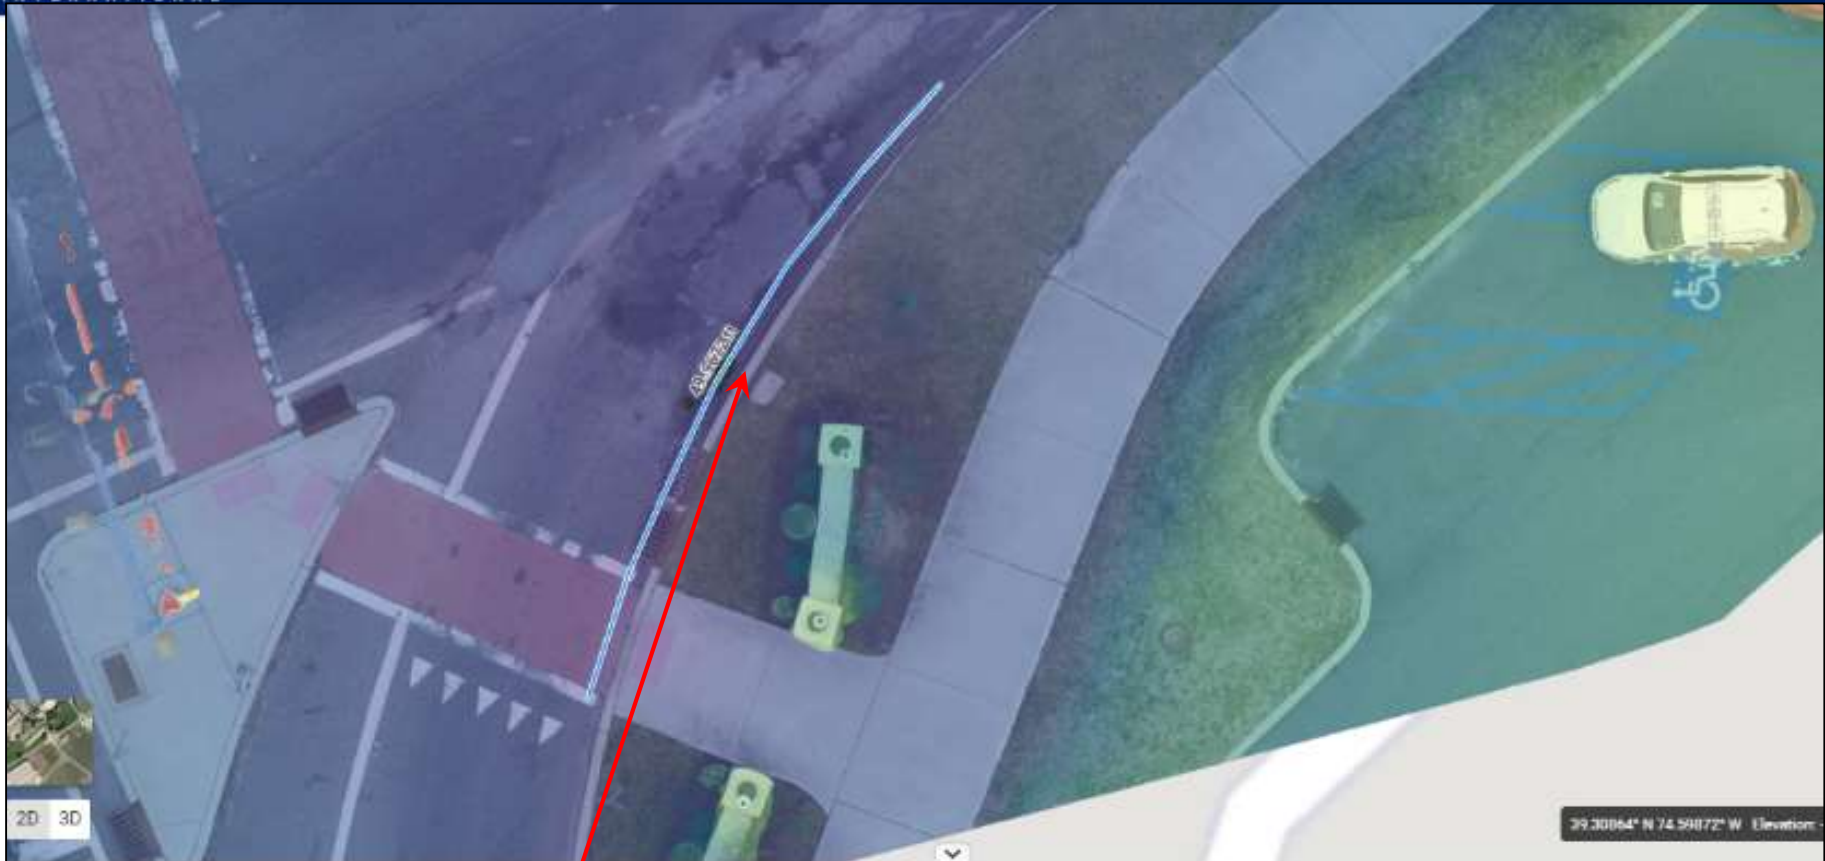
Inlets 1 & 2

Inlets 1 and 2 Do Not Coincide with Low Point of Road

Deposited Aggregates Inhibiting Flow of Water

- Seal coat the pavement that was placed circa 2012 between Stations 103+90 to 109+90 (600') to delay further raveling and loss of aggregates.
- Remove the surface course in the failed pavement area to a depth of 4" and replace with a binder rich mix that can resist HMA stripping better. Use of anti-stripping agents in the mix may be considered.
- Regularly remove the deposited aggregates to allow for free flow of surface run-off water and avoid ponding potential.
