Virtual Surface for Runway, Multi-Lane Highways, Bridge Decks at 1mm Resolution

Joshua Qiang Li, Kelvin C. P. Wang, Guangwei Yang

Oklahoma State University

Pavement Evaluation 2014

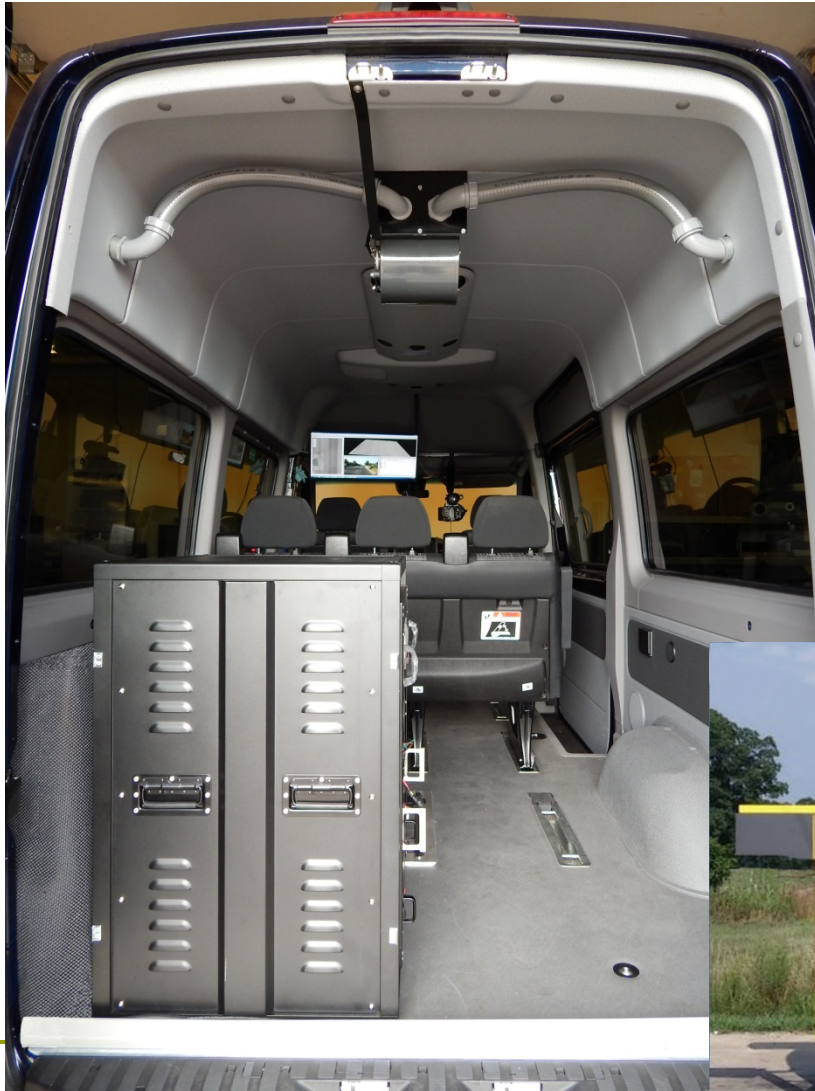
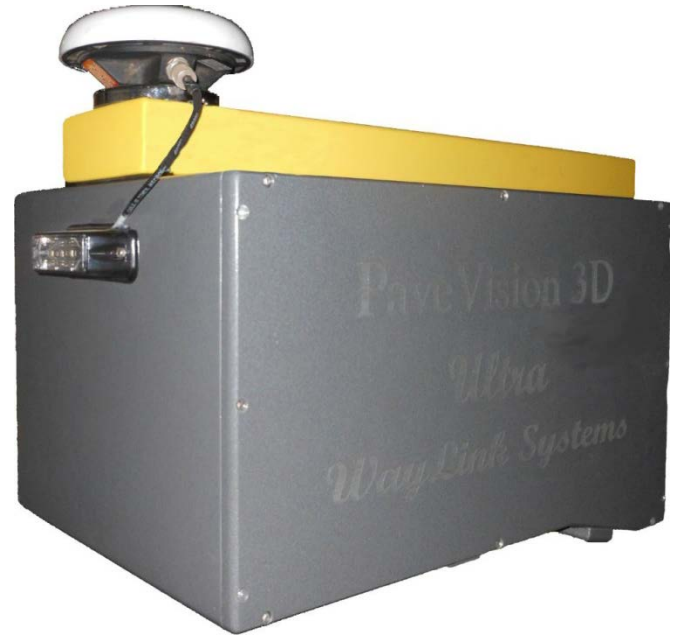
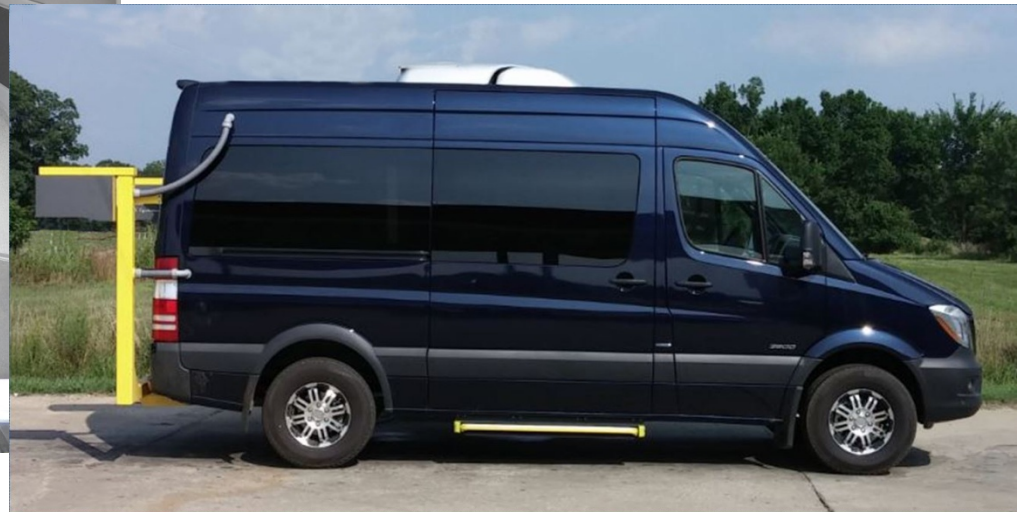
PaveVision3D Ultra - New

- Green lasers: previous red lasers
 - More uniform illumination
 - Substantially better sensitivity for 3D cameras
 - Consistently higher quality data, regardless of ambient light condition changes and pavement color variations

- 3D Ultra: simultaneously acquire both 3D "Range" and "Intensity" data
 - Totally synchronized with pixel-to-pixel accuracy
 - Complement each other for cracking detection and rutting measurement
-

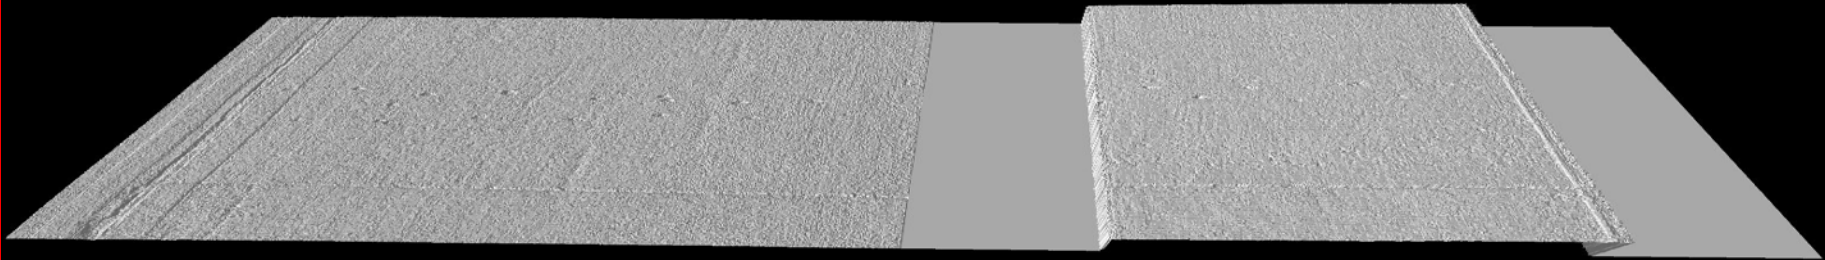
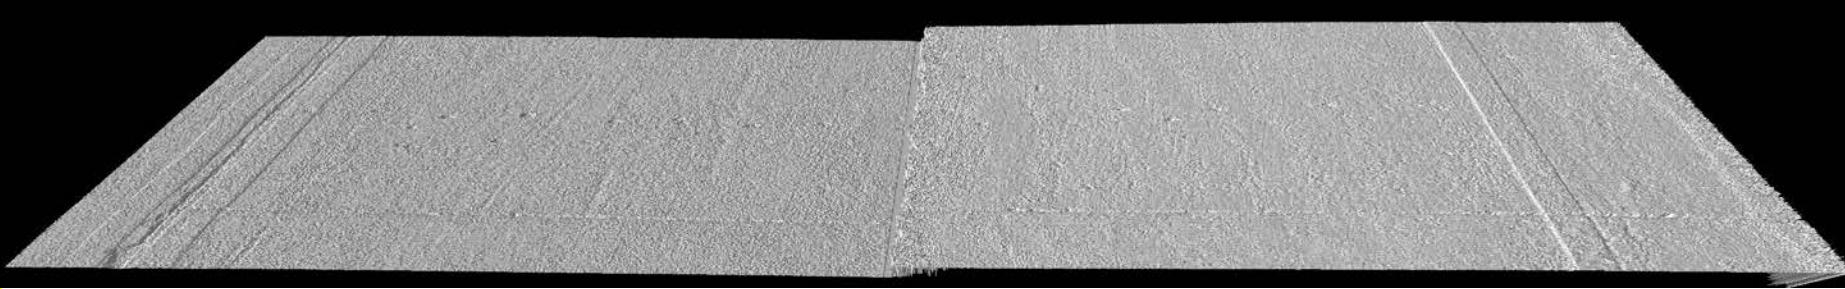
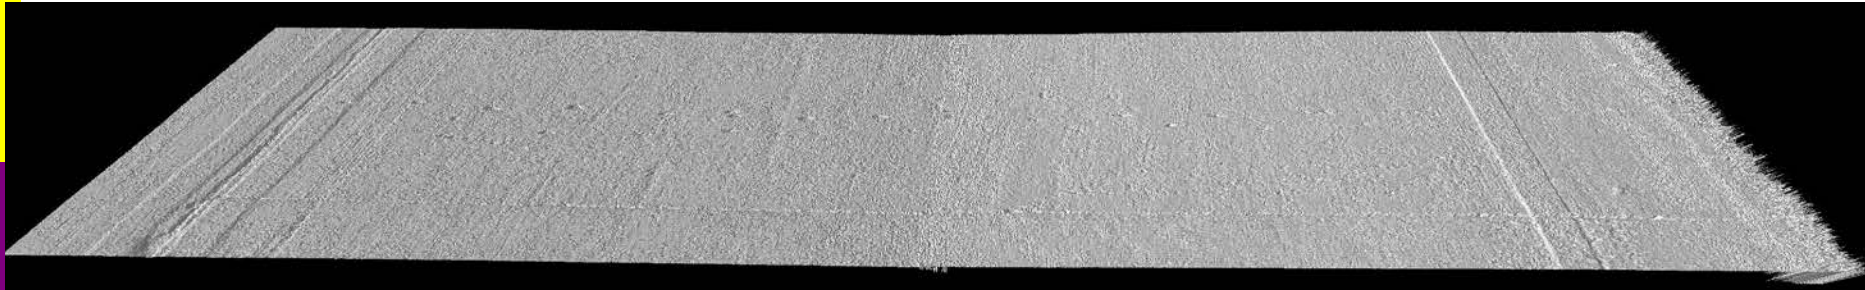
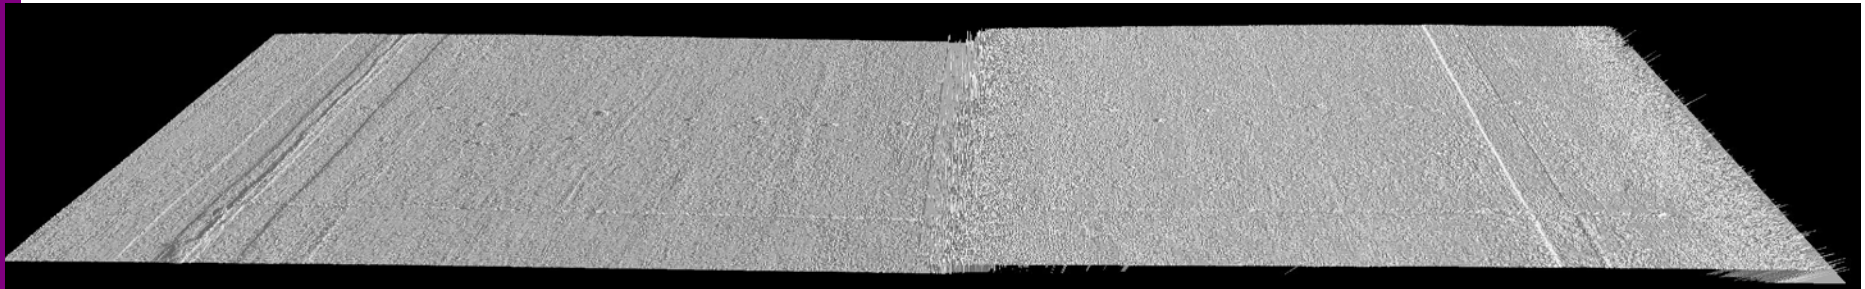
Jardot – New PCC (Exposure #1)

- Left: red laser; Right: green laser
- Field Testing
 - Brand New Asphalt (Husband Rd)
 - Brand New PCC (Jardot St)
 - Typical Surface at High Speed (US51)
- Various exposure time setting

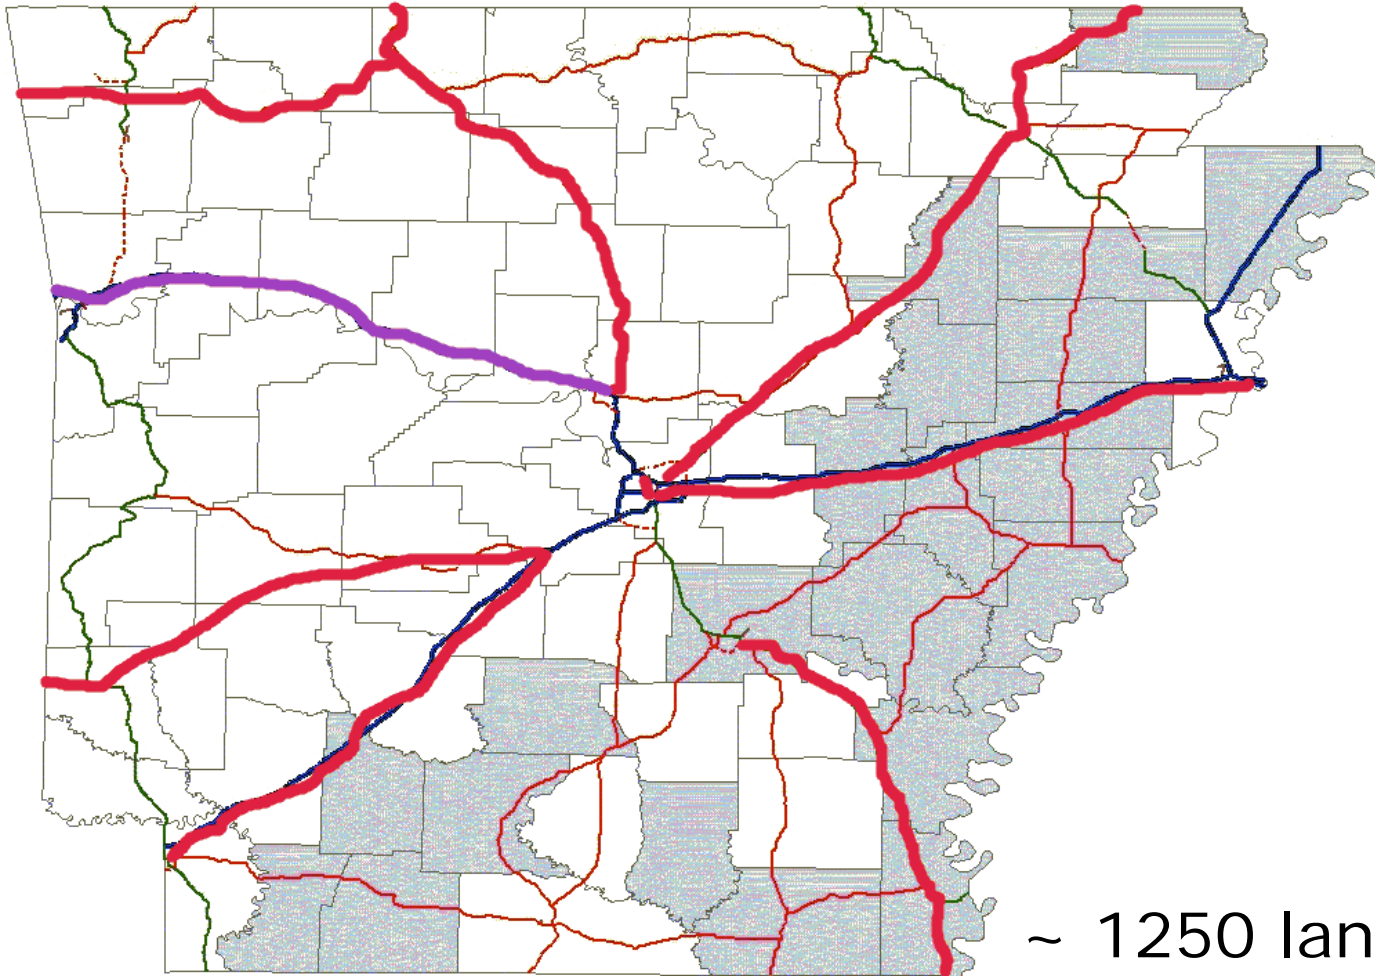
AHTD NHS Survey

~ 1250 lane miles

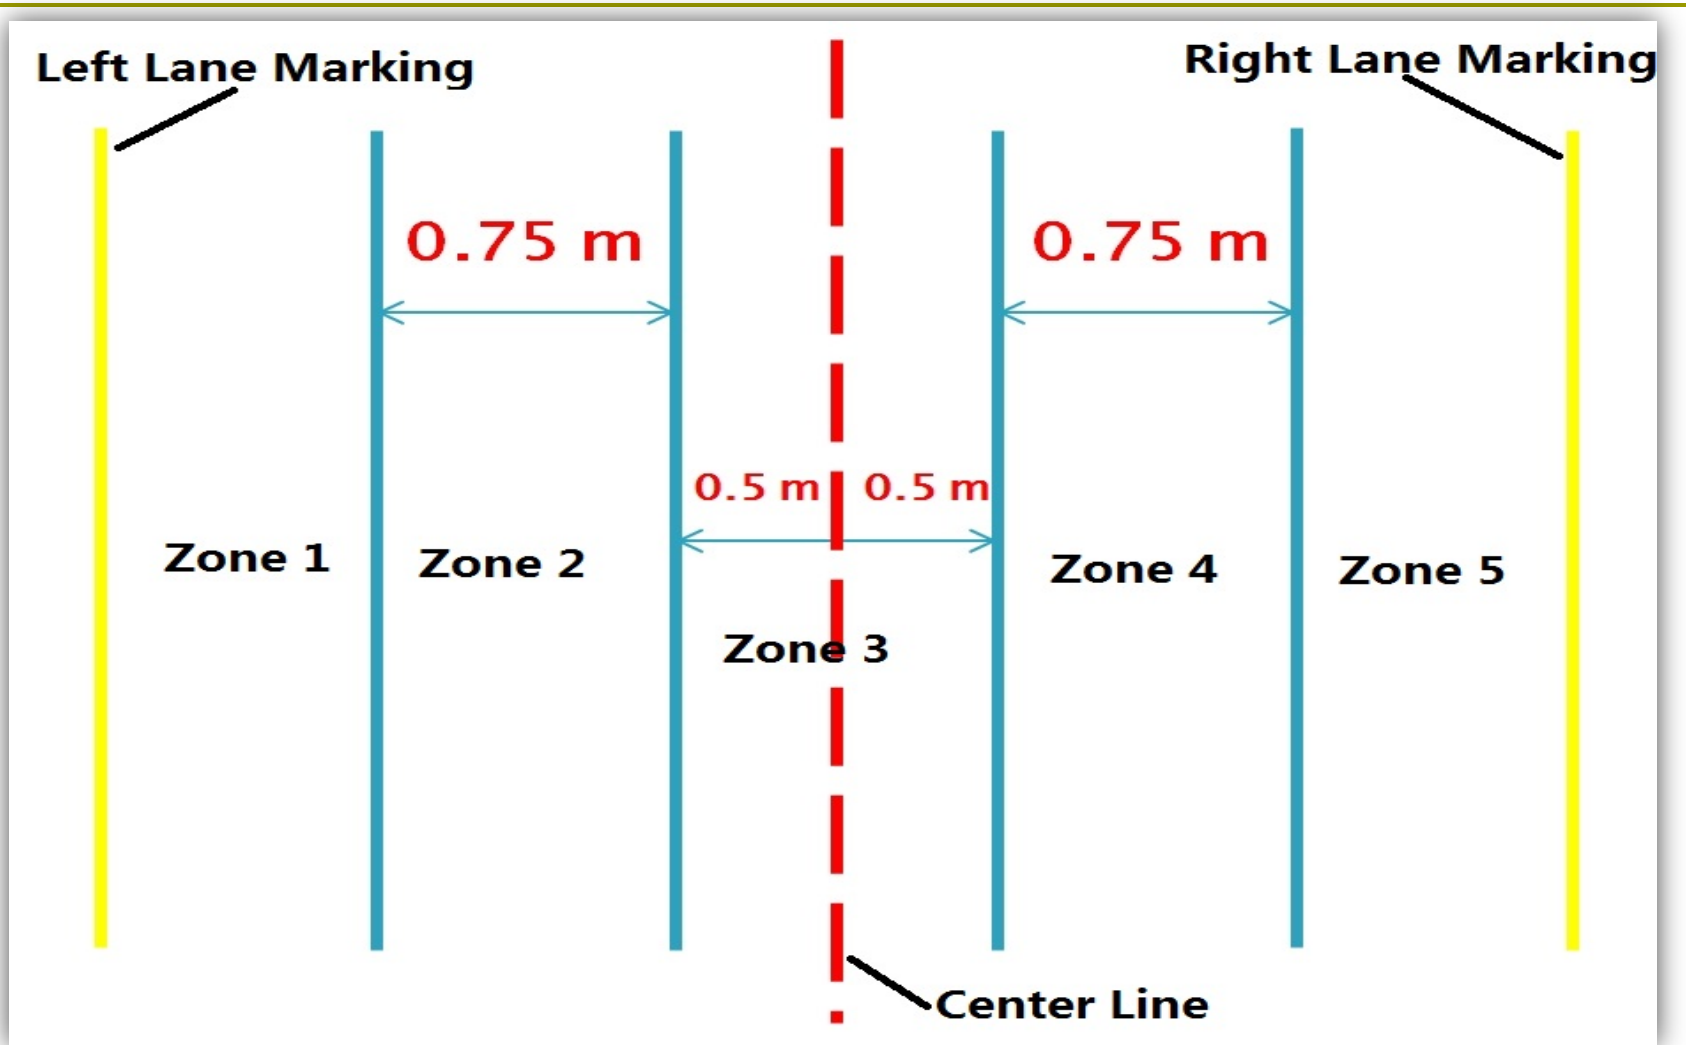
Wheelpath (WP) Definition

- Two cracking properties
 - Cracking length & width
- Three cracking types (by orientation)
 - Transverse, longitudinal & pattern cracking
- Five zones
 - Defined by WP & NWP

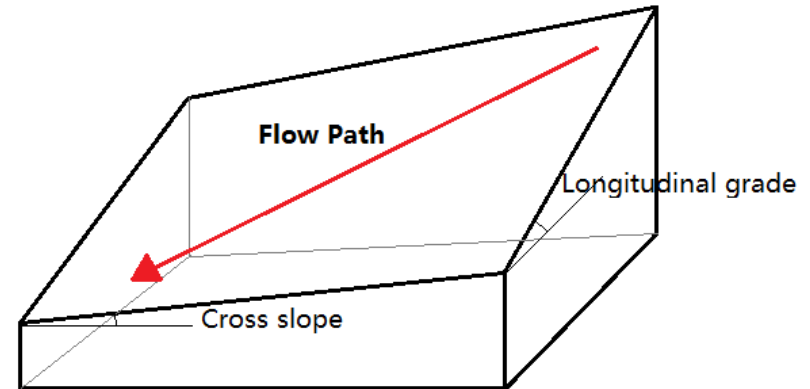
PAVDRN Model

$$WFD = \left[\frac{nL_f I}{36.1S_f^{0.5}} \right]^{0.6} - MTD$$

$$S_f = (S_l^2 + S_c^2)^{\frac{1}{2}}$$

$$L_f = W \frac{S_f}{S_c}$$

$$HPS = 26.04WFD^{-0.259} \quad (WFD \text{ (in)} < 0.095)$$

$$HPS = 3.09 A \quad (WFD \text{ (in)} \geq 0.095)$$

WFD: Water Film Depth (in)

MTD: Mean Texture Depth (in)

HPS: Hydroplaning (Hydroplaning) Speed (mph)

L_f: Flow path length (in)

S_f: Flow path slope (mm/mm)

S_l: Longitudinal grade

S_c: Cross slope

I: (*i* - *f*) = Excess rainfall rate (in/hr)

i: Rainfall intensity (in/hr)

f: Infiltration rate or permeability of pavement (in/hr)

n: Manning's roughness coefficient

- Inertial Measurement Unit (IMU) Data
 - ❖ Positioning, cross slope and vertical slope
- PaveVision3D texture data
- Hydroplaning speed model
 - ❖ Water film depth: pavement texture, pavement type, cross slope, vertical grade, rain intensity
 - ❖ Hydroplaning speed: FHWA PAVDRN model

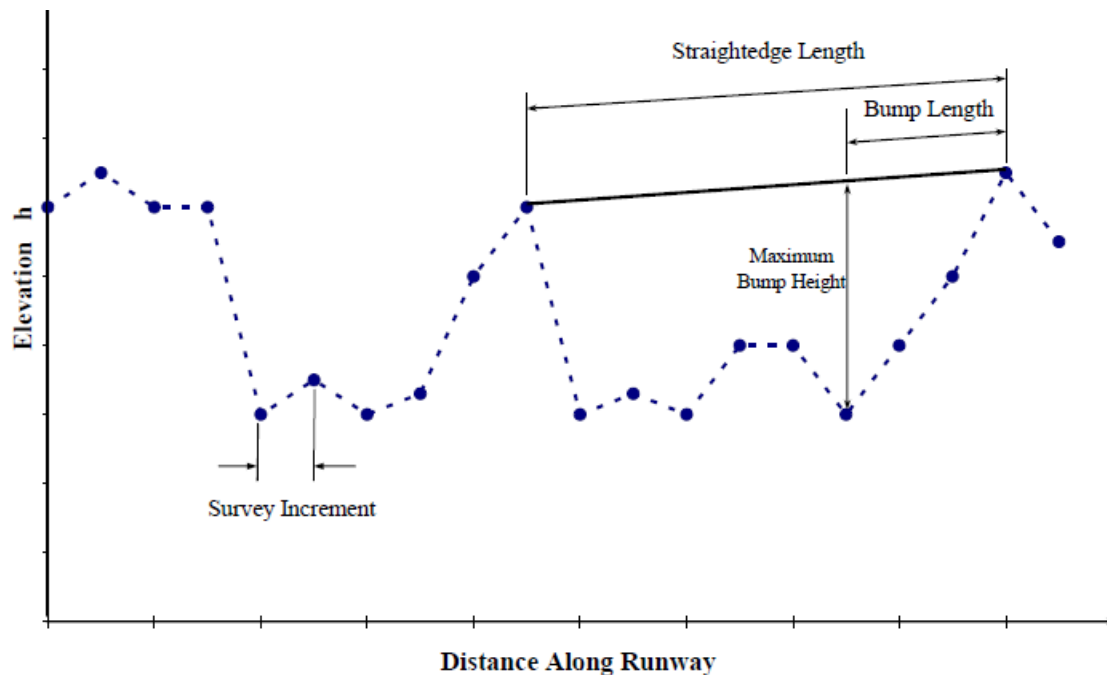
Runway Longitudinal Profiling

- Boeing Bump Methodology
 - FAA AC 150/5380-9

BBI = (measured bump height) / (limit of acceptable bump height)

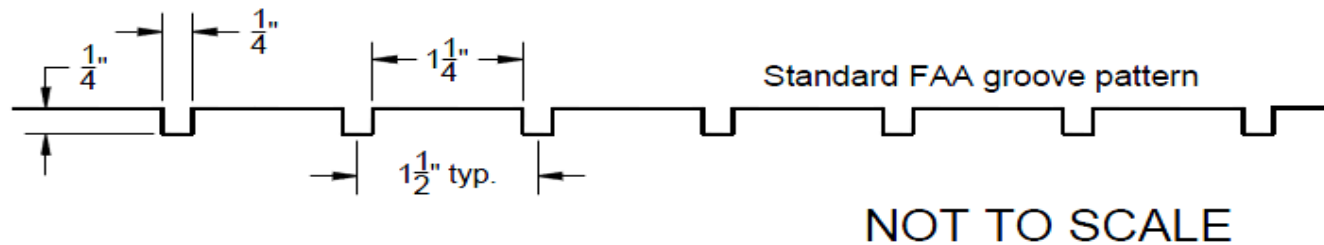
Runway Groove Evaluation

- Standard Rectangle Groove (AC 150/5320-12C)

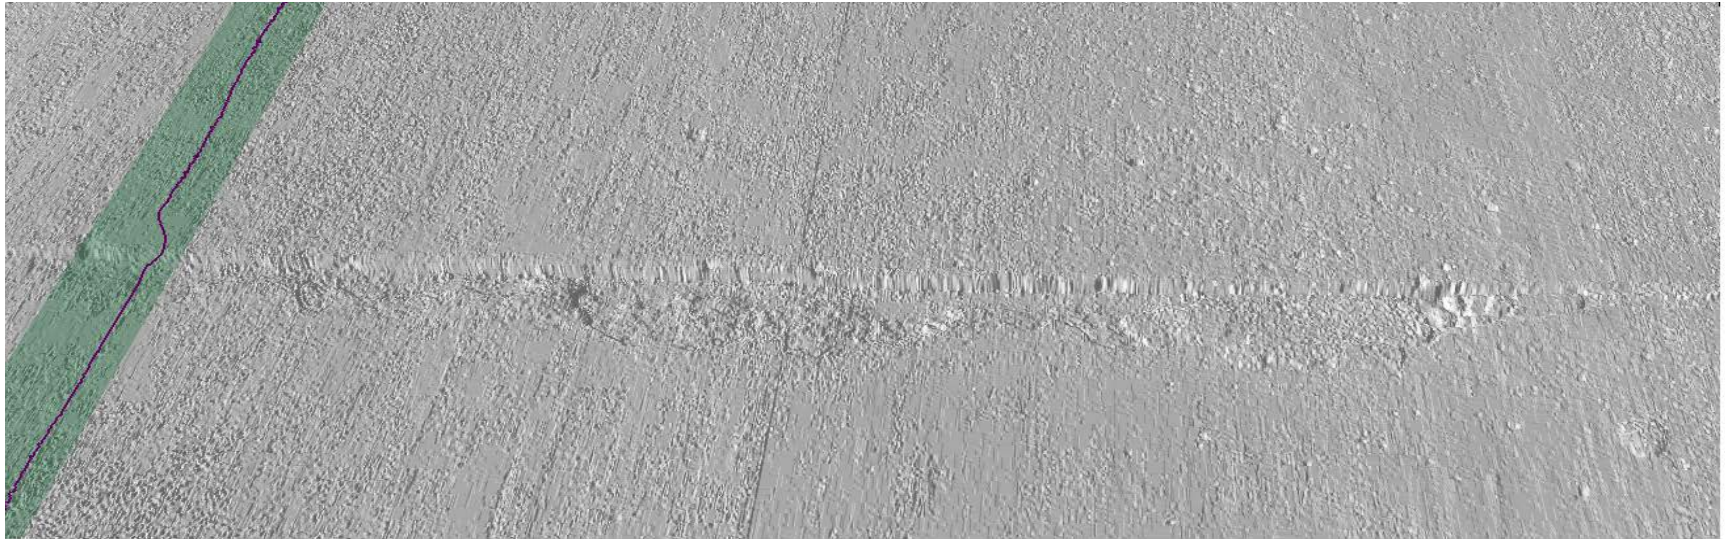
(a)

Example Faulting Results

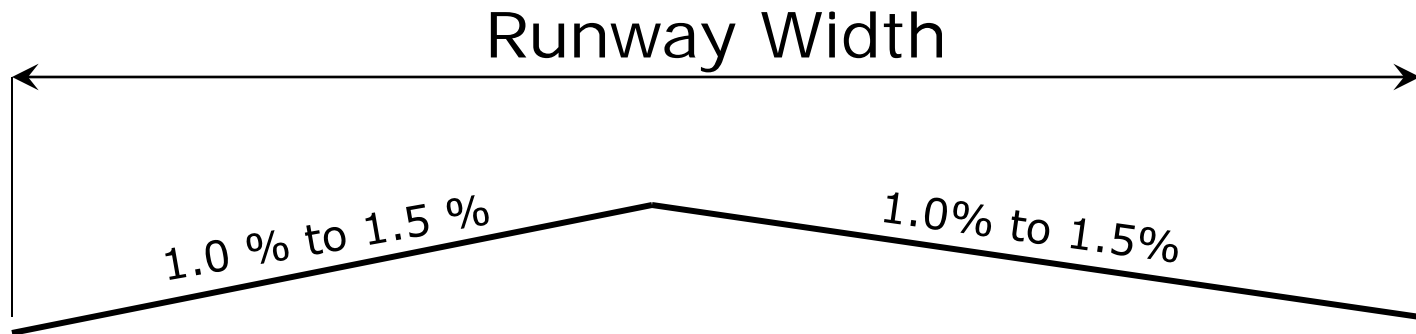
Transverse Profiling & Cross Slope

- Cross Slope Calculation
 - AASHTO method
 - TxDOT method
 - Linear regression method
- Transverse Grade – Category C & D Airports (FAA Guidance)

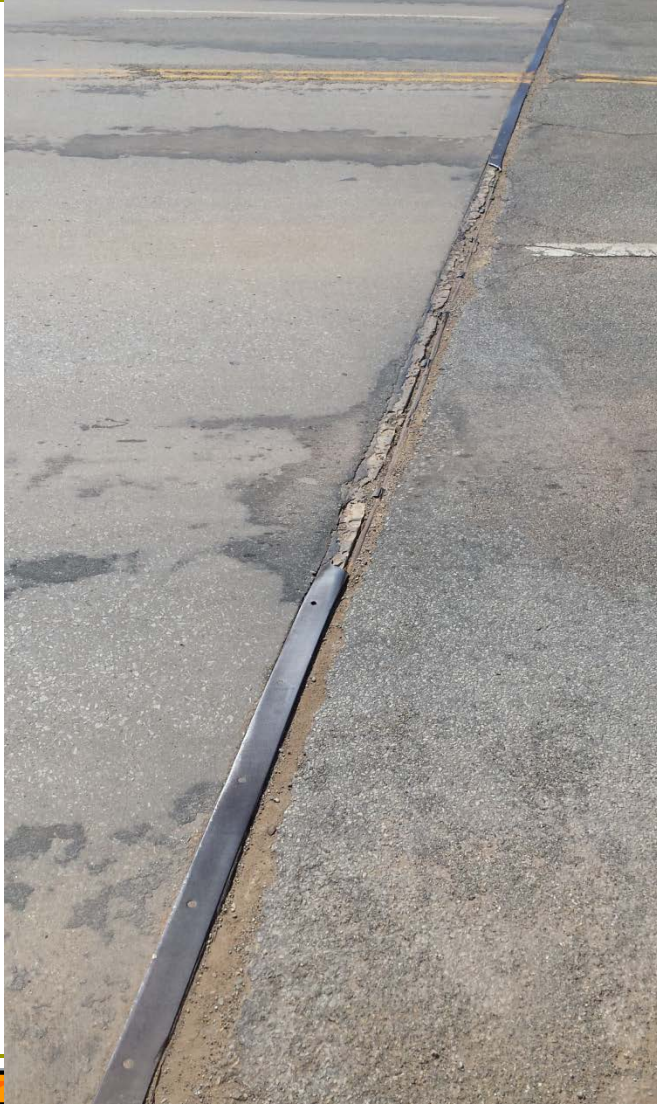
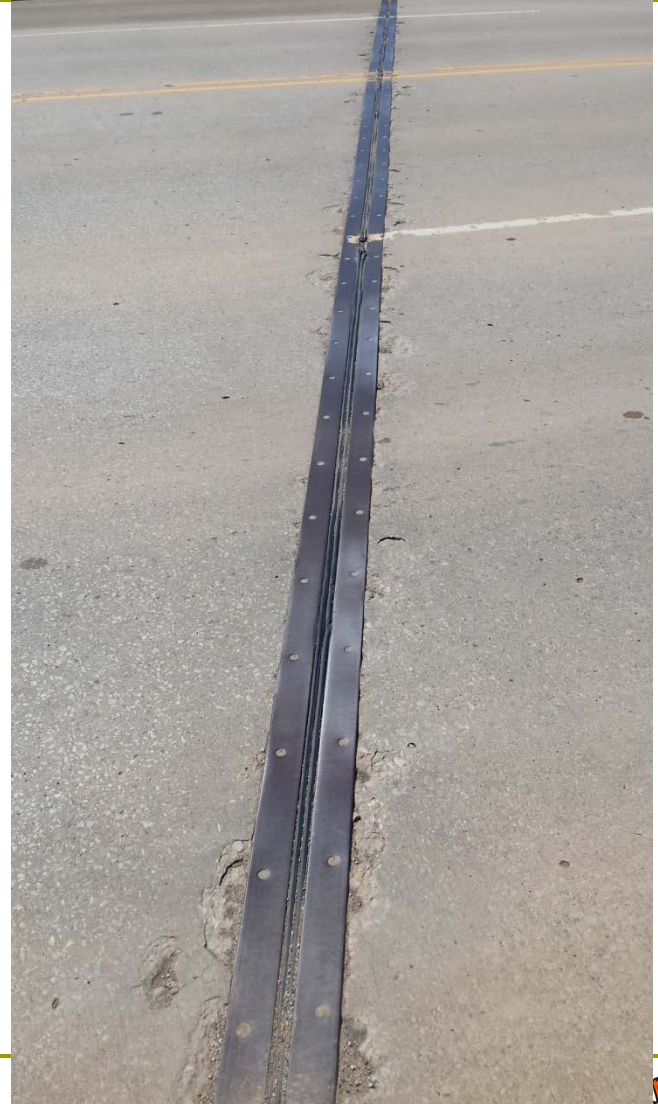
Bridge Deck (Joint #1 & #2)

(b) Bridge Deck
