Pavement Evaluation 2019

September 17-20, 2019
Roanoke, Virginia

Experiences in the use of Automatic 3-D Distress Evaluation System for pavement monitoring in Argentina

Eng. Gustavo Mezzelani
ITYAC S.A. – Rosario, Argentina

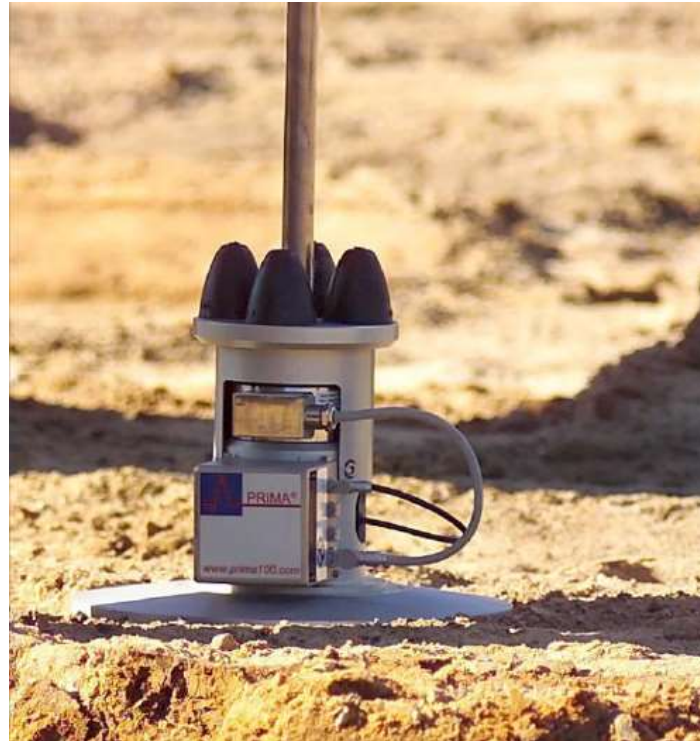
Light Weight Deflectometer
PRIMA 100

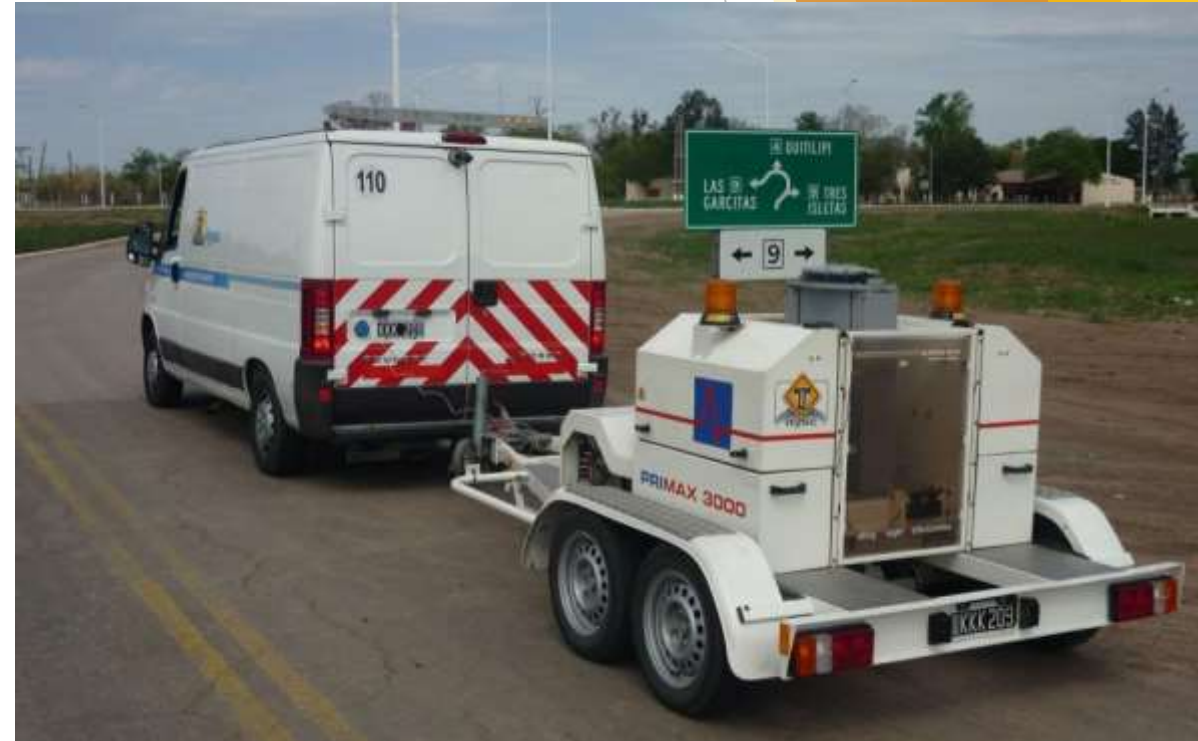
Super Heavy Weight Deflectometer
PRIMAX 3000

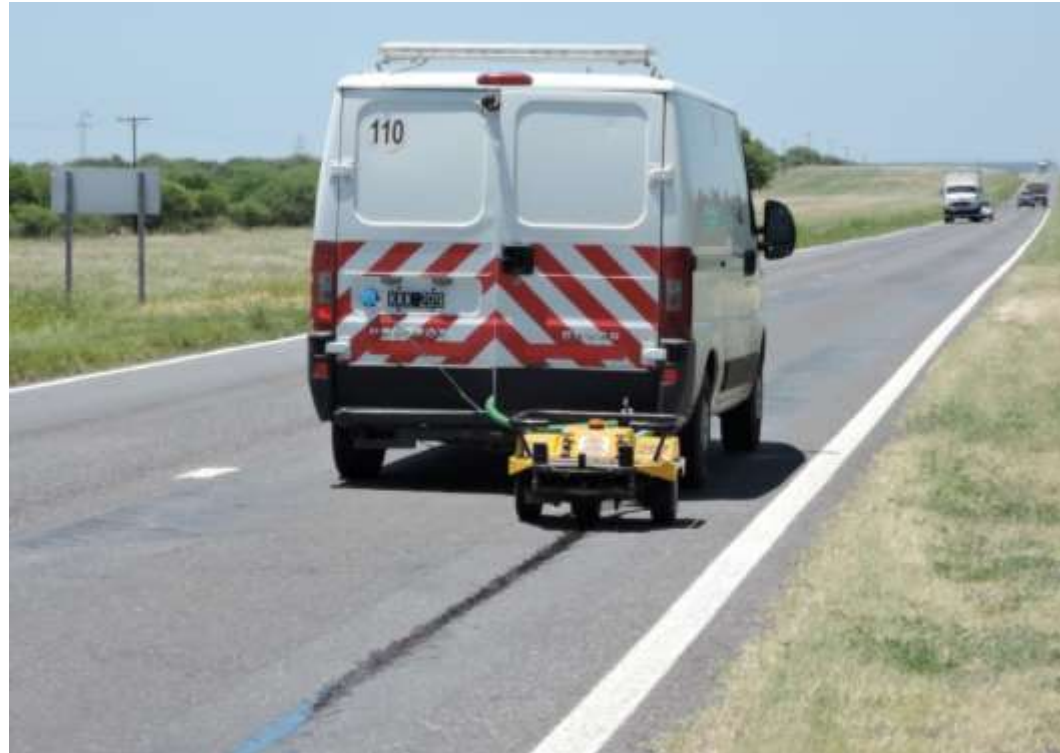
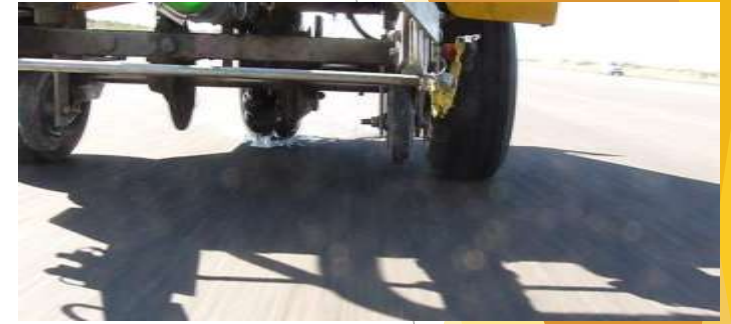
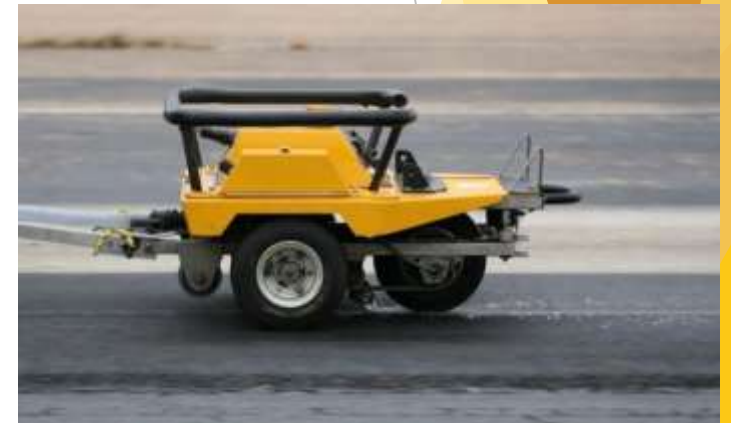
Grip Tester Mk2 D-Type

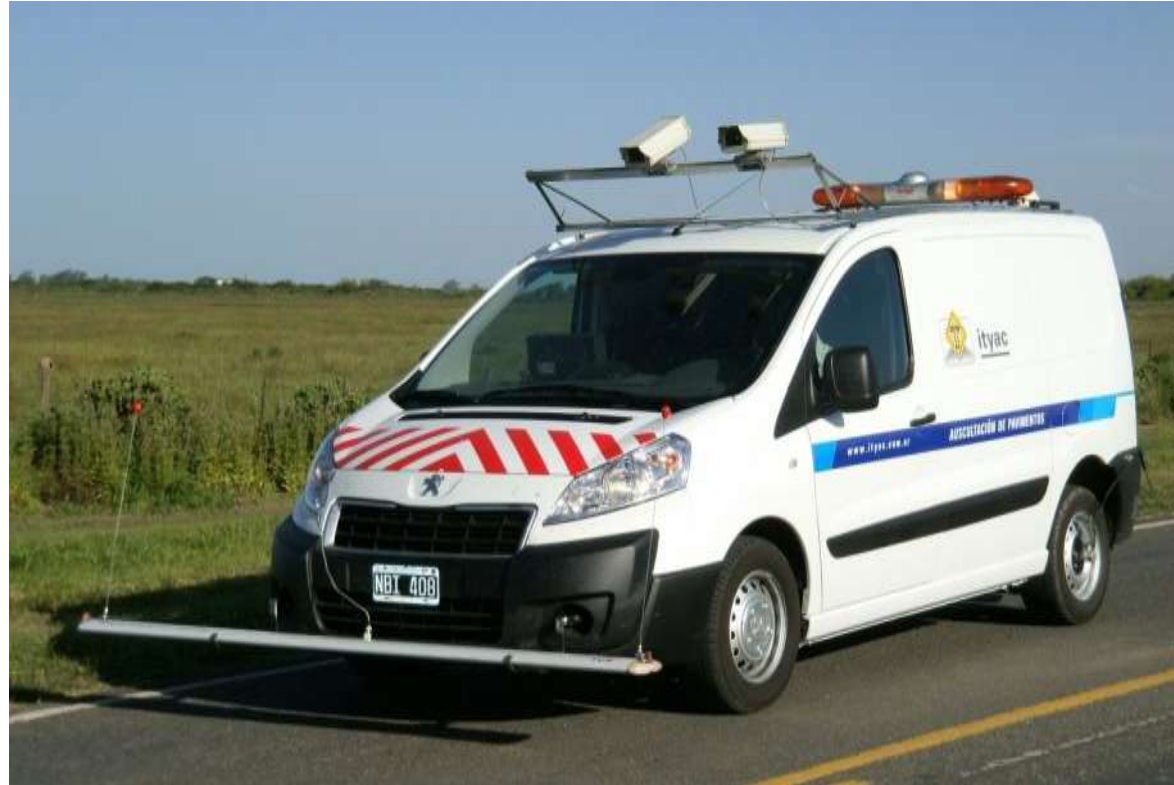
**ASTRA™ Multifunction System – Laserprof IRI and Tx
– Ultrasound Transversoprofilometer (TUS)**

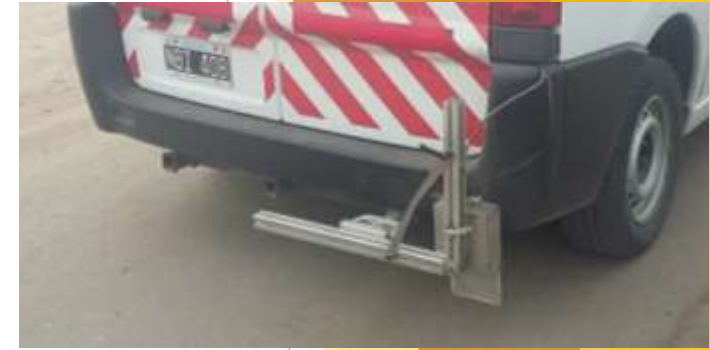
Dipstick 2277 - Profiler

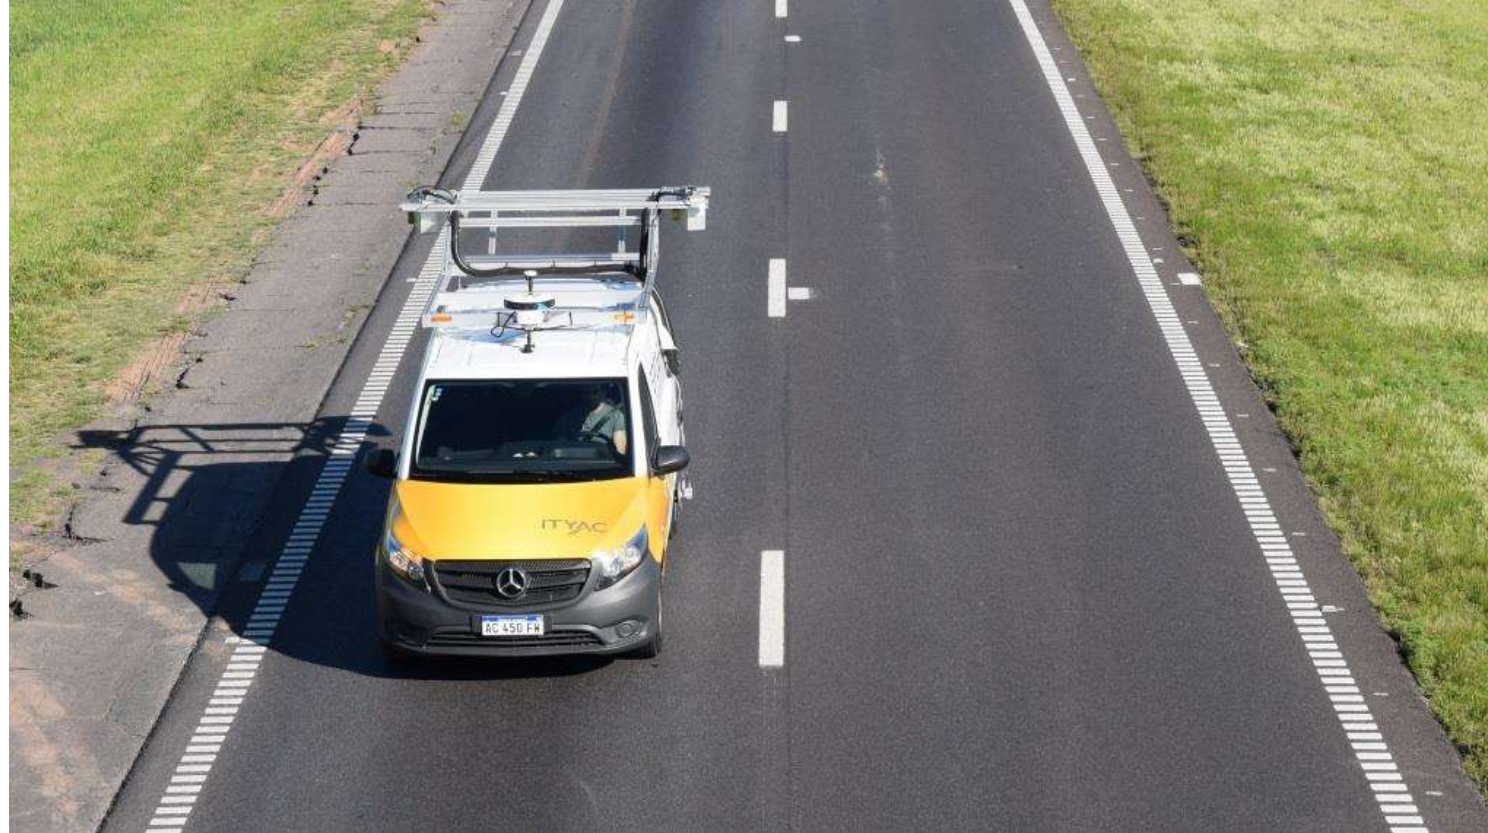
SPIDER™ Multifunction System – Laser Crack Measurement System (LCMS)

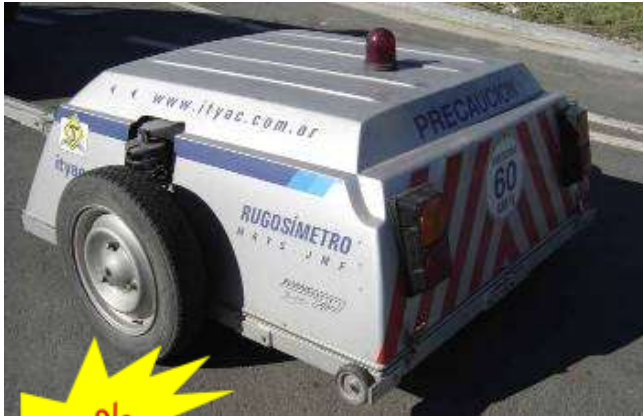
Roughness

Bump Integrator

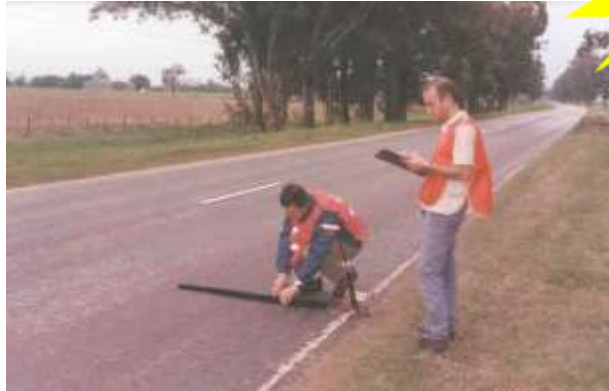
Rutting

Straightedge 1,20 m

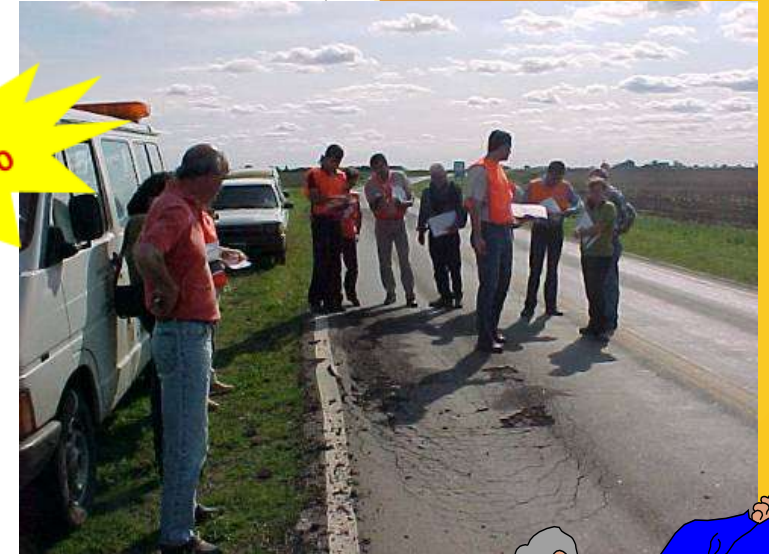
Visual Distress Evaluation

20 m

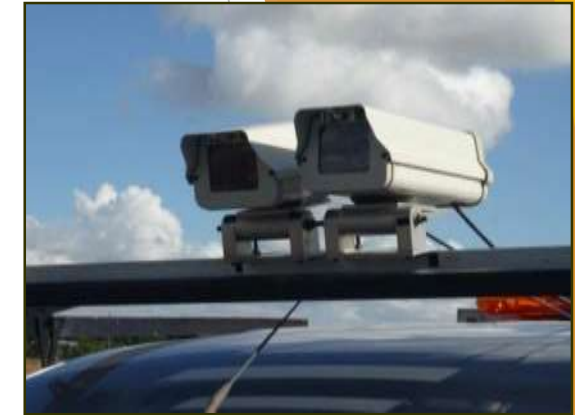
Distress Evaluation
High quality cameras

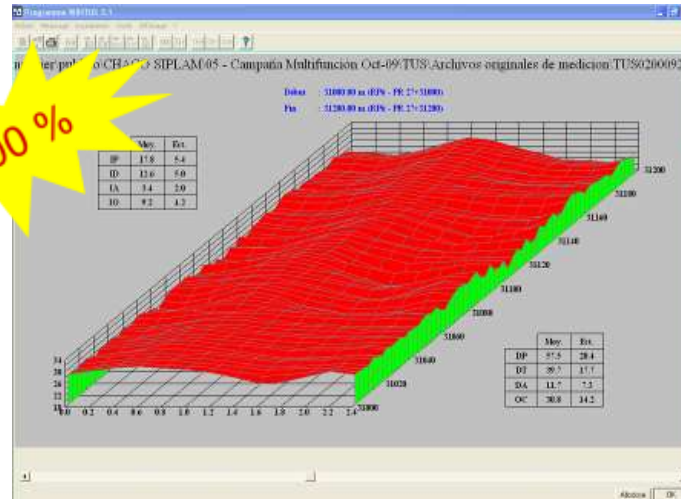
Rutting
TUS (Ultrasonic Sensor)

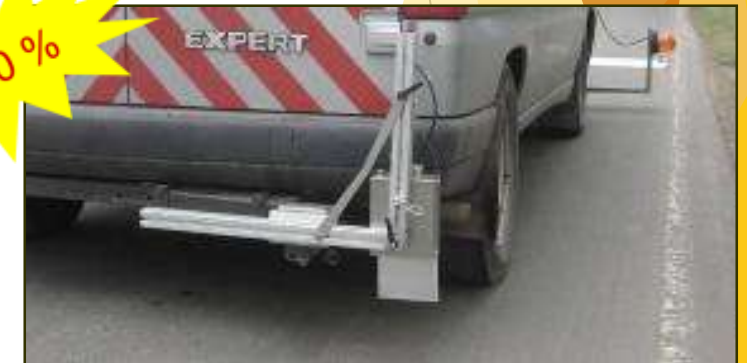
16 Roughness
Laserprof

Laser Crack Measurement System vs Laserprof

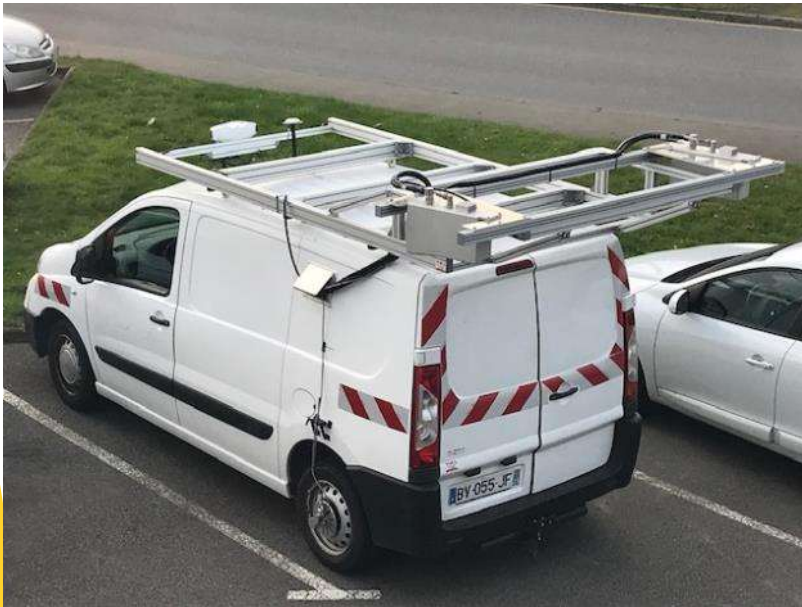
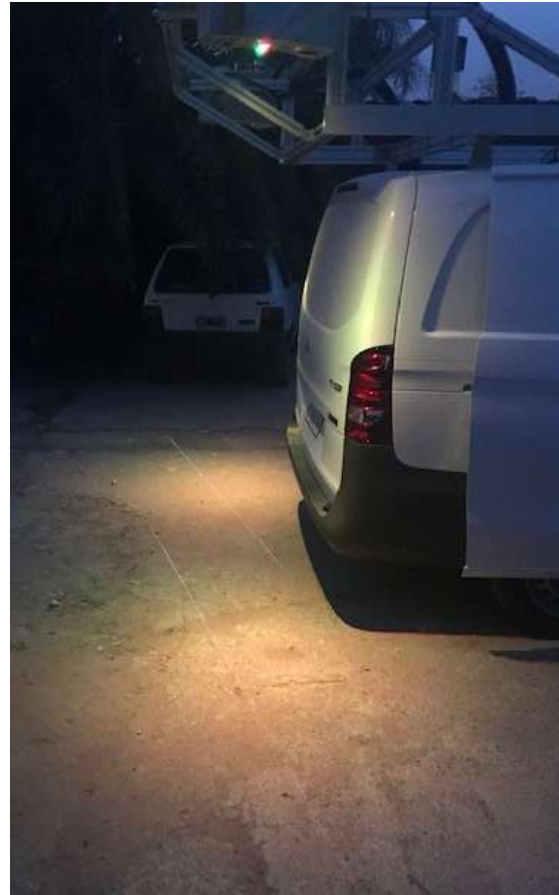
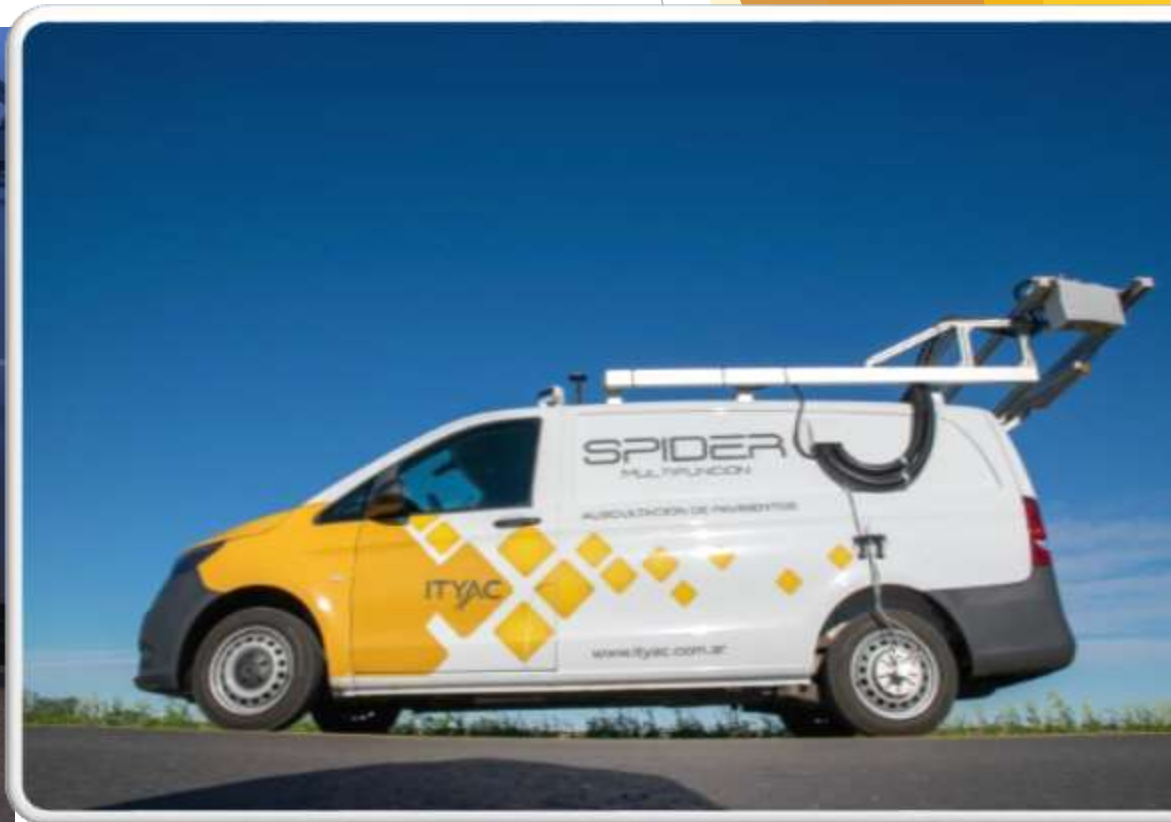
LCMS SPIDER™ FEATURES

PRINCIPAL FEATURES

- ❖ Longitudinal profile measurements (I.R.I.) – Class I ASTM E950
- ❖ Macrotexture (MPD/MTD) in all 5 AASHTO bands
- ❖ Rutting measurement (ASTM E1703/ Taut Wire/ Moving straithege/ Brazilian Method/ 5 Point Rut Depth)
- ❖ Automatic pothole and ravelling detection
- ❖ Bleeding detection
- ❖ Road Geometry
- ❖ Automatic cracking detection and measurement (both sealed and unsealed)
- ❖ Digital Road Inventory

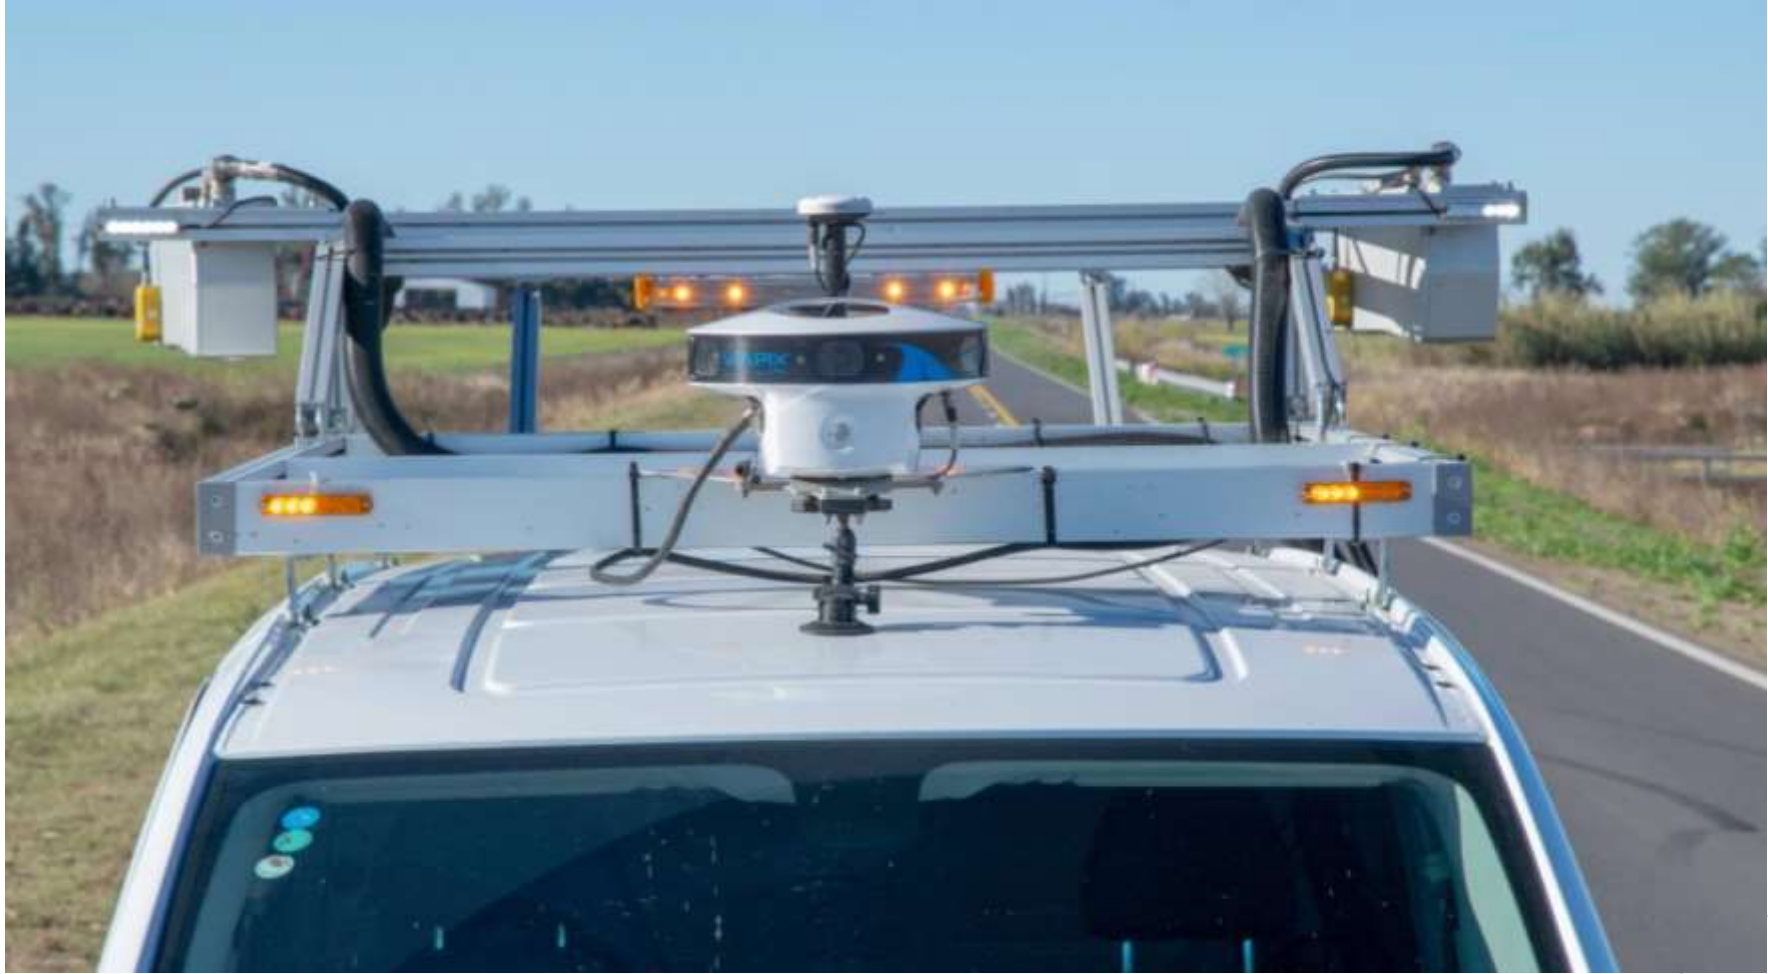
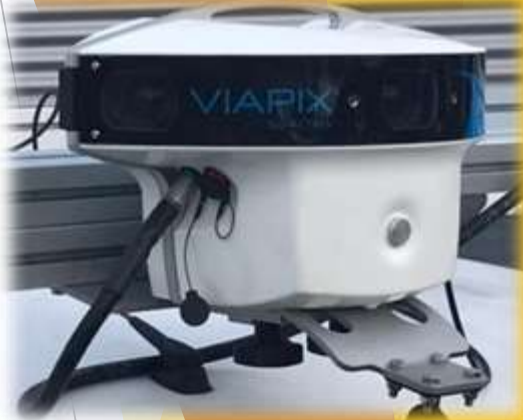
DIGITAL ROAD INVENTORY

VIAPIX

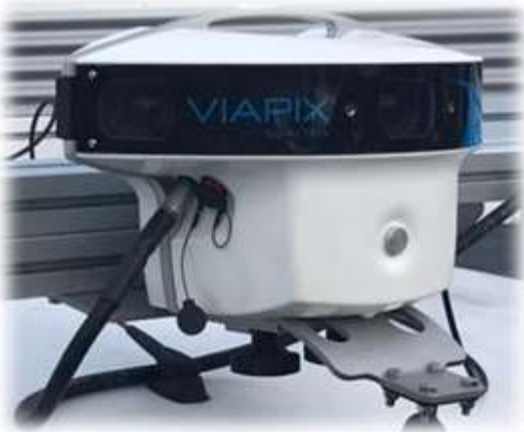
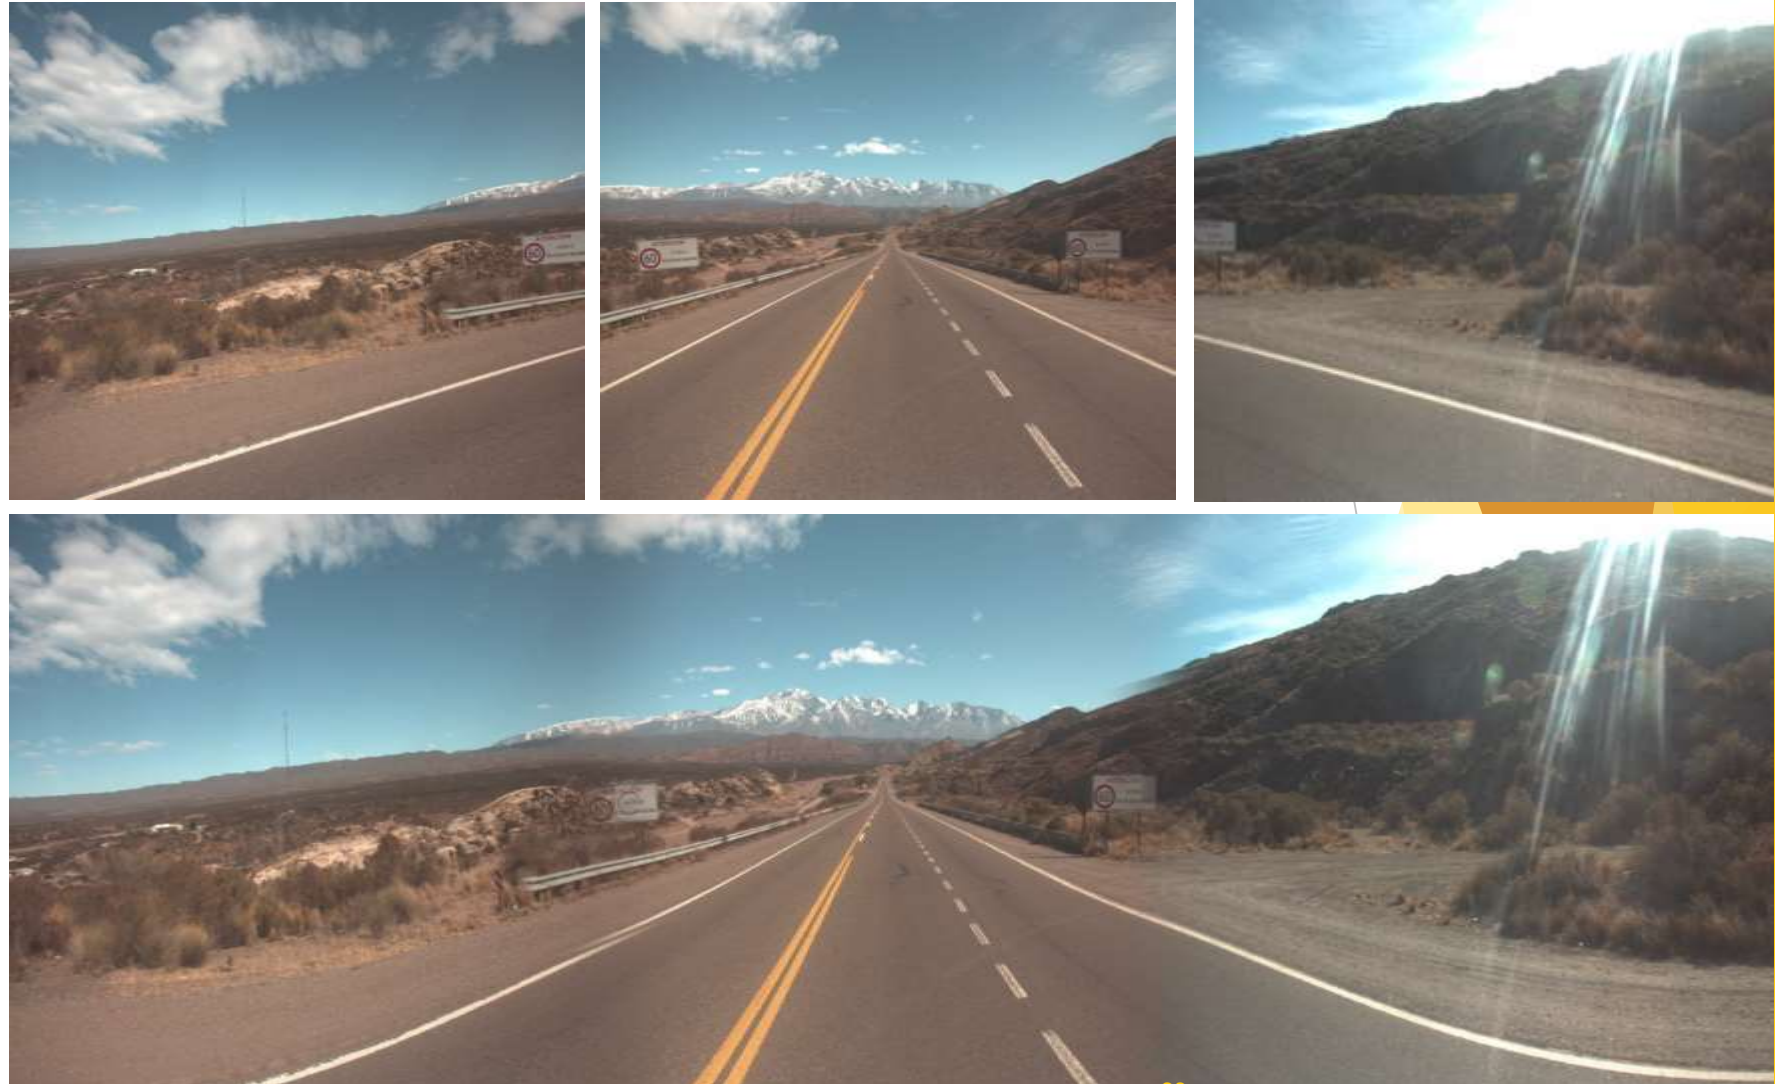
DIGITAL ROAD INVENTORY

PRINCIPAL FEATURES

- ❖ 3 High Quality Cameras
- ❖ Panoramic View (180°)
- ❖ Hybrid Navigation System (High Precision GPS / GLONASS / DGPS / Inertial Measurement Unit / DMI)

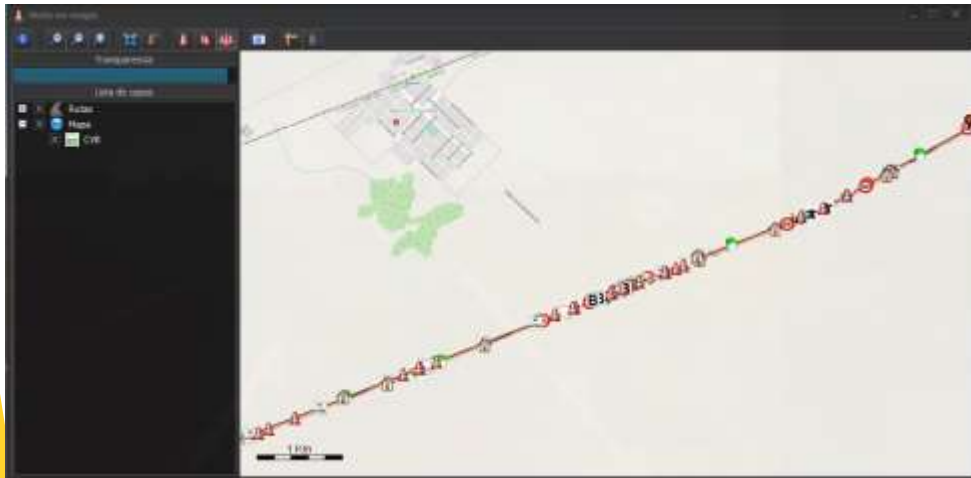
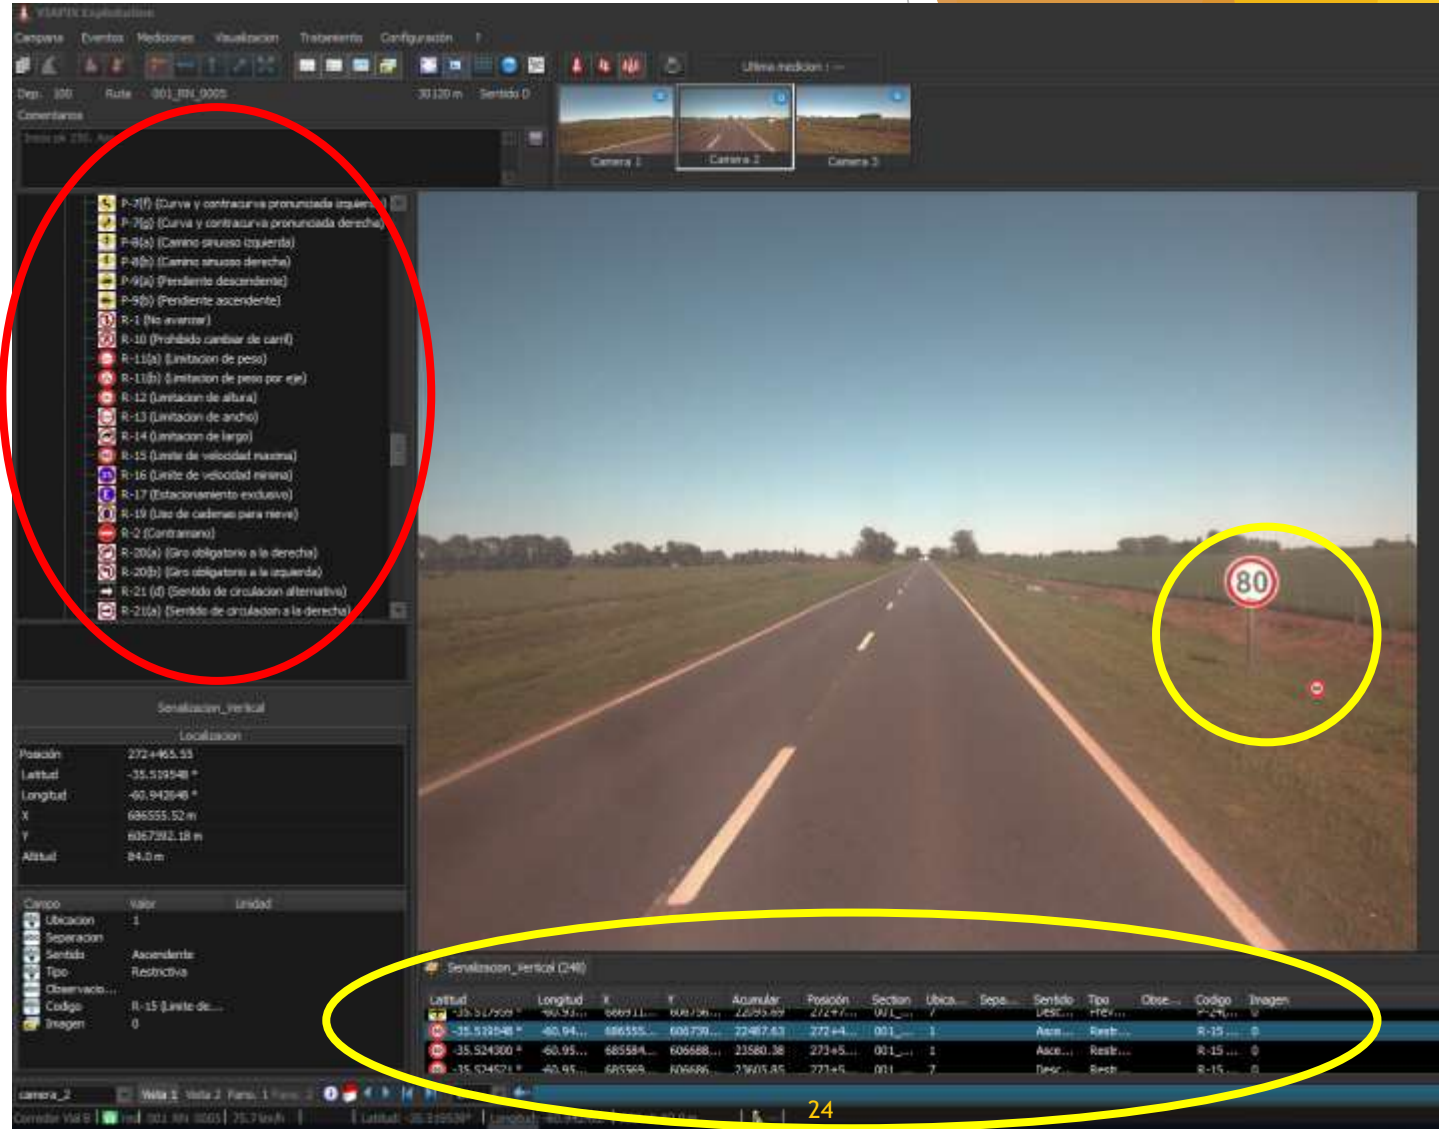
DIGITAL ROAD INVENTORY

TREATMENT SOFTWARE

- ❖ Fully Detailed Data Base (including + 4000 different objects)
- ❖ Geolocalized Objects (Latitude, Longitude, Altitude, Position)
- ❖ Vehicle Mapping Tracking (ArcGIS, Google Earth)

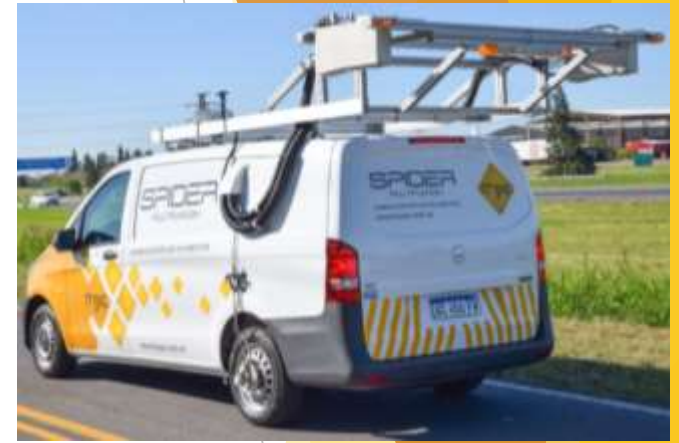
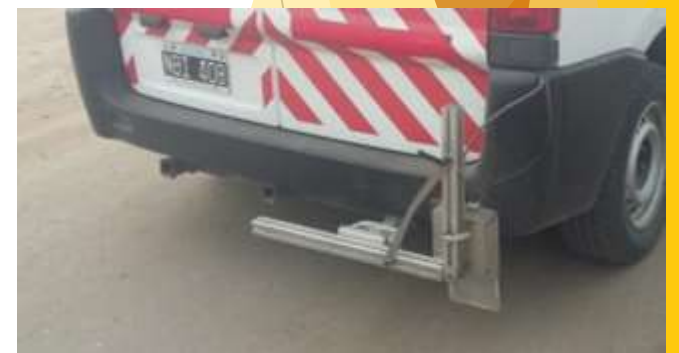
LONGITUDINAL PROFILE (I.R.I.)

NETWORK "F" – National Road N° 09

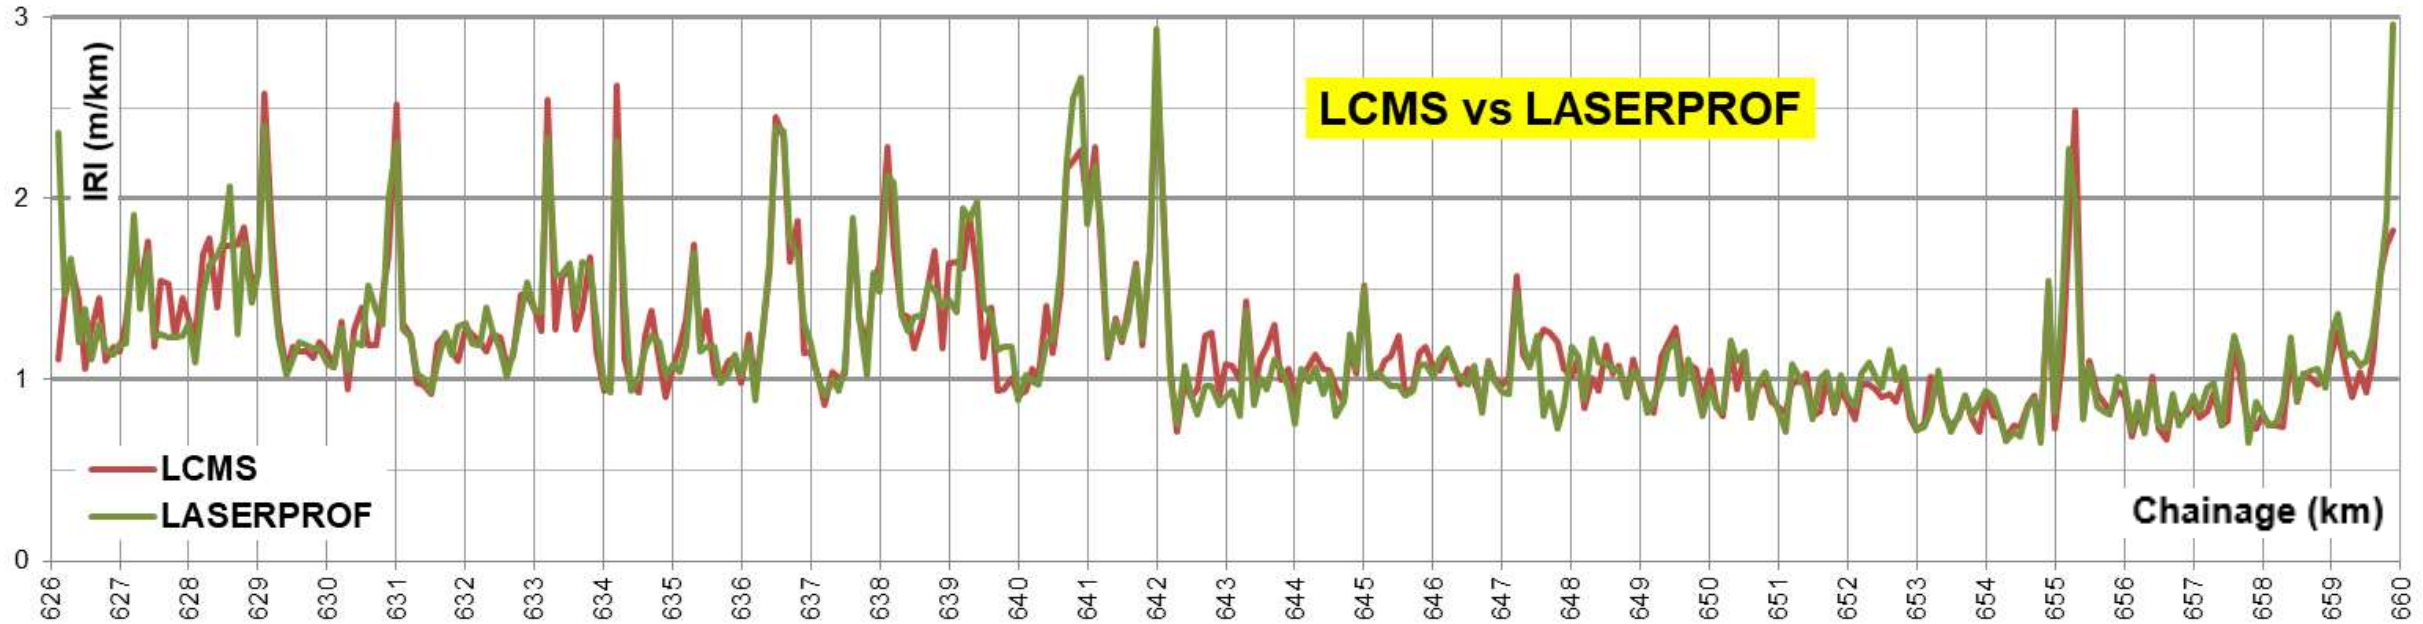
LONGITUDINAL PROFILE (I.R.I.)

NETWORK "F" – National Road N° 09

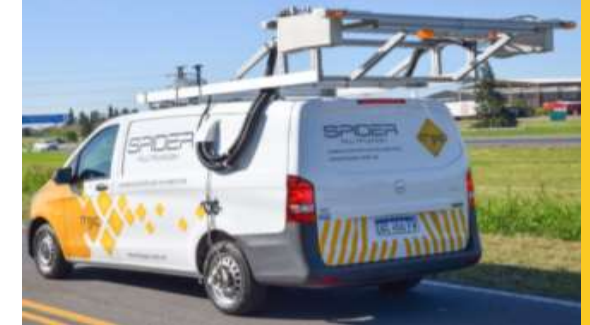
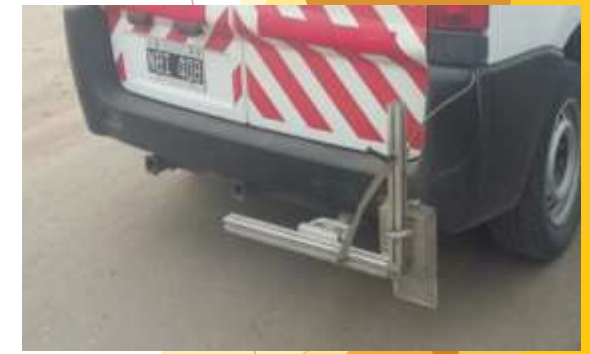
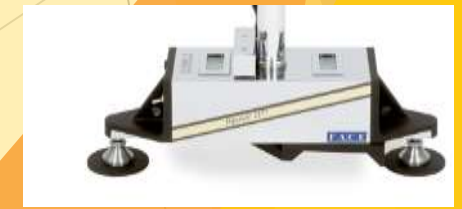
LONGITUDINAL PROFILE (I.R.I.)

LCMS vs Laserprof vs Dipstick

EQUIPMENT SECTION CONTROL TEST

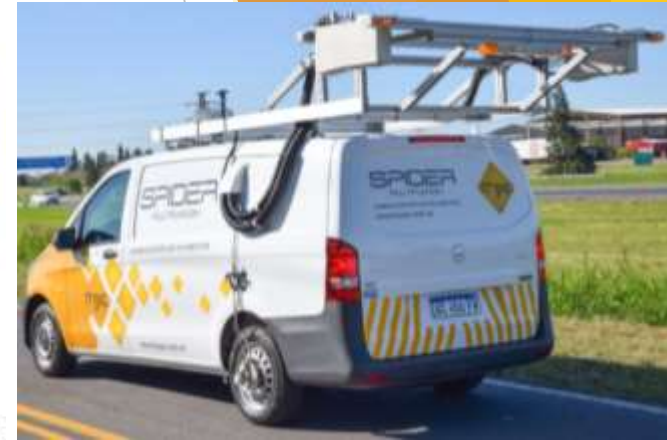
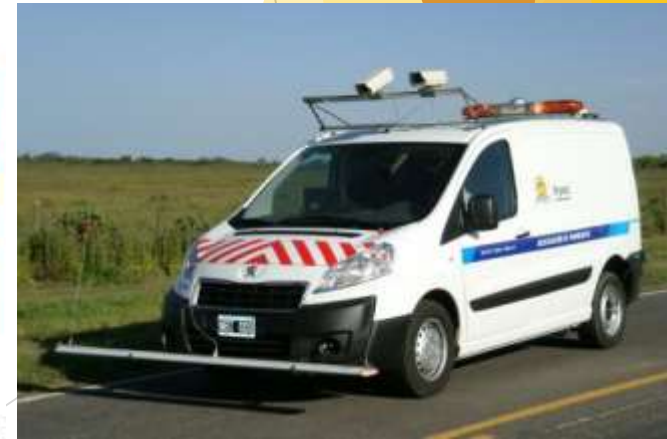
RUTTING

Laser Crack Measurement System vs TUS

NETWORK "F" – National Road N° 09

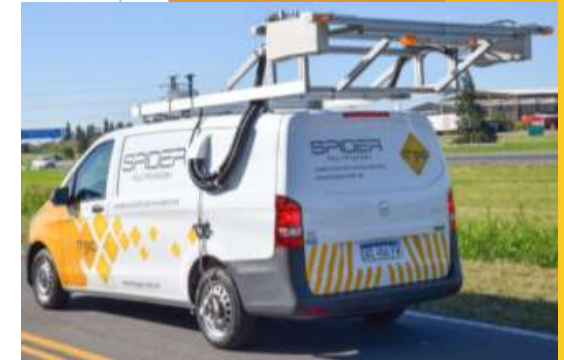
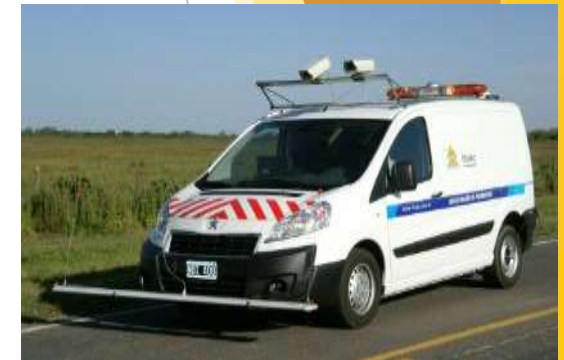
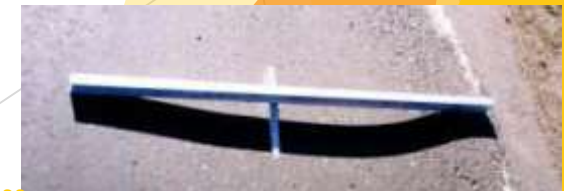
RUTTING

Laser Crack Measurement System vs TUS vs Straightedge 1,20 m

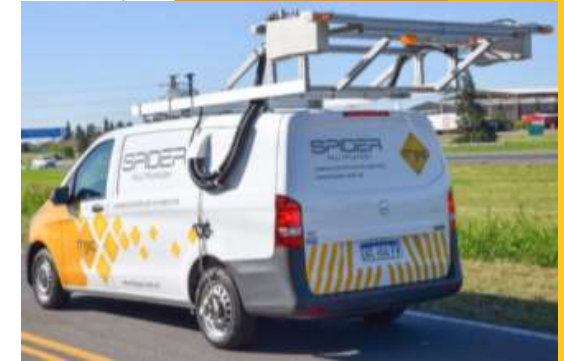
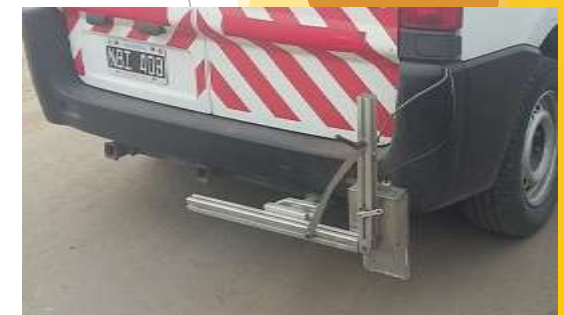
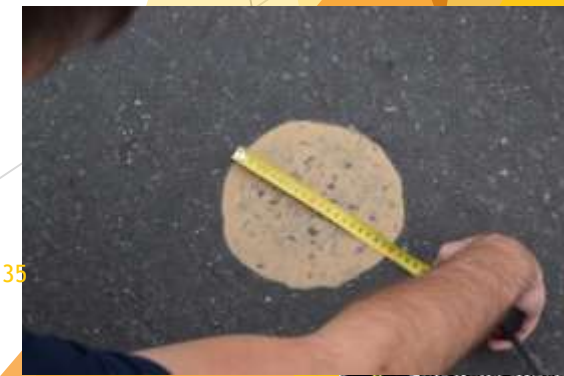
MACROTEXTURE (M.T.D.)

Laser Crack Measurement System v.s.
Laserprof v.s. Sand Patch

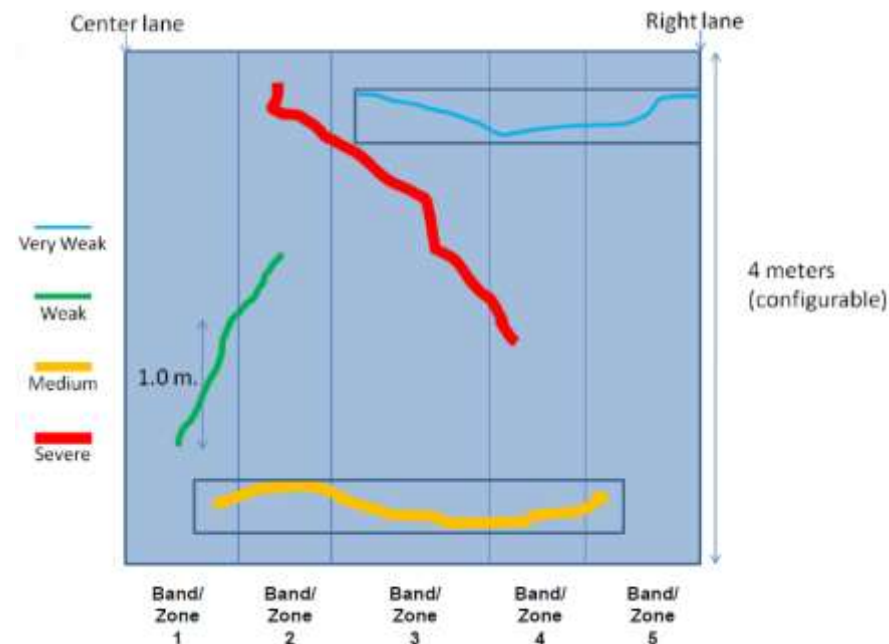
AUTOMATIC DISTRESS DETECTION CRACKING

Quantified Cracking Protocol: MTQ

- ❖ Five configurable road zones / bands
- ❖ Four severities (width detection): Very Weak, Weak, Medium, Severe (setup)

Very Weak (0-3 mm), Weak (3-6 mm), Medium (6-20), Severe (>20) (setup)

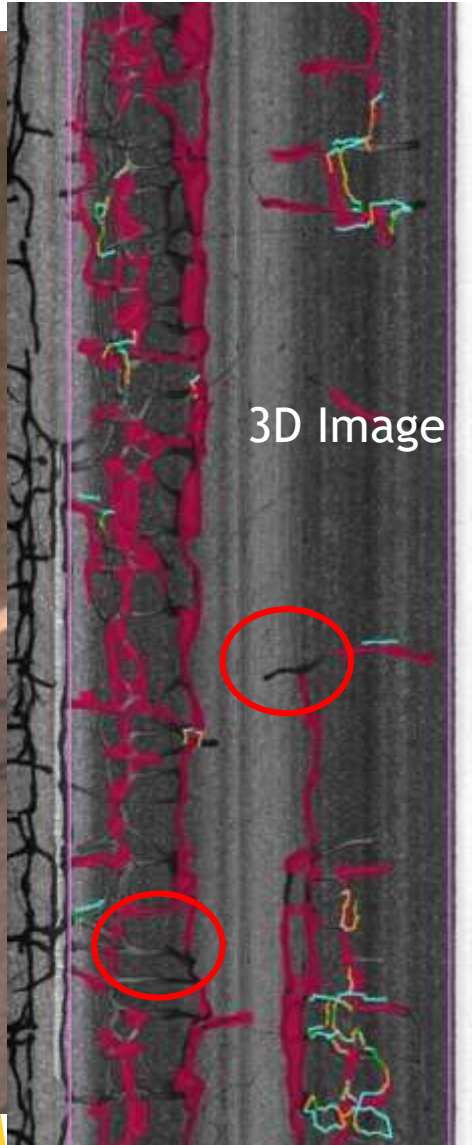
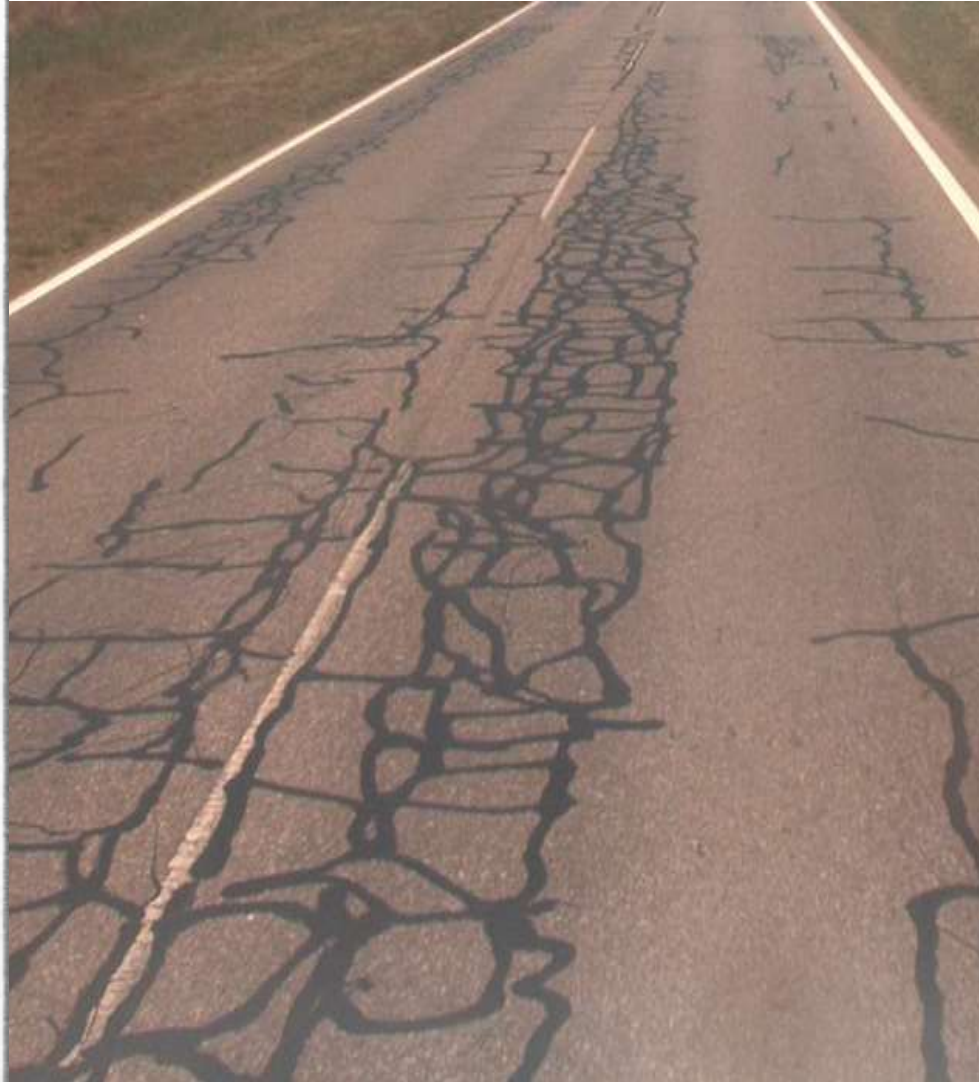
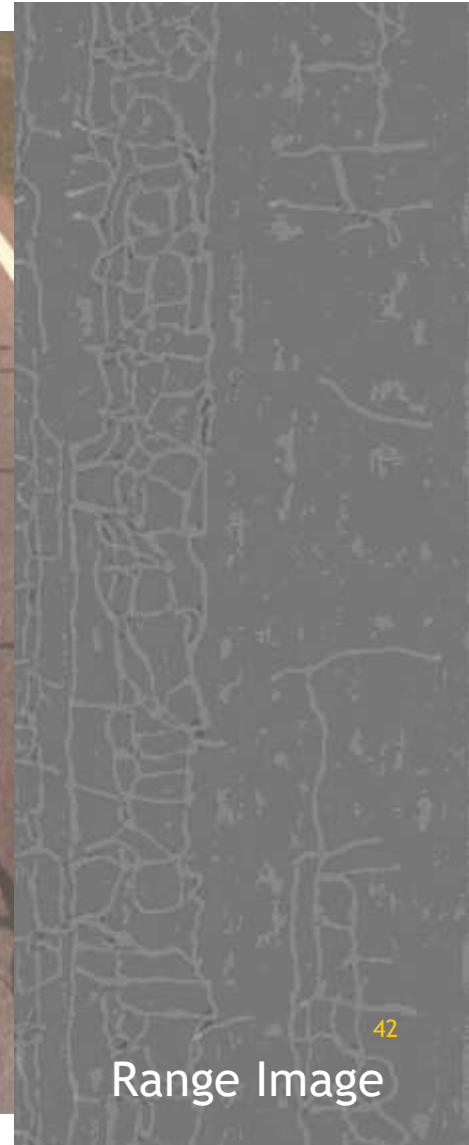
SEALED CRACKS

NETWORK "B" – National Road N° 05
