Pavement Evaluation 2019

September 17-20, 2019
Roanoke, Virginia

Experiences in the use of Automatic 3-D Distress Evaluation System for pavement monitoring in Argentina

Eng. Gustavo Mezzelani
ITYAC S.A. – Rosario, Argentina

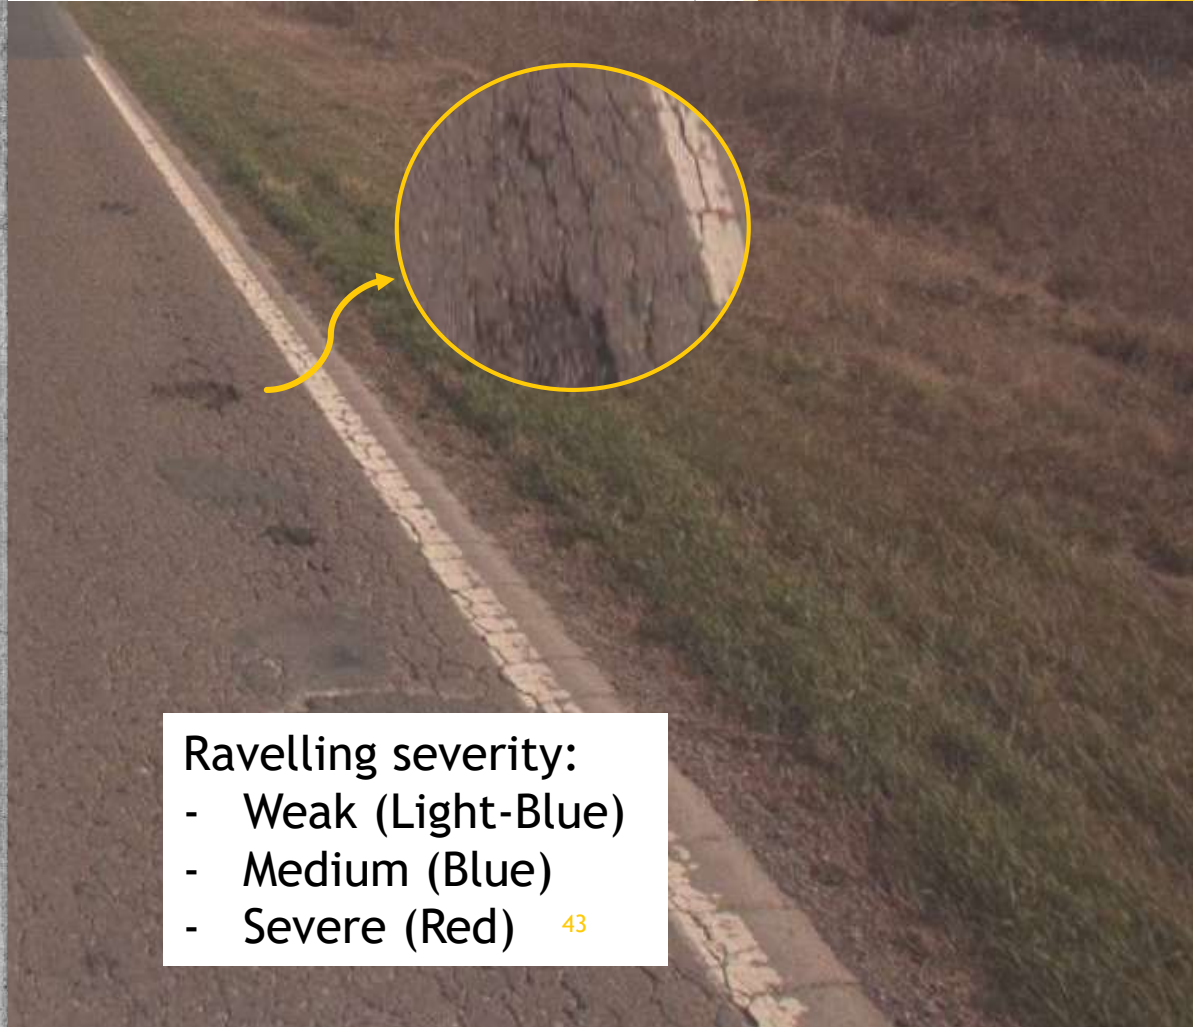
POTHOLES AND RAVELLING

NETWORK "F" – National Road N° 33

Ravelling severity:

- Weak (Light-Blue)
- Medium (Blue)
- Severe (Red)

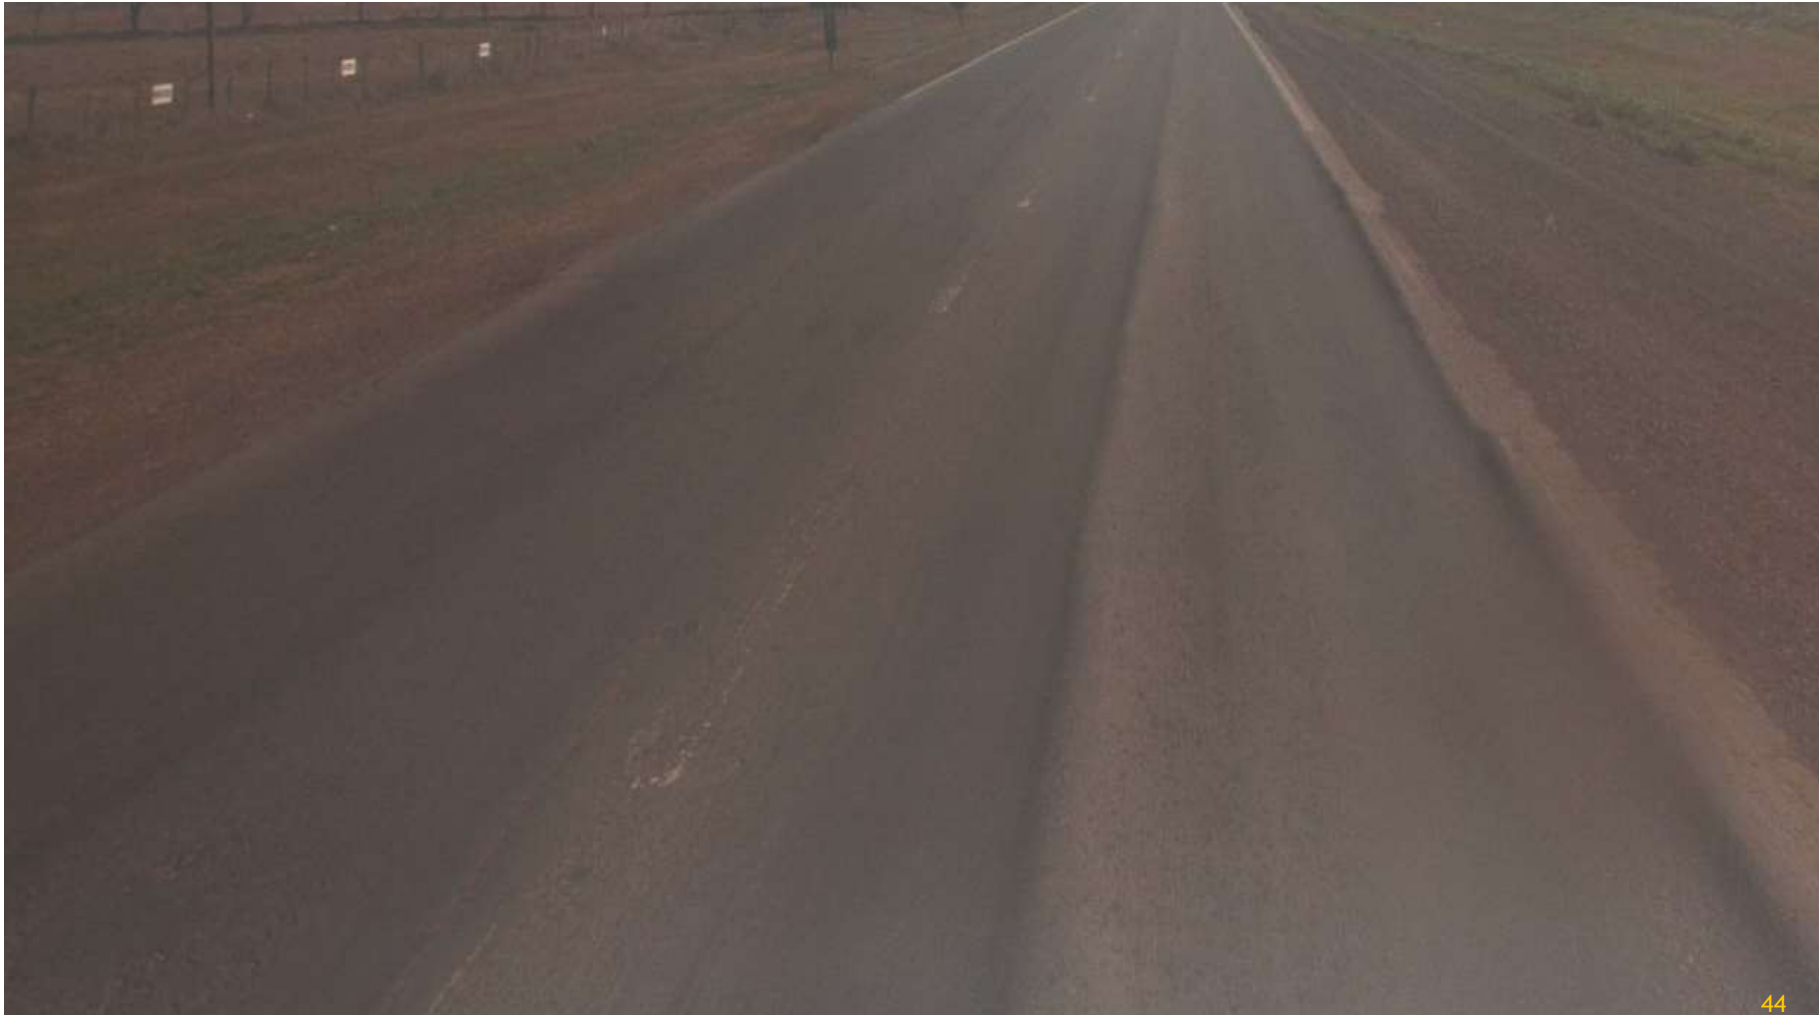
TO BE CONSIDERED... RUTTING

NETWORK "E" – National Road N° A-012

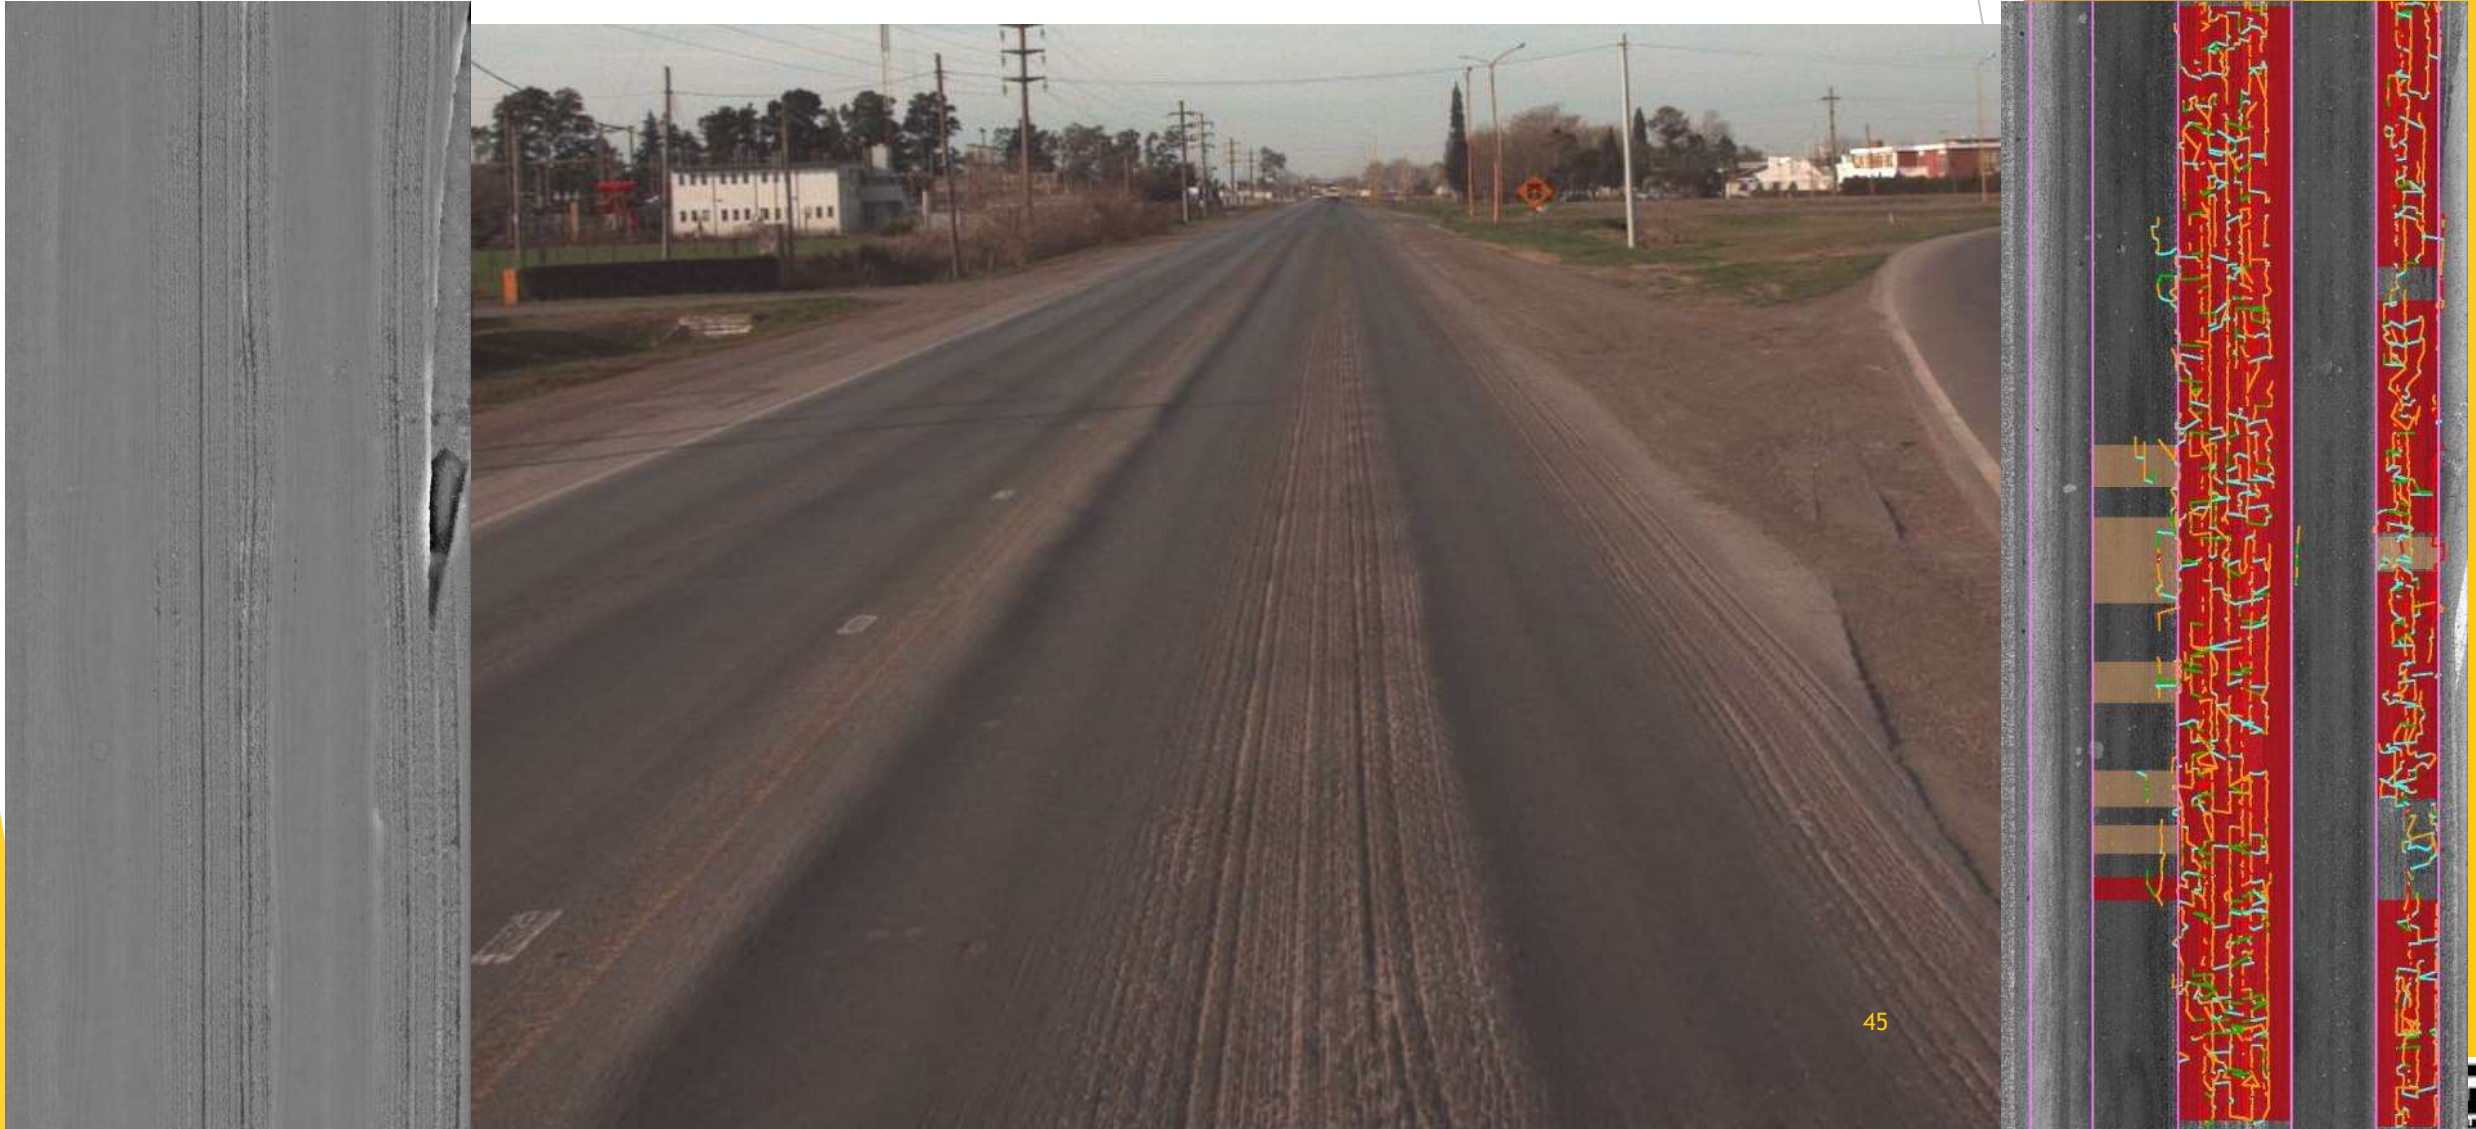
**TO BE CONSIDERED...**
PRESENCE OF MILLING
